CALSPAN ON-SITE CHILD SAFETY SEAT CRASH INVESTIGATION

CASE NO: CA07-031

VEHICLE: 2006 KIA OPTIMA

CRASH DATE: SEPTEMBER 2007

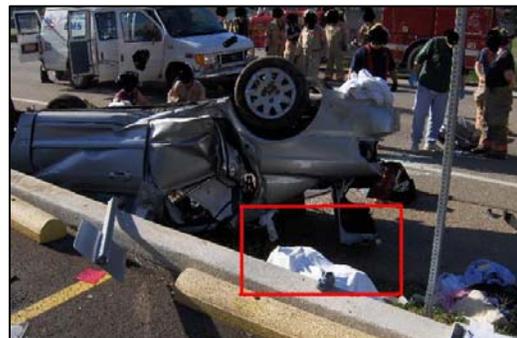
Figure 2 - The final rest position of the CSS (outlined) in relation to the Kia Optima.

1.5 m (5 ft) west of the rest position of the vehicle (**Figure 2**). The child sustained bilateral cerebrum lacerations, multiple skull fractures, fractures of the left clavicle and humerus, and multiple soft tissue injuries while being ejected from the vehicle, and expired at the scene. He was pronounced deceased at the scene. The remaining three occupants were transported to a local hospital with non-life threatening injuries.

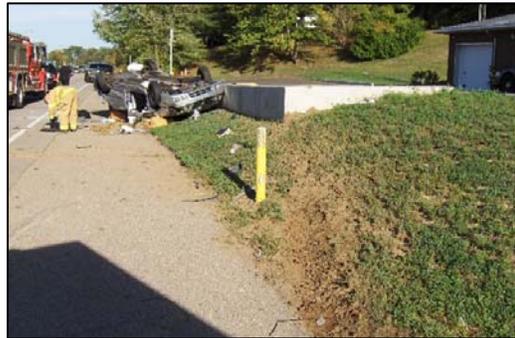
The force of the impact was rearward of the Kia's center of gravity, which caused the Kia to rotate CCW and off-track toward the north roadside (**Figure 5**). Both right side tires left yaw marks on the north shoulder and grassy roadside as the vehicle side-slipped to the right. The yaw mark attributed to the front right tire measured 5.8 m (19 ft) in length and was slightly CCW in orientation. It began slightly outboard of the white fog line and terminated slightly inboard of the grassy roadside. The yaw mark attributed to the right rear tire measured 3 m (9.8 ft) in length and began where the roadway transitioned from asphalt to soft soil on the roadside. During this CCW rotation, the vehicle's center of gravity shifted to the right and additional load was transferred to the outboard sidewalls of right side tires. The sidewall of the right rear tire rolled under the right rear wheel and the tire de-beaded resulting in an air out. The front right rim sustained direct contact damage from roadway interaction but the tire did not flatten. The front rim contact and the de-beading of the right rear wheel caused the vehicle to begin to overturn.

Figure 5 - Post-impact trajectory of the Kia, including the impacted guard post, retaining wall, and the area of final rest.

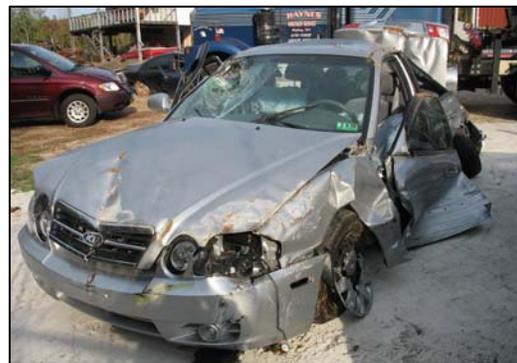
The 2006 Kia Optima sustained moderate damage at several locations due to the multiple impact crash (**Figure 6**). The initial area of impact was to the vehicle's left side; specifically, the direct damage began 13 cm (5") aft of the front left axle and extended rearward for 269 cm (106"). There was no induced left side damage outside of the direct damage pattern. The maximum crush was located 121 cm (48") aft of the front left axle and measured 19 cm (7.5") in depth. The crush profile consisted of six equidistant crush measurements taken along the sill and was as follows: C1 = 1 cm (0.5"), C2 = 13 cm (5"), C3 = 19 cm (7.5"), C4 = 9 cm (3.5"), C5 = 4 cm (1.2"), C6 = 4 cm (1.2"). The Collision Deformation Classification (CDC) for the impact with the 1999 Dodge Neon was 10-LDEW-2. The left rear wheel snagged the Dodge's

Figure 6 - Front and left side planes of the Kia Optima.

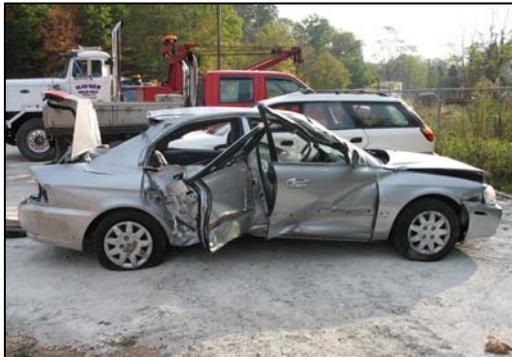
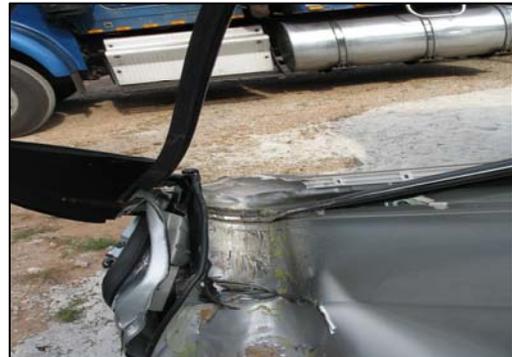
The second impact to the 2006 Kia Optima was a right side impact with a 13 cm (5") diameter guard post (**Figures 7 and 8**). The impact resulted in moderate damage to the right rear door area of the vehicle. The direct contact damage began 36 cm (14.2") forward of the right rear axle and measured 30 cm (11.8") in width. The combined direct and induced damage began 20 cm (7.8") forward of the right rear axle and measured 71 cm (30") in width. The maximum crush was located 46 cm (18.1") forward of the rear axle and crushed laterally to a depth of 20 cm (7.8"). The crush profile consisted of six equidistant measurements taken along the sill. The sill was utilized because the right rear door panel was deformed outward of the vehicle's beltline. The crush profile was as follows: C1 = 3 cm (1.2"), C2 = 20 cm (7.8"), C3 = 14 cm (5.5"), C4 = 6 cm (2.4"), C5 = 3 cm (1.2"), C6 = 0 cm. The CDC for this impact was 02-RPAN-2.

Figure 7 - Overall view of the right side of the Kia Optima.

Figure 8 - Direct contact damage from the impact with the guard post.

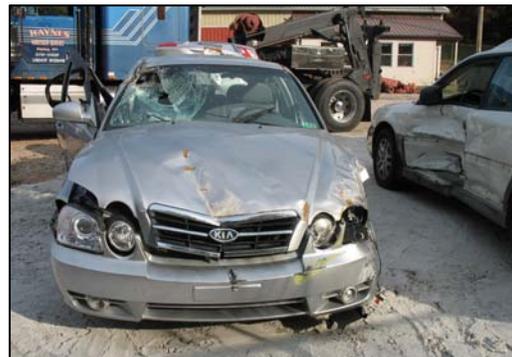
The Kia sustained multiple areas of damage to its front, back, left side, right side, and top planes during the rollover onto the retaining wall. The damage to the front (**Figure 9**) was present in two locations with the first beginning at the left front bumper corner and extending 46

Figure 9 - Frontal plane of the Kia Optima.

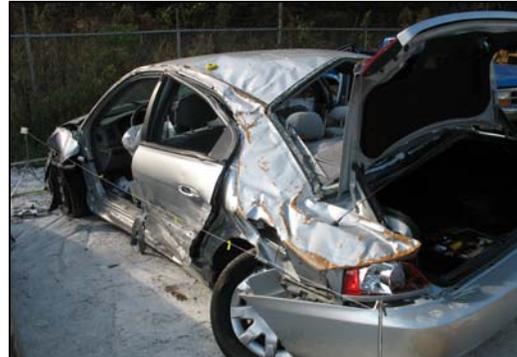
In addition to the left side damage sustained during the impact with the Dodge, the left side of the Kia sustained moderate damage at two separate locations, which resulted from the rollover event along the retaining wall (**Figure 10**). The first area of damage began at the left front bumper corner and extended along the fender rearward 69 cm (27"). The left front wheel sustained multiple tears to the sidewall and the rim displayed numerous vertical striations and several gouges. The second area of damage began at the junction of the left front

Figure 10 -Left rear oblique view of the Kia Optima.

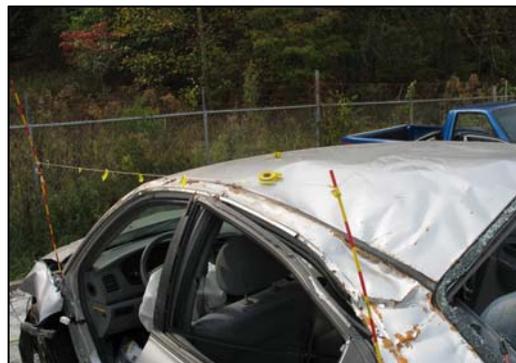
Figure 11 - Damaged roof and C-pillar of the Kia Optima.

and a non-horizontal top impact to the retaining wall (**Figure 11**). The direct contact damage along the roof began at the vehicle's centerline and extended laterally to the left roof side rail 58 cm (22.6"). The damage extended longitudinally 127 cm (50"), the full length of the roof. The maximum vertical crush was located in the C-pillar zone and measured 17 cm (6.5") in depth. The crush profile consisted of six equidistant crush measurements taken vertically from the roof side rail and was as follows: C1 = 17 cm (6.5"), C2 = 10 cm (4"), C3 = 1 cm (0.5"), C4 = 1 cm (0.5"), C5 = 1 cm (0.5"), C6 = 1 cm (0.5"). Two CDC's were assigned to the roof due to the simultaneous events. The CDC for the rollover event was 00-TDDO-3 and the CDC for the top impact was 00-TDYW-3.

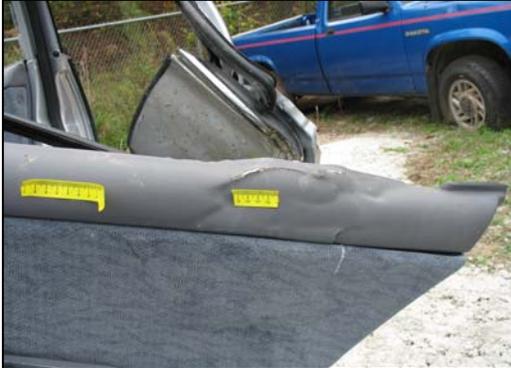
The inboard aspect of the right rear door of the 2006 Optima exhibited three discernable areas of probable contact with the CSS (**Figure 12**). A scratch was present on the plastic door panel. The scratch was 1 cm (0.5") in length and located 17 cm (6.7") forward of the rear aspect of the door panel. It is probable that the scratch occurred as the door intruded and contacted the CSS. A linear oriented tear was present on the fabric of the inboard door panel. The tear was 1 cm (0.5") in length and was located 62 cm (24.4") aft the B-pillar. A longitudinally oriented 38 cm (15") abraded crack was present along the beltline of the door panel. It began 30 cm (11.8") aft of the B-pillar and terminated 68 cm (27") aft of the same. A lone hair was identified at the mid aspect of the roof side rail consistent with the ejection path of the child.

Figure 12 - Inboard aspect of the right rear door panel.

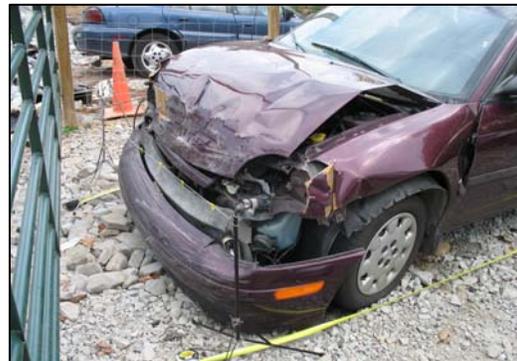
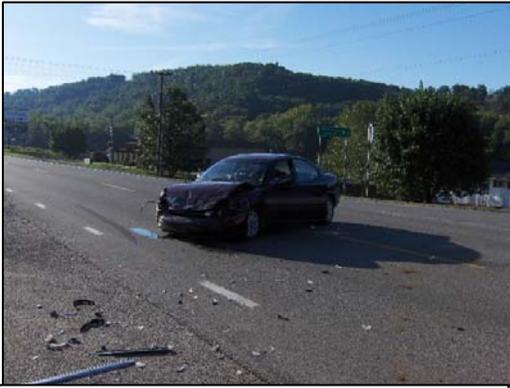
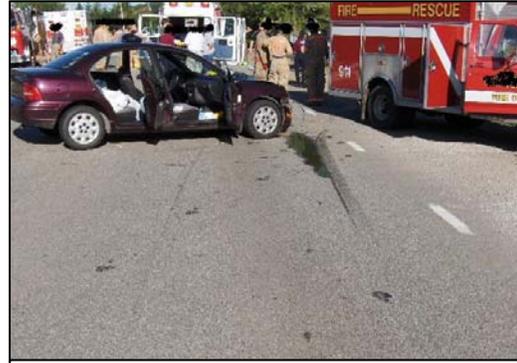
The 1999 Dodge Neon sustained moderate damage as a result of the impact with the Kia Optima (**Figure 14**). The direct contact damage and the combined direct and induced damage extended from the left bumper corner to right bumper corner. The bumper cover and energy absorption material separated from the reinforcement bar; therefore, the rebar was utilized as the Field L and to generate the crush profile. The rebar measured 119 cm (46.9") in length and the undeformed end width was 142 cm (56"). The maximum crush was located at the vehicle's centerline and measured 14 cm (5.5") in depth. The crush profile consisted of six equidistant measurements taken along the rebar and was as follows: C1 = 10 cm (4"), C2 = 12 cm (5.25"), C3 = 14 cm (5.5"), C4 = 14 cm (5.5"), C5 = 10 cm (4"), C6 = 9 cm (3.5"). The CDC for the impact with the Kia was 01-FDEW-1. **Figures 15 and 16** are on-scene views of the Dodge Neon at final rest.

Figure 14 - Frontal damage to 1999 Dodge Neon.

Figure 15 – Frontal damage and the on-scene final rest position of the Dodge Neon.

Figure 16 - Damage and final rest position of the Dodge Neon

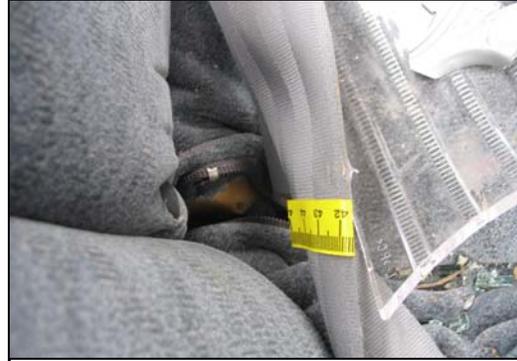
The second row belts were configured with sliding latch plates. The right rear lap belt was used to install the CSS without the attachable base in the right rear seating position. The lap belt was routed across the belt paths on the forward aspect of the CSS. Post-crash, the right rear belt remained buckled with the latch plate still engaged with the receiver (**Figure 17**). The investigating police officer advised that since the CSS was completely ejected from the vehicle there was no need to unlatch the belt system post-crash. In this position, the slack in the lap belt from the anchor point to the latch plate engaged in the buckle measured 71 cm (28"). The full length of the right rear belt webbing was 220 cm (90"). The switchable retractor was fully operational and in the ELR mode at the time of the SCI inspection. Body fluid transfers were present along the lower half aspect of the belt webbing, which began at the anchor point and extended upwards 104 cm (41"). A small tear was also present on the webbing; it was located 15 cm (6") above the anchor point and measured 1 cm (0.5") in length (**Figure 18**).

Figure 18 - Small tear in lap belt webbing.

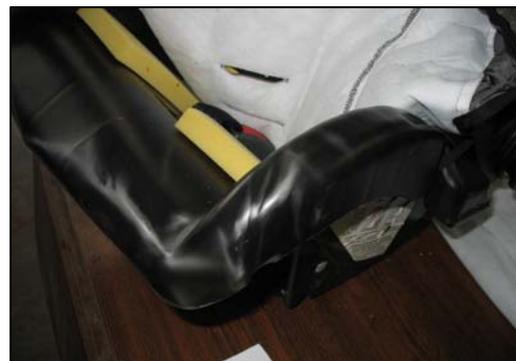
The combination of the slack and crash forces allowed the lap belt to become free of the left belt path. The intruding door contacted the lower forward aspect of the CSS shell resulting in stress marks [an area of 11 x 11 cm (4.5 x 4.5”)] to the CSS (**Figure 20**). The lap belt was still engaged within the right belt path; however, as the CSS responded to the crash forces, the right belt path fractured (**Figure 21**). After the fracture of the belt path, the CSS became disengaged from the belt system and was partially ejected from the right side of the vehicle during the subsequent crash events.

Figure 20 - Stress marks on lower left frontal aspect of the CSS shell.

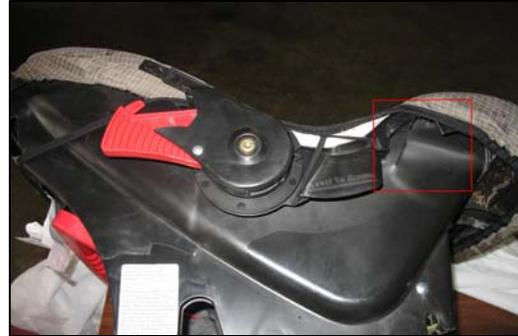
(20") gap between it and the roof side rail. As the vehicle rolled two-quarter turns, the CSS and child's head were contacted by the vehicle. Body fluid transfers were found within the parking stalls of the police barracks parking lot following the crash. Additional damage to the CSS is outlined below.

Figure 21 - Fractured right belt path.

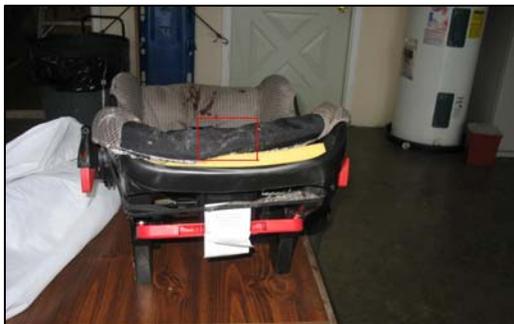
The top of the CSS revealed surface scratching and torn fabric at the uppermost aspect of the CSS. The tear to the fabric encompassed the entire top aspect and was 35 cm (14") in width. Blue, yellow, and red substance transfers were present within the fabric of the CSS (**Figure 22**). The parking space lane lines in the area of the body fluid transfers on the cement were painted blue and the parking curbs within the parking spaces were painted yellow. It is probable that transfers to the top aspect fabric of the CSS occurred as it was partially ejected from the vehicle. A fabric abrasion was also identified 20 cm (8") below the top of the CSS. This is the area where the child's head would be positioned. The abrasion is consistent with contacting concrete and had white dust particles embedded within the fabric (**Figure 23**). Associative body fluid transfers were prevalent within this area of the CSS as well.

Figure 22 - Damage and paint transfers to the top of CSS.

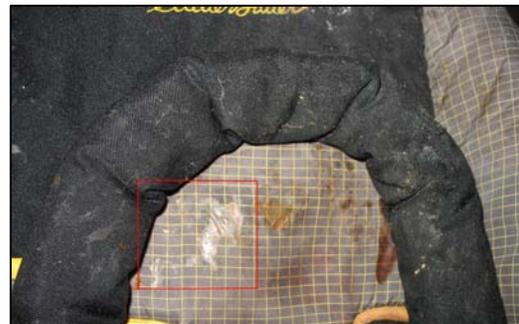
Figure 23 - White substance transfers to the front of the CSS.

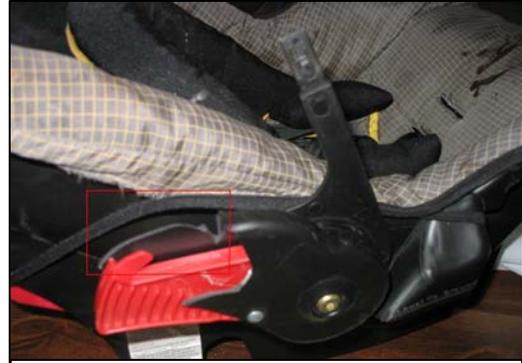
In addition to the aforementioned fracture of the right belt path, the right side of the child seat revealed a 10 cm (4") longitudinally oriented fracture to the lower rear aspect of the shell, aft of the arch designed to engage the CSS base. A 9 cm (3.5") semi-circular fracture was present on the lower aspect of the right side carrying handle slightly above the handle adjuster (**Figure 24**). Additional scuffing and scratching was located along the right side surface of the shell indicative of engaging the abrasive surface of the retaining wall. An underlying 10 cm (4") diagonally oriented fracture to the shell of the CSS was present beneath the fractured belt path

Figure 24 - Damage to the mid right side aspect of the CSS.

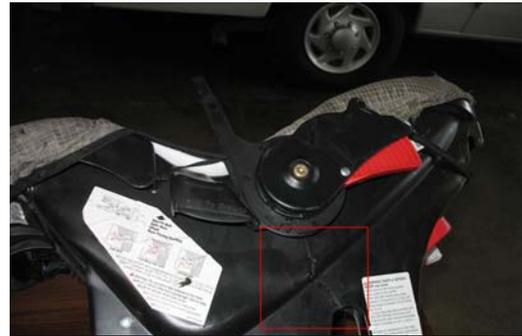
The left side of the CSS sustained additional damage which included a fracture at the base of the carrying handle, additional fractures to the shell, and torn fabric at multiple locations. An 8 cm (3") vertically oriented fracture began at the base of the carrying handle adjuster and extended downward to the base attachment of the CSS (**Figure 25**).

Figure 25 - Damage to the mid left aspect of the CSS.

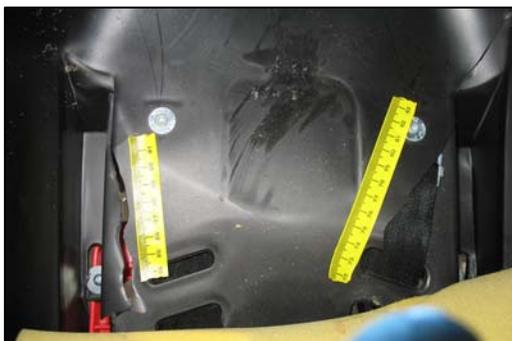
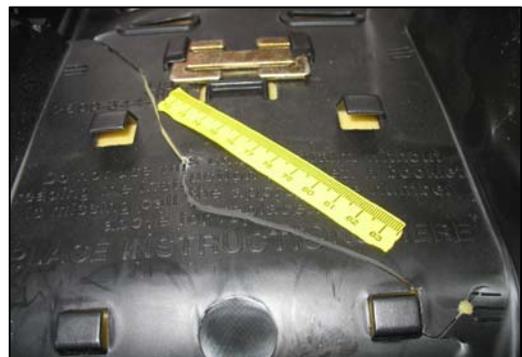
The back and underside of the shell sustained multiple fractures and concentrated areas of surface scratching. Both outboard aspects of the shell sustained vertically oriented fractures during the crash (**Figure 26**). The fracture to the left outboard aspect of the CSS began 21 cm (8.3") below the top aspect of the CSS and extended downward 11 cm (4.5"). The fracture to the right outboard aspect of the shell began 12 cm (4.5") below the top aspect and extended downward 44 cm (17"). An additional 22 cm (8.7") long diagonally oriented fracture, which emanated from the lower right aspect and terminated at the upper left aspect, was identified (**Figure 27**). Areas of surface scratching from concrete were present in several areas on the back and underside of the shell consistent from contacting an abrasive material such as concrete.

Figure 26 - Dual fractures to the back of the CSS.

Figure 27 - Diagonally oriented fracture to the back of the CSS.

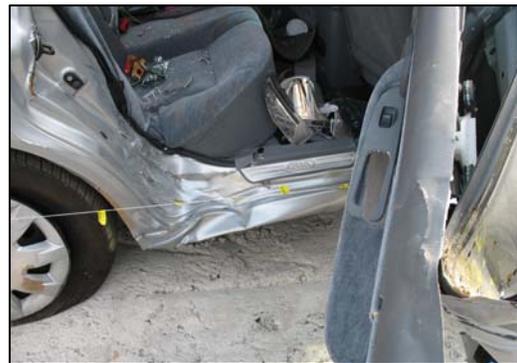
Figure 28 - Intruding right rear door panel, crush to the sill, and compressed right rear seat.

rotated CCW, its wheels dug into the soft roadside soil and it began to partially overturn. As it was partially overturning, its right side impacted an 88 cm (34.5") guard post that was located on the right roadside. The impact resulted in crush that pocketed in the area of the rear aspect of the right rear door. This impact resulted in 11 cm (4.5") of intrusion to the right rear door and it compressed the right seat cushion (**Figure 28**). As this occurred, the CSS was also compressed, resulting in stress marks to the lower left frontal aspect. Additionally, the impact caused the outboard anchor of the safety belt to deform inboard. Slack in the belt webbing was introduced and the safety belt disengaged from the left belt path. During the dynamic movement of the CSS in relation to the crash forces, the right belt path fractured.
