**CALSPAN ON-SITE SIDE IMPACT INFLATABLE  
OCCUPANT PROTECTION CRASH INVESTIGATION**

**CASE NO: CA07-032**

**VEHICLE: 2007 ACURA MDX**

**CRASH DATE: OCTOBER 2007**

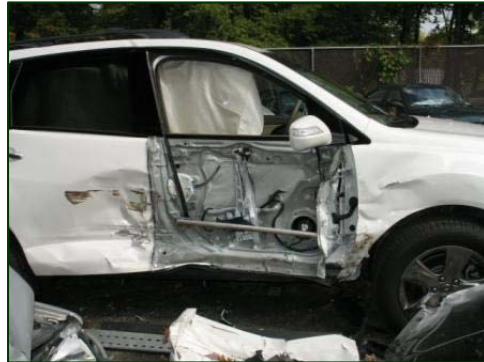
**Figure 1. Right side damage to the Acura.**

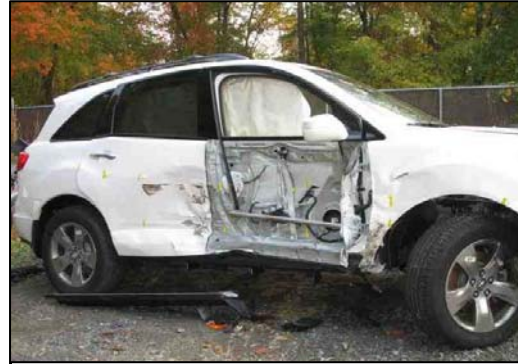
The 2007 Acura MDX sustained moderate damage as the result of the impact with the Land Rover (**Figure 4**). The direct contact damage began 69 cm (27") forward of the right rear axle and measured 191 cm (75") in length. The combined direct and induced damage began 13 cm forward of the right rear axle and measured 284 cm (116") in length. The maximum crush was located between C3 and C4, 170 cm (67") forward of the right rear axle. The maximum crush measured 22 cm (8.7") in depth. The crush profile consisted of six equidistant measurements taken along the mid-door level of the vehicle's right side and was as follows: C1 = 0 cm, C2 = 2 cm (0.5"), C3 = 10 cm (4"), C4 = 19 cm (7.5"), C5 = 4 cm (1.5"), C6 = 0 cm. The Collision Deformation Classification (CDC) for this impact was 01-RYEW-2.

**Figure 4 - Damaged right side of the Acura.**

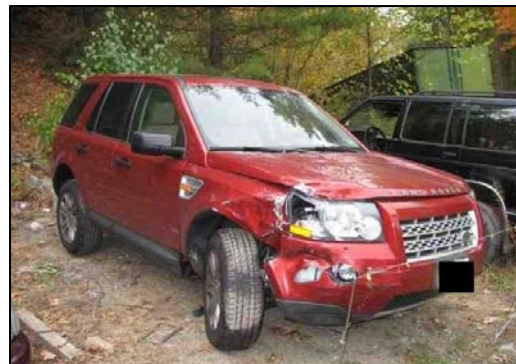
The 2008 Land Rover LR2 sustained minor damage during the impact with the 2007 Acura MDX (**Figure 5**). The direct contact damage began 36 cm (14") right of the vehicle's centerline and extended 48 cm (19") to the front right bumper corner. The direct and induced damage encompassed the full frontal bumper width and measured 160 cm (63"). The maximum crush was to the front right bumper corner and measured 22 cm (8.7") in depth. Six

**Figure 5 - Damaged front plane of the Land Rover.**

equidistant crush measurements were taken along the front bumper of the Land Rover and were as follows: C1 = 0 cm, C2 = 0 cm, C3 = 0 cm, C4 = 1 cm, C5 = 2 cm, C6 = 12 cm (4.7"). The CDC for the impact with the Land Rover was 12-FDEW-1.

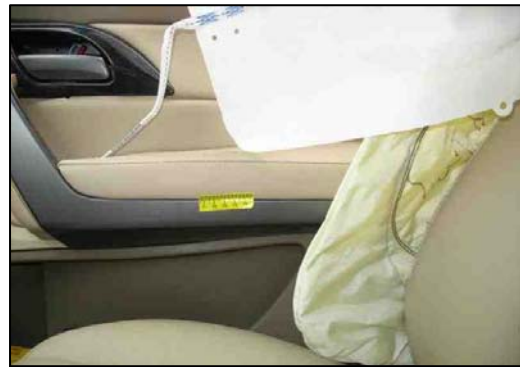
The thorax bag was housed within a module in the outboard aspect of the seat back and expanded forward to offer a measure of inflatable protection between the occupant's thorax and the door panel (**Figure 6**). The deployed air bag was rectangular and measured 15 cm (5.75") horizontally and 50 cm (20") vertically. The air bag had two stitch patterns that created a chamber effect. The area within the stitched chambers does not inflate during the deployment of the air bag. The front right door panel and right B-pillar intruded 9 cm (3.5") laterally into the vehicle during the impact; however, there remained a sufficient path in between these components and the seat back to allow for the deployment of the thorax bag. During the NMVCCS phase of the investigation, the researcher reported a possible failure of the seat back air bag, specifically, that the bag's deployment path was impeded by the passenger compartment intrusion. It was also reported that the membrane remained partially rolled up, was restricted between the seat back and B-pillar, and did not fully deploy. During the SCI investigation, however, it was determined that the intrusion of the B-pillar did not impede the air bag's path and it deployed correctly. It is probable that the air bag was manipulated post-crash by either the front right occupant or an emergency responder. Further, there was no evidence of occupant contact to the thorax bag nor was there evidence of deployment restriction on the air bag membrane or surrounding components. **Figures 7 and 8** were provided by the NMVCCS investigator to the SCI team for review of the potential air bag failure.

**Figure 6 - Seat back mounted side air bag.**

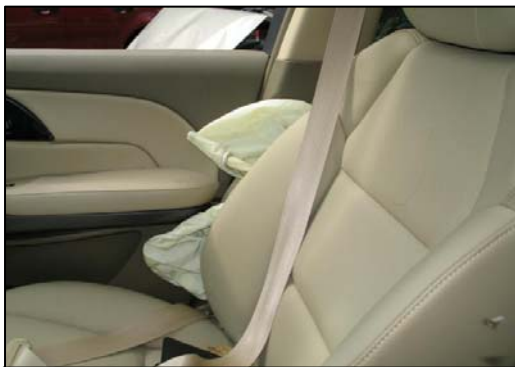
**Figure 7 - Side impact seat back mounted air bag.**

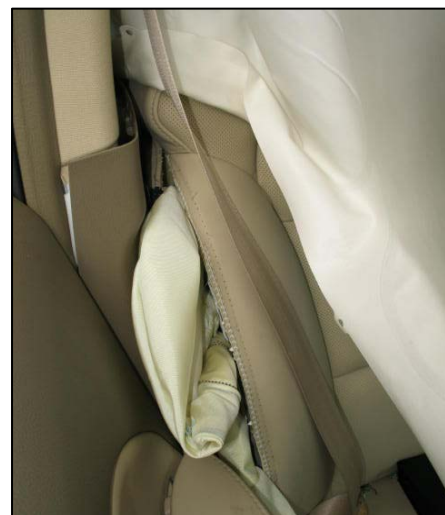
**Figure 8 - Seat back mounted side air bag.**

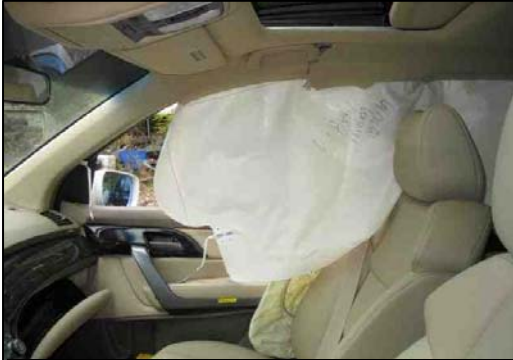
The right IC (**Figures 9 and 10**) deployed downward from its mounting in the vehicle's roof side rail. The rectangular IC provided coverage that extended from the A- to the C-pillars. At deployment, the IC was inflated by compressed helium that was stored in a

canister located in the roof-rail behind the C-pillar. The overall dimensions of the air bag measured 224 cm x 53 cm (21" x 88"), length by height, respectively. The IC was tethered at the A-pillar and to the roof side rail between the C- and D-pillars. The front tether was cut at its midpoint post-crash. There was no discernable loading evidence on the deployed side air bags.

**Figure 9 - Right side first row inflatable curtain air bag.**

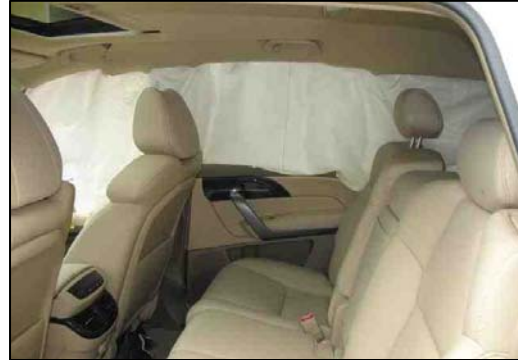
**Figure 10 - Right side second row inflatable curtain air bag.**
