CALSPAN ON-SITE CHILD SAFETY SEAT FATALITY INVESTIGATION
GRACO SNUG RIDE CHILD SAFETY SEAT
SCI CASE NO: CA07-033

VEHICLE: 1998 FORD EXPLORER
LOCATION: TENNESSEE
CRASH DATE: OCTOBER 2007

**CALSPAN ON-SITE CHILD SAFETY SEAT FATALITY INVESTIGATION
SCI CASE NO.: CA07-033**

**VEHICLE: 1998 FORD EXPLORER
LOCATION: TENNESSEE
CRASH DATE: OCTOBER, 2007**

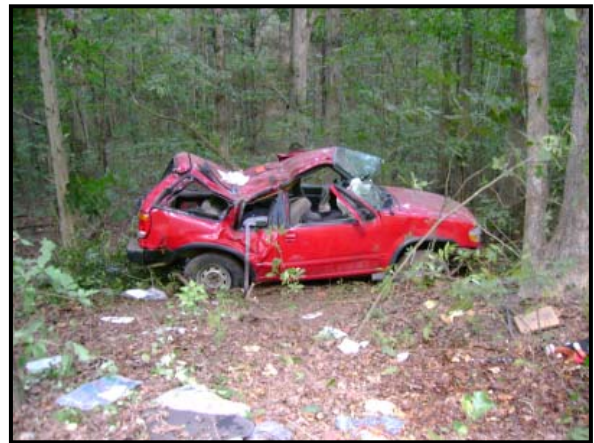
Figure 1: Final rest position of the Ford Explorer.

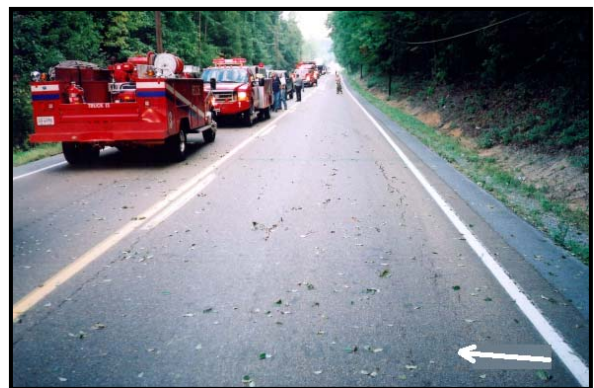
The investigating police officer documented the yaw marks with photographs and basic measurements. **Figure 3** in a north trajectory view at the initiation of the right rear yaw mark. The yaw mark began in the outer third of the travel lane (denoted by the arrow). The mark initially traveled toward the east edge line and then arced to the northwest. The length of the right rear yaw mark measured 47 m (155 ft). The right front yaw mark measured 35 m (115 ft). Due to the passage of time between the crash date and the SCI on-site inspection, the yaw marks in the travel lanes had deteriorated. The physical

Figure 3: On-scene trajectory view of the yaw marks.

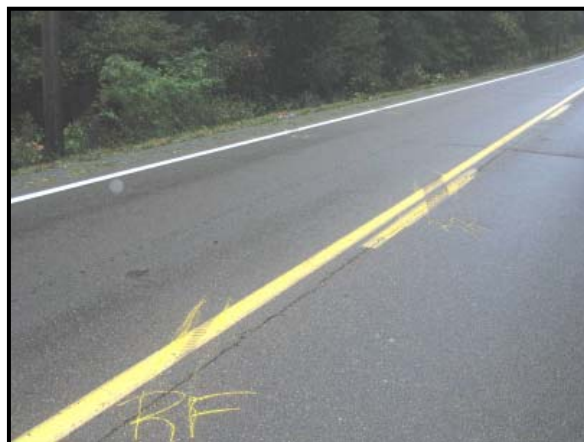
Figure 4 is a trajectory view of the Ford taken during the SCI inspection. The figure depicts the right front and right rear tire marks crossing the center line during the fully developed yaw.

Figure 4: View of the yaw marks.

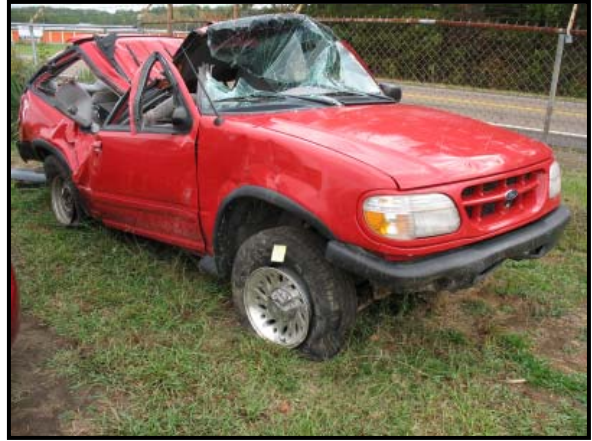
The Ford Explorer sustained contact damage to its right, top and left planes as a result of the crash. **Figure 5** is a front right oblique view of the Explorer. The right plane sustained minor body panel deformation to the right fender as a result of the small tree/brush contacts. The fender was deformed over a 53 cm (21 in) length that began at the right front axle location and extended rearward. The maximum deformation in this region measured 4 cm (1.5 in). A 10 cm (4 in) region of the right rear quarterpanel was deformed to 6 cm (2.25 in) depth as a result of contact to a fence post. This deformation was located 50 cm (19.5 in) aft of the rear axle. A 55 cm (21.5 in) area of the right side plane sustained 14 cm (5.5 in) of induced vertical crush as a result of the roof impact. This area began 3 cm (1 in) forward of the right rear axle.

Figure 5: Front right oblique view of the Ford. 14 cm (5.5 in) of induced vertical crush as a result of the roof impact. This area began 3 cm (1 in) forward of the right rear axle.

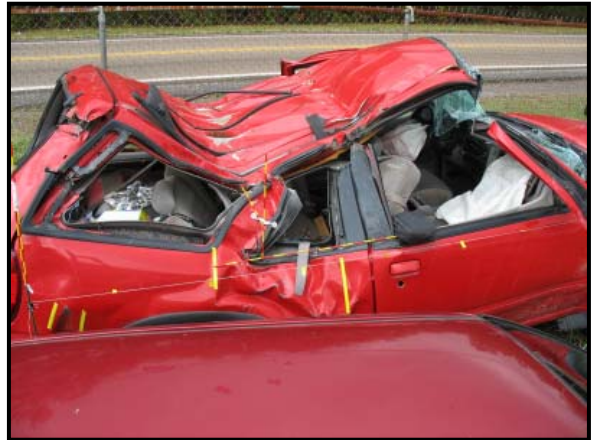
During the first quarter-turn of the rollover, the Explorer impacted the tree with its roof. The direct contact to the tree began 71 cm (28 in) aft of the header and extended rearward 91 cm (36 in). The roof crush was biased to the right side of the vehicle. The right bias of the crush indicated the vehicle had not completed the first quarter-turn prior to the impact. The vertical crush of the right roof rail was documented during the SCI inspection. Refer to **Figure 6**. A reference line was established 69 cm (27 in) above and parallel to the sill. The crush of the roof rail was measured from the D-pillar to the A-pillar relative to the reference line. The Field L was 175 cm (69 in). The crush profile was as follows: C1 = 6 cm (2.5 in), C2 = 30 cm (12.0 in), C3 = 41 cm (16.0 in), C4 = 28 cm (11.0 in), C5 = 10 cm (4.0 in), C6 = 10 cm (4.0 in). The maximum lateral and vertical crush were located at the right C-pillar and measured 43 cm (17 in) and 41 cm (16 in), respectively. The extension of the base of the front right window sill (beltline) was used as a reference.

Figure 6: Right side view depicting the roof deformation.

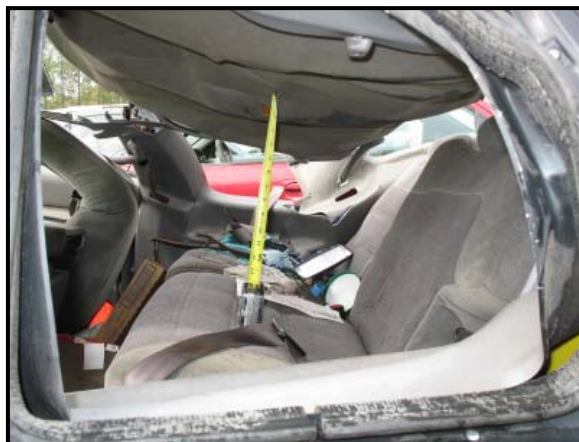
The CSS was restrained in a rear-facing mode in the left rear position. The left rear seat back angle measured 27 degrees. The residual height of the roof measured 43 cm (17 in) above the center of the seat cushion, (**Figure 7**). Although, the intruding roof between the B- and C-pillars contacted the CSS and was the source of the infant's head injury, examination of the headliner was unremarkable.

Figure 7: Measurement of the residual roof height above the left rear seat cushion.

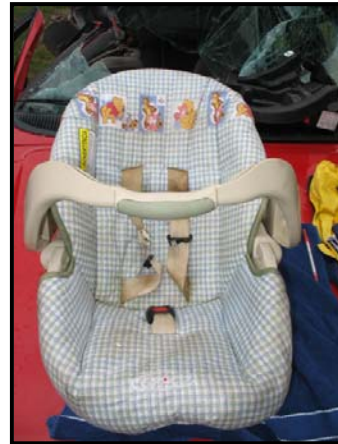
Figure 8 is a front view of the Child Safety Seat (CSS) in use at the time of the crash. The CSS was a Graco Snugride rear-facing infant seat Model No: 7350D0H2, Serial No: JJ0910050936, manufactured September 10, 2005. The CSS without the base was installed in the rear left position of the Ford Explorer, using the vehicle's 3-point lap and shoulder, in a rear-facing mode. The seat was labeled for use by infants that weighed between 2 kg to 10 kg (5 lb to 22 lb) with a height of 74 cm (29 in) or less. The CSS was configured with a 5-point harness system. The harness was routed through the top slots. The harness straps were flat and were not folded over, roped, or creased. The harness retainer clip was present and operational. The two-piece latch plate and buckle assembly operated as designed.

Figure 8: Front view of the Graco Snugride.

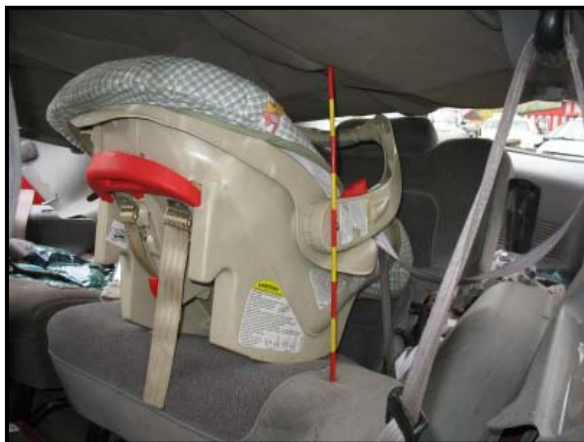
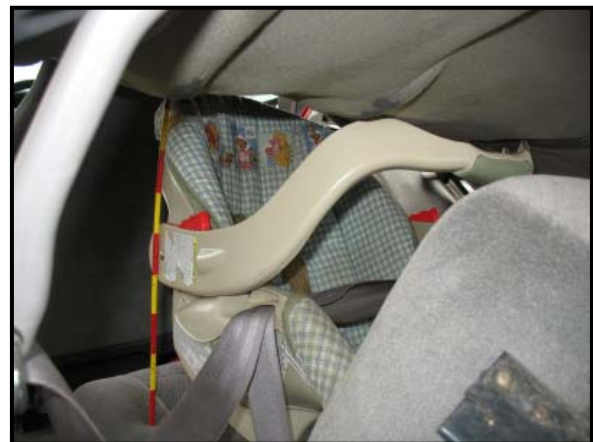
The driver installed the CSS within the vehicle by threading the lap and shoulder belt through the cut-outs of the belt path and buckling the latch plate. She indicated that she removed the slack from the webbing, pulling it tight across the shell. She then set the switchable retractor to the automatic locking mode and fed the balance of the webbing back into the retractor. The carrier handle was in the vertical position. The harness retainer clip was over the mid-chest and the harness straps were reported as “snug” on the infant’s shoulders. **Figures 9 and 10** are a view of the CSS reinstalled within the Explorer.

Figure 9: Left front oblique view of the reinstalled CSS.

Figure 10: Left rear oblique view.

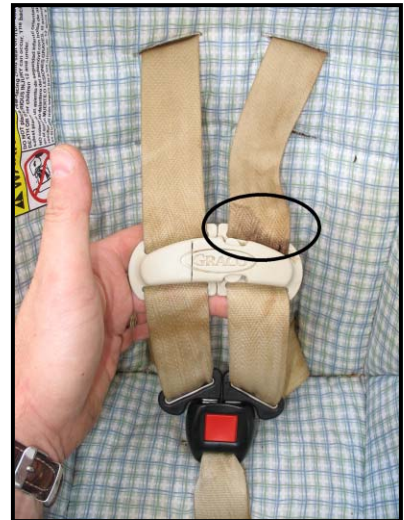
Inspection of the CSS revealed multiple stressed areas (whitened plastic) and a fracture of the shell. Blood evidence was identified on the right strap, immediately above the retainer clip, **Figure 11**. Reportedly, the infant was bleeding from the right ear indicative of a basilar skull fracture. The shell's carrier handle was jammed in a forward position (toward the foot area of the shell). The intruding roof contacted the (vertically positioned) handle, and caused it to rotate forward (opposite its normal rotation) and become jammed. The fabric covering the CSS shell was removed during the SCI inspection. **Figure 12** is a view of the shell with the fabric

Figure 11: Harness straps.

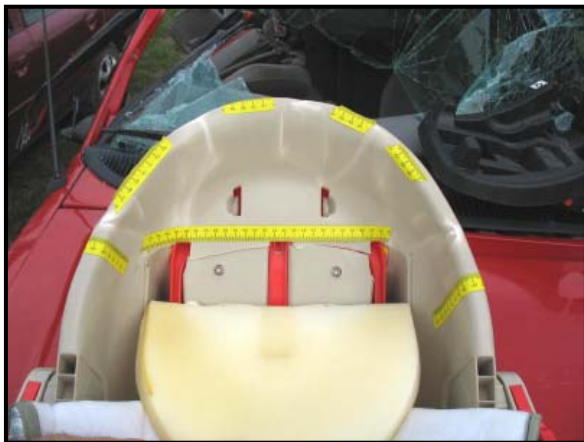
removed. The upper arch of the shell's back was heavily stressed from impact by the intruding roof. The shell was stressed over a 46 cm (18 in) arc length. The infant's head was located in this area and directly contacted the roof. A 25 cm (10 in) long linear fracture was also observed. The shell fractured laterally through the molded cut-outs for the shell's release handle and 6 cm (2.4 in) down the left side to the molded reinforcement below the left harness strap slot. **Figure 13** is a view of the back side of the shell and the fracture line. Additional stress marks were observed to the forward right aspect of the shell in the area of the infant's feet (**Figure 14**). This region of stresses developed as the shell was compressed downward and rearward into the vehicle's seat back by the intruding roof. The examination of the belt path cut-outs was unremarkable for crash related evidence.

Figure 12: Stress marks and fracture across the arch of the upper shell

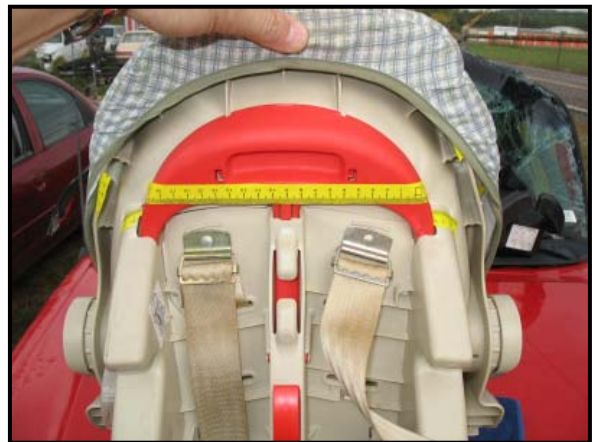
Figure 13: Back view of the fractured shell.

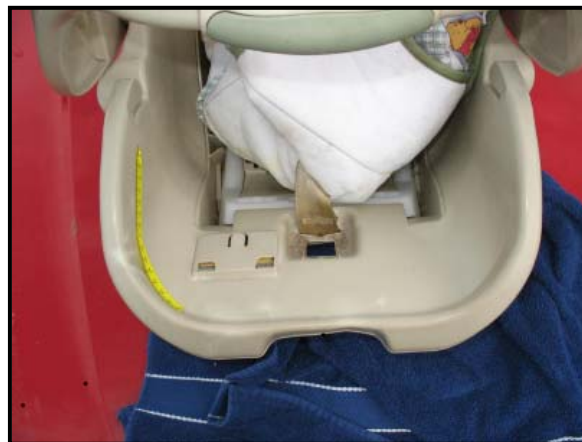
Figure 14: Stressed forward left aspect of the shell.
