ON-SITE NOT IN TRAFFIC SURVEILLANCE BACK OVER INVESTIGATION

CASE NUMBER - IN07034

VEHICLE - 1999 TOYOTA COROLLA CE

INCIDENT DATE - September 2007

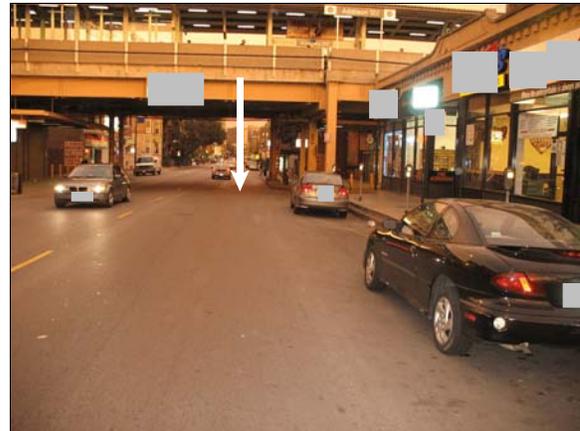
Pre-Crash: There were vehicles parallel parked along the south side of the street and the Toyota was traveling east (**Figure 1**). The Toyota driver (21-year-old, male) was looking for a place to park and found an open space on the south side of the street. He stopped the Toyota an unknown distance east of the parking space and prepared to parallel park (**Figure 1**). The driver stated he looked at his left side view mirror and rearview mirror, then turned and looked over his right shoulder out of the backlight prior to starting the backing maneuver. The driver estimated the elapsed time between stopping the Toyota and beginning the backing maneuver was approximately 2 seconds. There was insufficient information to establish the likely location of the pedestrian relative to the Toyota at the time the driver stopped and prepared to back up. According to the back left passenger, the pedestrian was crossing the street from the north to the southeast, walking slowly, toward the back left of the Toyota (**Figure 2**). However, the police crash report indicated that the pedestrian ran across the street. The pedestrian was reportedly going to his vehicle, which was east of the scene. The driver indicated his intention was to back the Toyota toward and into the open parking space. The driver stated he was in a hurry to park the Toyota because a cab was stopped in the street behind him. The incident occurred in the roadway as the Toyota's driver backed up toward the parking space.

Figure 1: Overview of incident area; driver stopped in area indicated by arrow, then backed to parallel park to the right.

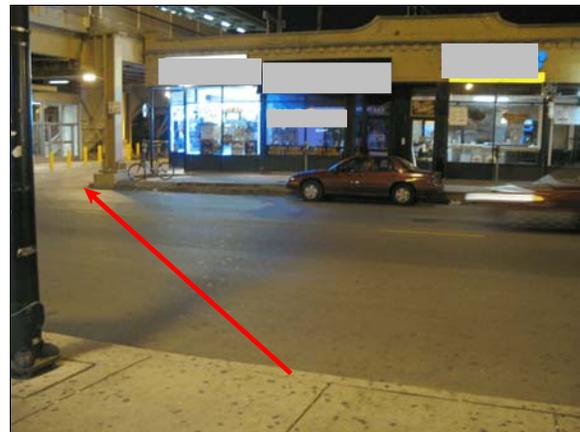
Figure 2: Path of pedestrian from north to southeast

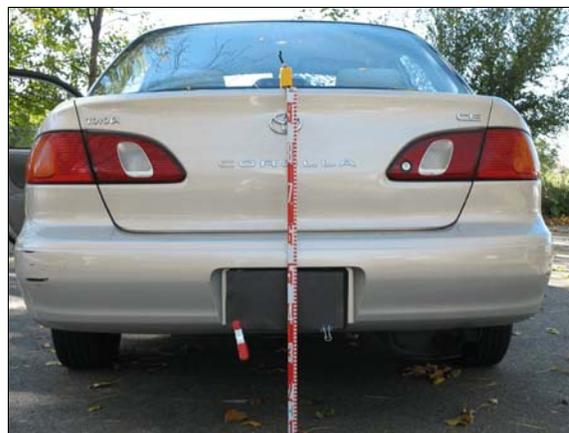
According to the Toyota's back left passenger, as the driver backed up, the back left corner of the Toyota (**Figure 3**) impacted the pedestrian and projected him over the trunk and into the backlight glazing. The driver and back left passenger indicated the pedestrian's impact to the backlight disintegrated the glazing. The police crash report also indicated that the backlight glazing disintegrated as a result of the pedestrian impact. The back left passenger further stated that he remembered the pedestrian's back impacting the backlight glazing. The driver estimated that he had backed up between 2 and 5 seconds before the impact. Based on the driver's statement that he was in a hurry to park because a cab was stopped in the street behind him, the bottom of the driver's time range estimate of 2 seconds appeared to be a reasonable estimate of the time to impact. The driver also estimated he was traveling 8-16 km.p.h. (5 to 10 m.p.h.) when the impact occurred. Based on the outcome of the pedestrian striking and disintegrating the backlight glazing, the top of the driver's speed range estimate of 16 km.p.h (10 m.p.h.) appeared to be a reasonable estimate of the impact speed. It was not possible to determine the distance traveled from the Toyota's stopped position to impact or the distance traveled from impact to final rest due to the lack of scene evidence and the lack of specific information provided by the driver and back left passenger regarding where the driver had stopped prior to backing up. Therefore, an independent time, speed and distance analysis could not be conducted.

Figure 3: Overview of back of Toyota Corolla; scale in tenths of meter

There was no contact evidence to the back of the Toyota Corolla or on the trunk lid, and the damaged backlight had been repaired before inspection by this contractor. Based on the vehicle inspection, the description of the contact by the back left passenger, and Collision Deformation Classification (CDC) guidelines for coding pedestrian impacts, the CDC was estimated to be: **06-BLHN-6 (180 degrees)**. The Toyota was driven from the scene.

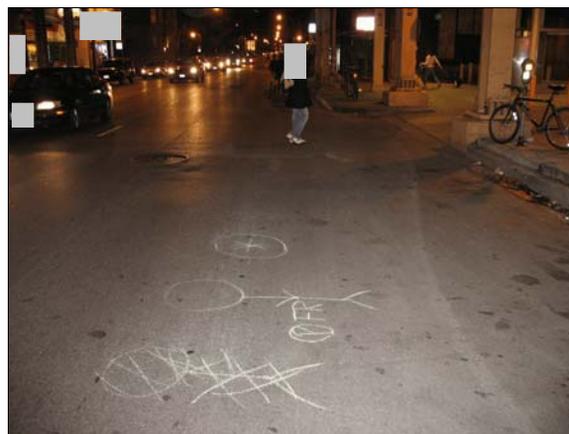
Post-Crash: The Toyota's driver stopped the vehicle, got out, and found the pedestrian on his hands and knees facing north, approximately 1 meter (~3 feet) behind the Toyota (**Figure 4** above). An ambulance was called to the scene and the pedestrian was transported to a hospital where he was treated and released.

Figure 4: Area of final rest of Toyota and pedestrian

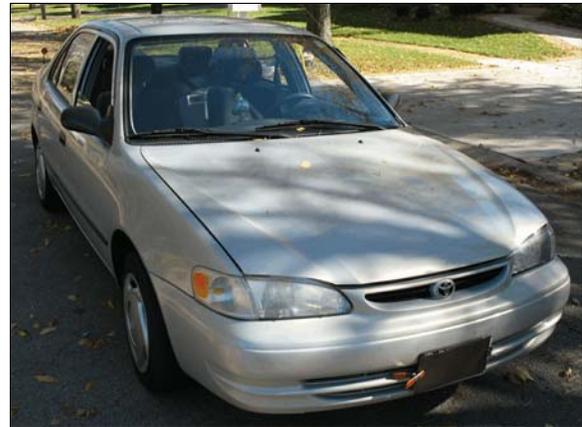
Figure 5: Front right overview of Toyota Corolla

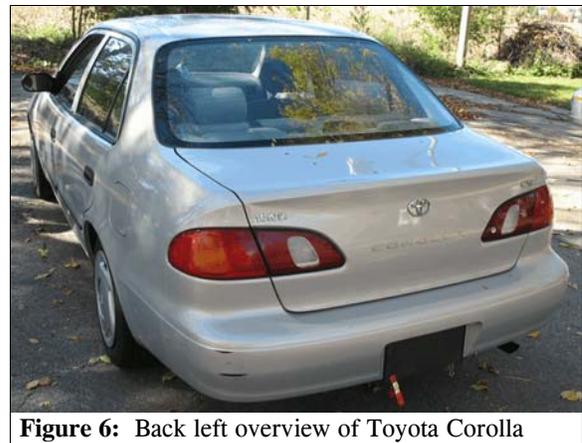
Figure 6: Back left overview of Toyota Corolla

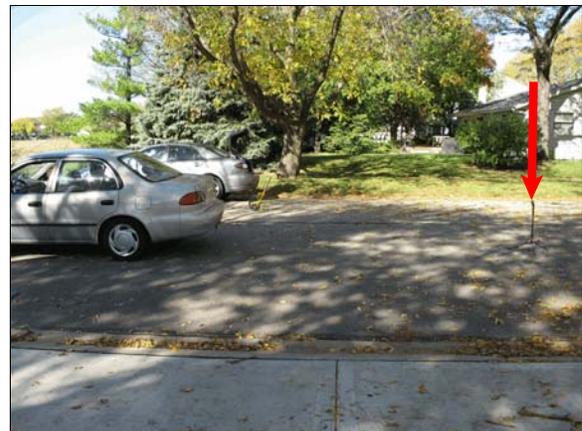
The initial set of observations was made with the surrogate driver looking over her right shoulder out of the backlight as the driver did at the time of the incident. The target was moved

rearward from the back bumper along the Toyota's approximate centerline until it came into the driver's view. The target had to be moved rearward from the back bumper 4.1 meters (13.4 feet) before the top of target came into the driver's view, just to the left of the Center High Mounted Stop Lamp [CHMSL (**Figures 7 and 8**)]. If the target was moved 0.5 meter (1.6 feet) to the right of the approximate centerline, it became obstructed by the CHMSL. The target became visible again to the right of the CHMSL when the target was moved an additional 1.3 meters (4.3 feet). When moved another 1.4 meters (4.6 feet), the target became obstructed by the right "C"-pillar. Finally, the target was moved 2.8 meters (9.2 feet) further to the right, where it became visible to the driver through the right rear window. The target was then placed back at the centerline. When moved 0.3 meter (1 foot) to the left of the approximate centerline, it became obstructed by the back left head restraint. It could not be seen when moved further to the left because it was beyond the limits of normal neck movement for the surrogate driver. A person was not available at the time of the inspection to act as a surrogate back left passenger. However, subsequent to the field investigation, a person of the same height as the back left passenger [i.e.,

Figure 7: Arrow shows target at location where surrogate driver could first see it as she looked over her right shoulder out of backlight

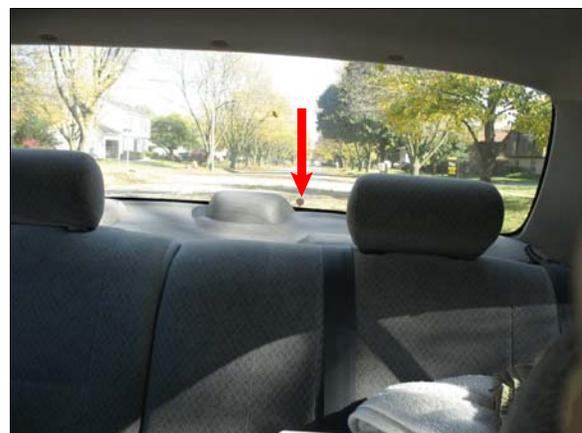
Figure 8: Driver perspective of target (arrow) viewed over right shoulder

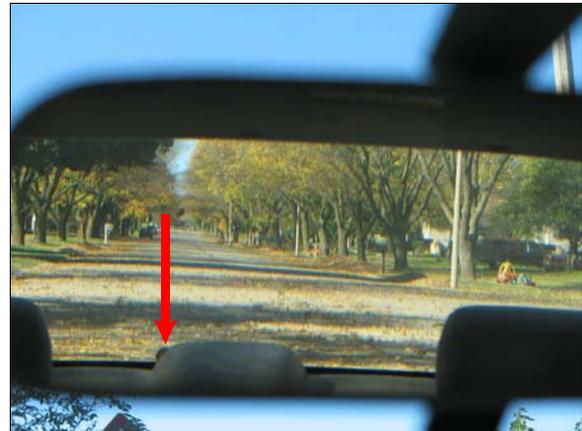
The surrogate driver was then asked to view behind the vehicle through the rearview mirror. The target was placed at the back bumper and moved rearward 3.6 meters (11.8 feet) before the surrogate driver could see it through the rearview mirror (Figure 9). The target was then moved to the right 1.0 meter (3.3 feet) from the Toyota's approximate centerline where it became obstructed by the back right head restraint. The target was not visible when moved further to the right because it went out of the rearview mirror's field of view. When the target was moved left from the centerline 0.9 meters (3.0 feet), it became obstructed by the back left head restraint. The target was not visible when moved further to the left because it again went out of the rearview mirror's field of view. The area behind the CHMSL represented a small additional blind zone for the view through the rearview mirror. The blind zone in this area extended rearward an additional 0.4 meter (1.3 feet) and was 0.5 meter (1.6 feet) wide.

Figure 9: Close view of target (arrow) on left side of CHMSL as seen through rearview mirror viewed from driver's seat

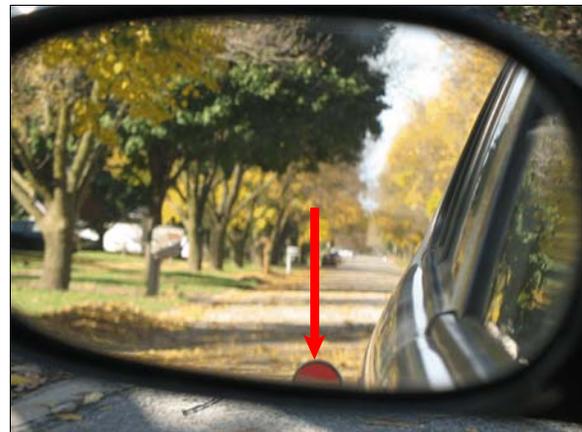
The target was then placed at the back left bumper corner as the surrogate driver viewed through the left side view mirror. The surrogate driver indicated that her side view mirrors were positioned for her and not as the driver had them positioned at the time of the incident. The target was then moved from the driver's door rearward. The surrogate driver indicated she could not see the target through the left side view mirror until it was positioned 0.4 meter (1.3 feet) forward of the back left corner (Figure 10). The target was then moved left 0.5 meter (1.6 feet) from the back left bumper corner where it went out of the mirror's field of view and the driver could no longer see it. The target was then positioned at the back right bumper corner and the same process was

Figure 10: Close view of target (arrow) at location it first became visible to the surrogate driver as she looked through the left side view mirror

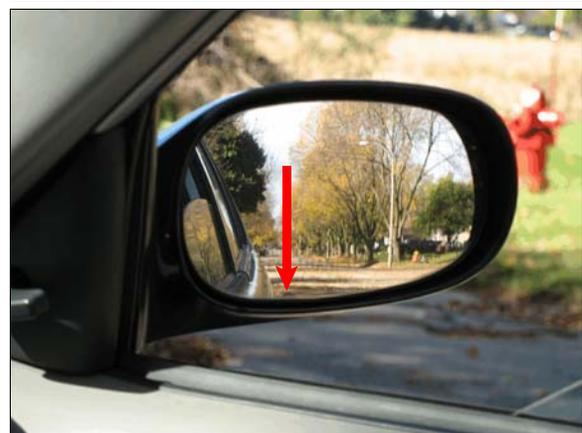
Figure 11: Close view of target (arrow) at location it first became visible to surrogate driver as she looked through the right side view mirror

repeated for the right side view mirror. It was necessary to move the target rearward from the back bumper 0.4 meter (1.3 feet) before the driver could see it in the right side view mirror (Figure 11 above). The target was then moved to the right 0.7 meter (2.3 feet) where it went out of the right side view mirror’s field of view and the driver could no longer see it.

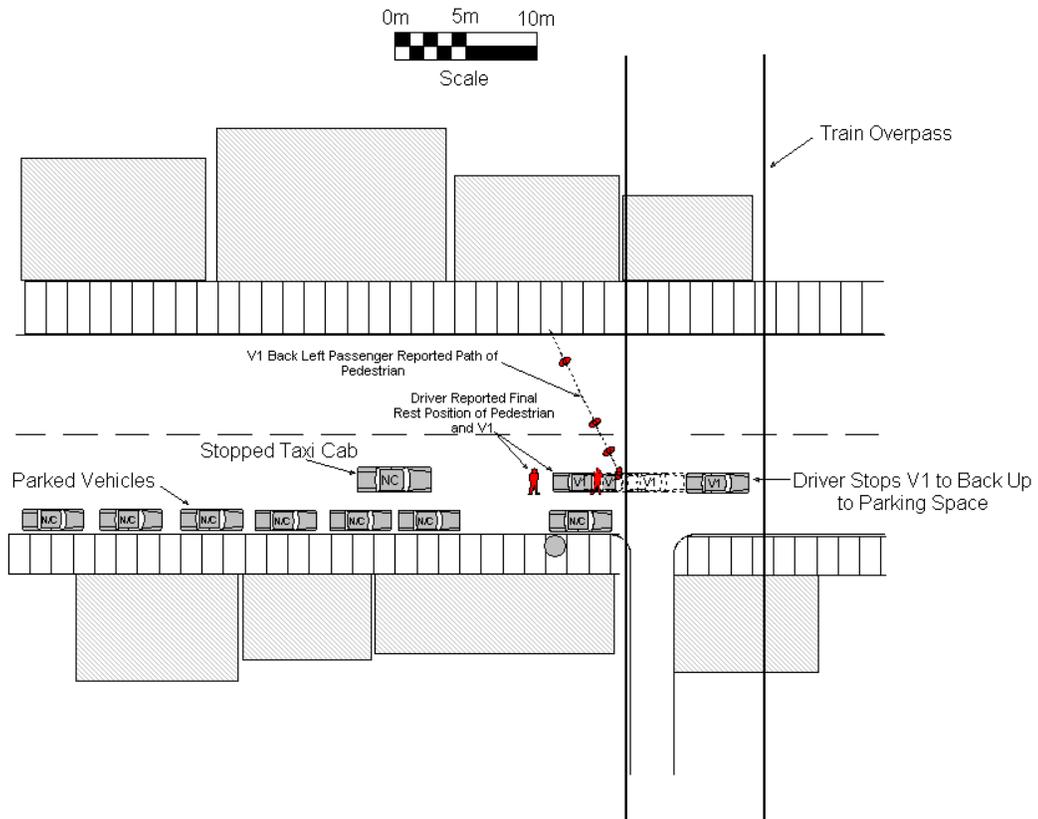
SCENE DIAGRAM 9

Initial Position of V1 and Point of Impact are Unknown
