CALSPAN ON-SITE FATAL BACK OVER INCIDENT INVESTIGATION

SCI CASE NO.: CA07-034

VEHICLE: 2004 CADILLAC ESCALADE

INCIDENT DATE: OCTOBER 2007

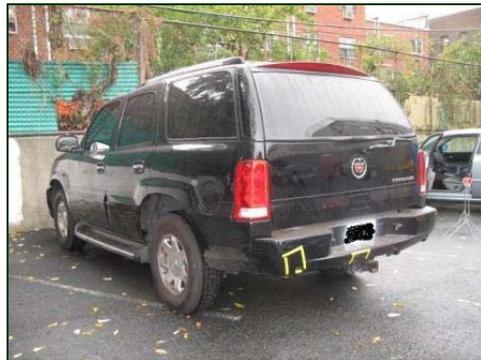
Figure 1. Back left view of the Cadillac Escalade.

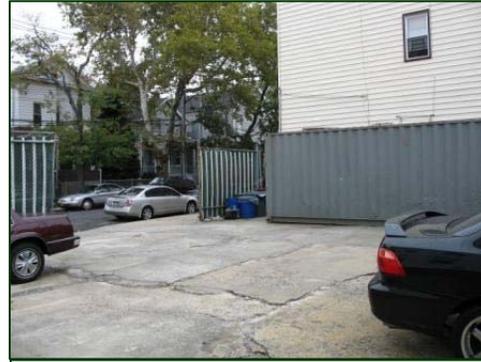
This back over incident occurred during daylight hours in October 2007 in an urban area. The Cadillac was parked in a fenced parking lot behind a commercial building (**Figure 2**). The building was located on a corner of two local streets. The parking lot was 18.1 m (59.3') in width (parallel to the street) and 15.2 m (49.9') in depth. The north and west side of the lot were bordered by a 2.4 m (8') chain link fence with privacy slats woven through the links. The west side of the fence was configured with gates that provided access to the lot from the local

Figure 2. Overall view of the parking lot and the approach of the non-motorists.

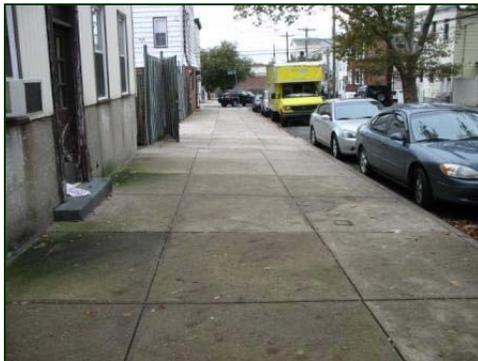
The child non-motorist was seated in the J.Mason stroller and was being pushed on the sidewalk in a southerly direction by his grandmother as depicted in **Figure 3**. While walking, the grandmother stopped at a neighbor's row house and called for the neighbor to come to the door. The neighbor did not immediately respond and the grandmother continued to push the stroller in a southerly direction. As she approached the fenced area for the parking lot, the driver exited his building and walked in a northerly direction on the sidewalk as he approached the open gated area of the parking lot. The driver and the grandmother passed one another as the driver entered the parking lot. The grandmother immediately stopped as she was called by the neighbor. The driver did note during the SCI interview that he observed the grandmother and the stroller, but did not make direct eye contact with her.

Figure 3. Trajectory of the pedestrian non-motorists toward the parking lot gate.

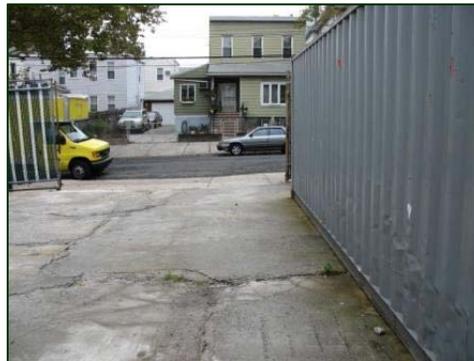
Figure 4. Backing trajectory of the Cadillac Escalade.

assumed she continued to walk to the corner of the street as he began to back straight rearward in a westerly direction toward the street (**Figure 4**).

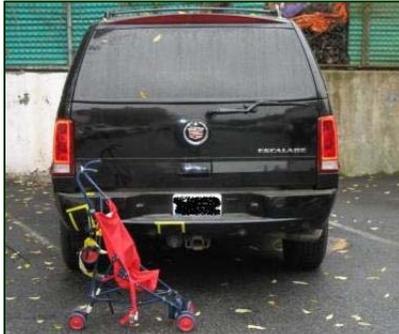
Figure 5. Rear view of the stroller in relation to the height of the Cadillac.

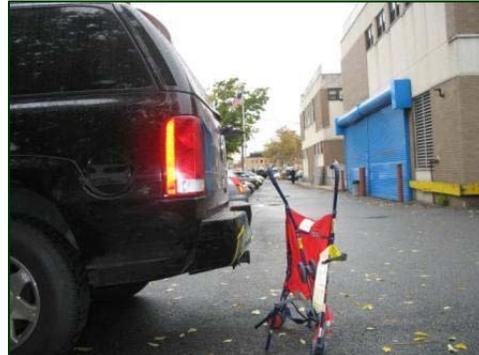
Figure 6. Lateral view of the stroller in relation to the Escalade.

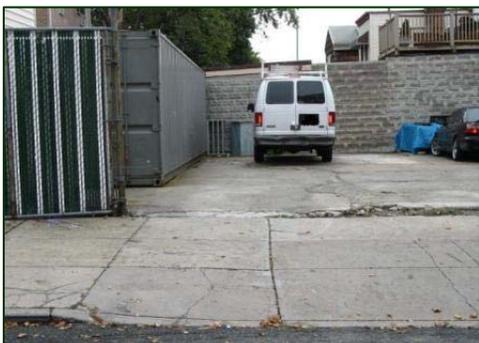
The impact knocked the stroller to the concrete sidewalk surface. The driver was unaware of this contact as he continued to back and steer the vehicle on a slight counterclockwise arc. The Escalade continued approximately 3 m (9.8') rearward of the initial point of contact. During this backing trajectory, the undercarriage contacted the stroller and the left rear tire ran over the child. The child apparently separated from the stroller during the incident. The child's grandmother ran hysterically toward the Escalade and captured the attention of the driver. He immediately stopped the vehicle to check on the actions of the grandmother. The driver stopped the Cadillac on the sidewalk with the back plane of the vehicle extending approximately 0.6 m (2') into the street. **Figures 7 and 8** are look-back views of the incident site.

Figure 7. Look-back view of the backing trajectory of the Cadillac.

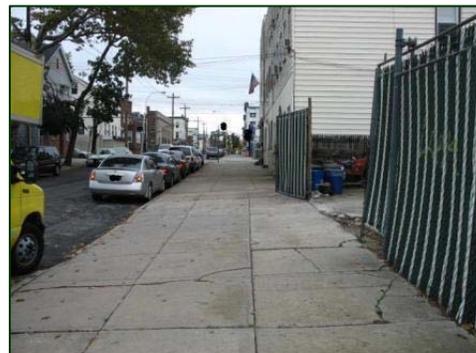
Figure 8. Look-back view of the non-motorist's path of travel.

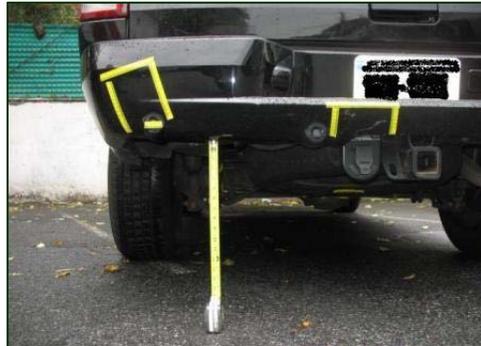
Several areas of possible contact to the face of the rear bumper fascia and undercarriage components were noted during the SCI inspection (**Figure 9**). The first area involved a diagonally oriented scratch with multiple laterally oriented scratches within a wipe mark (area where the road film was removed). The wipe mark with scratches was located 11-23 cm (4.25-9”) left of the vehicle’s centerline and 47-57 cm (18.5-22.5”) above ground level. Based on the orientation and cluster of the scratches, it was unlikely that these resulted from this backing incident. The wipe mark; however, was probably related to this event.

Figure 9. Suspected contact evidence to the back bumper fascia.

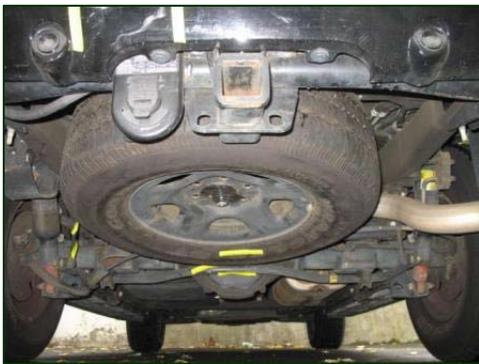
Figure 10. Wipe marks to the spare tire and rear sway bar.

The undercarriage of the Escalade exhibited several suspected contact areas. Again, these consisted of wipe marks and were isolated to the center and left areas of the undercarriage. The forward aspect of the spare tire sidewall (mounted to the undercarriage) was wiped from possible contact with the stroller. A similar wipe mark was noted to the trailing edge of the sway bar (**Figure 10**) at the centerline of the vehicle. This probable contact was 18 cm (7") in length. The left vertically oriented stabilizer link for the sway bar was wiped clean at two points. These wipe marks were located 53 cm (21") left of center and 37-41 cm (14.5-16") and 44-50 cm (17.5-19.5") above the pavement. Additional wipe marks were noted to the horizontal surface of the sway bar forward of the stabilizer link and to the jacket of the left emergency brake cable (**Figure 11**). Due to the isolated location of these marks, the stroller was the probable source of this contact.

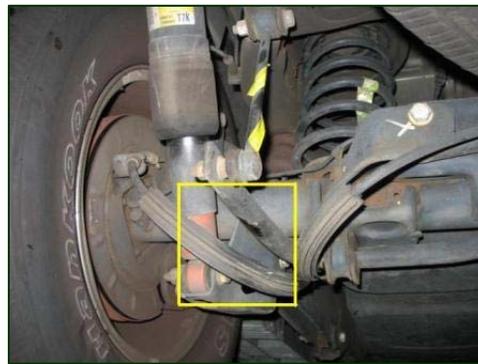
Figure 11. Wipe marks to the sway bar, stabilizer and emergency brake cable.

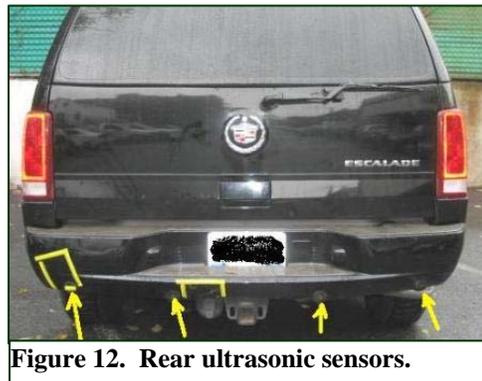
The Cadillac Escalade was equipped with an Ultrasonic Rear Parking Assist (URPA) system that utilized four ultrasonic sensors across the lower rear bumper fascia (**Figure 12**). The sensors were symmetrically positioned 28 cm (11") and 69 cm (27") from the centerline. The inboard sensors averaged 50 cm (19.6") above the pavement of the parking lot while the outboard sensors averaged 53 cm (20.9") in height to the center point of the sensor. The average heights were provided due to irregularities in the surface of the pavement.

Figure 12. Rear ultrasonic sensors.

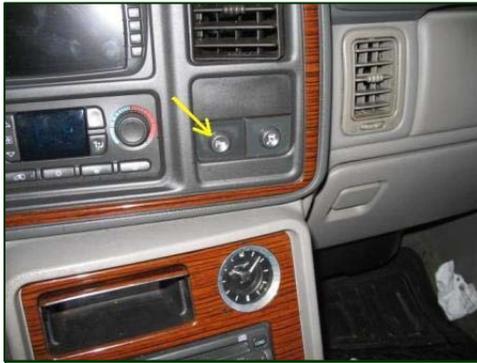
The system was activated by a hard switch that was mounted to the mid center instrument panel (**Figure 13**). The switch utilized a detent that required finger pressure to turn the system ON or OFF. The detent allowed the system to remain ON at all times or OFF at all times at the decision of the driver. The URPA system did not automatically cycle to ON at each ignition cycle. A small diameter amber light illuminated at the base of the switch when the system was turned OFF (**Figure 14**). The driver stated that the URPA system was turned off prior to the on-set of this trip as he frequently backs in congested areas that trigger false warnings. The driver further stated during the SCI interview that it was his understanding that the system would cycle to the ON position at each ignition cycle. He additionally stated that he would turn the system OFF when backing in close spaces only when he felt it was safe to back without the assistance of the URPA system.

Figure 13. Position of the URPA switch.

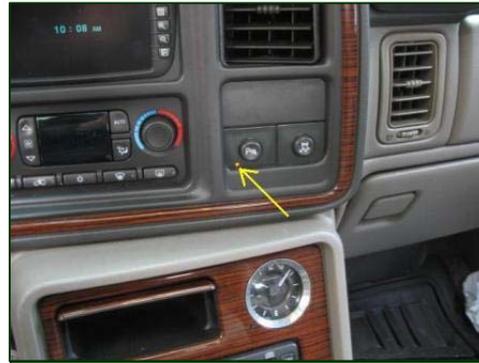
Figure 14. URPA switch OFF indicator light.

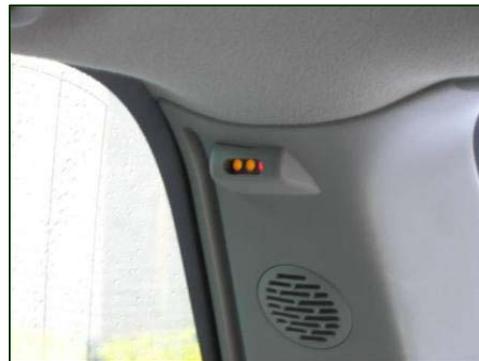
During the on-site investigation, the URPA was tested with the system turned ON, the ignition in the run position and the transmission selector placed in REVERSE. The URPA indicator display was positioned on the upper interior aspect of the right D-pillar. A series of three lights illuminated with a chime audible warning dependent on the proximity of an object to the rear surface of the vehicle. The system was comprised of three distinct zones that illuminated a single light at approximately 1.5 m (5') from the rear bumper, two lights at the 1 m (3') range and three lights (**Figure 15**) with a flash sequence and a intermittent chime at the 0.3 m (1') location.

Figure 15. URPA indicator warning lights.

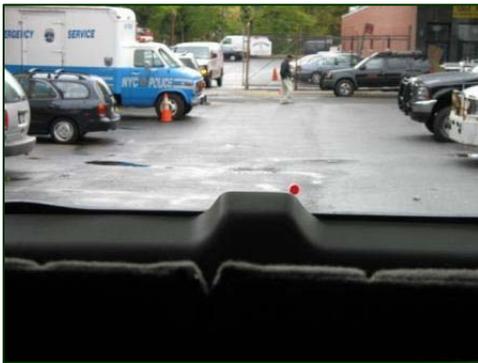
The substitute driver fully detected the reflective marker in the rear view mirror 8.7 m (28.7') aft of the back bumper. The substitute driver continued a straight line of sight that intersected the ground at a point that was 12.4 (40.8') from the rear bumper. The driver was also asked to turn and look over his right shoulder to locate the reflective marker. He located the full diameter of the marker 6 m (19.7') aft of the bumper (**Figure 16**). Based on the visibility study, the actual driver should have been able to detect the stroller and the non-motorist if he turned and looked over his right shoulder and should have detected the handles of the stroller in the rear view mirror.

Figure 16. Red reflective target visible through centerline of backlight.

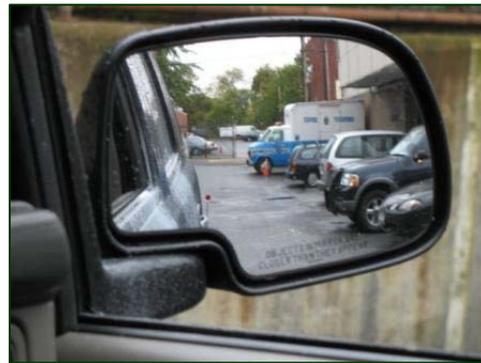
Figure 17. Right outside mirror cone of visibility.

Lateral cones of visibility were established using the adjusted positions of the rear view mirrors. The baseline distance of 6 m (19.7') from the back bumper was used for this procedure. The 71 cm (28") high reflective marker was placed at the maximum inboard and outboard positions that were visible to the driver. The left inboard position was located 1.1 m (3.6') left of the vehicle's longitudinal centerline. The left outboard position was 5.8 m (19') left of the referenced centerline resulting in a view width of 4.7 m (15.4'). The right outside mirror yielded the substitute driver a lateral cone of visibility that extended 1 m (3.3') right of the centerline to 6.4 m (21.3') right resulting in

a view width of 5.4 m (18'), 6 m (19.7') aft of the rear plane of the vehicle (**Figure 17**). These lines of sight are illustrated in the attached Rear Visibility Diagram, **Figure 19**.

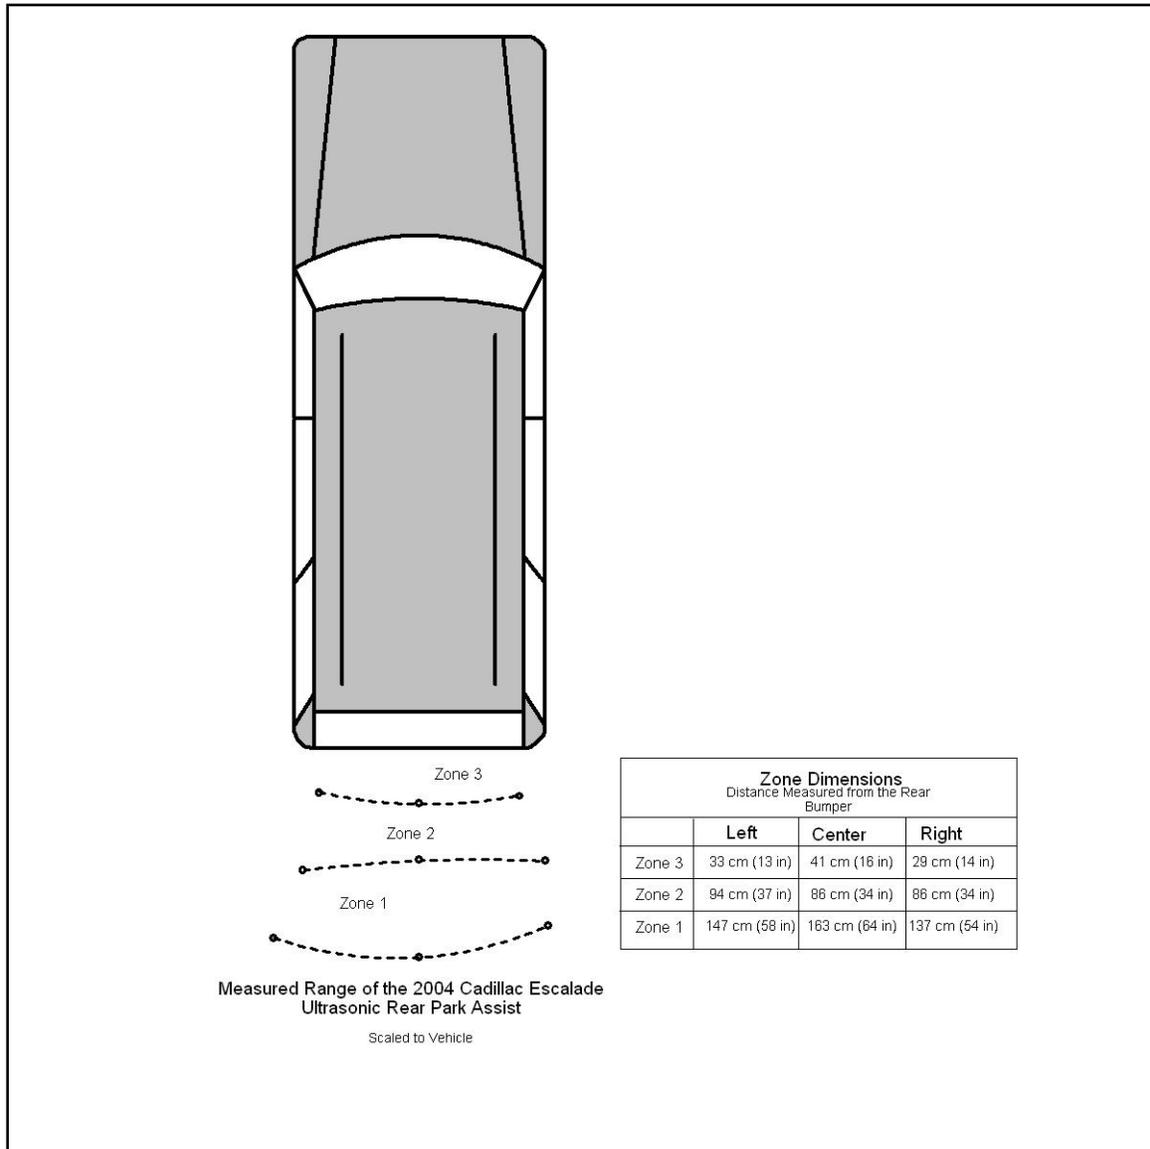
Figure 18. URPA Measured Range

The longitudinal and lateral detection zones of the URPA system were measured using a human subject and a substitute driver to identify the illumination and detection of the person. The first zone (most distant to the vehicle) detected the person 1.5 m (4'10") aft of the rear bumper and 1.2 m (3'9") left of the vehicle's centerline. On the centerline, the longitudinal distance was 1.6 m (5'4"). The right location of the first detection zone was 1.4 m (4'6") right and 1 m (3'4") right of center.

The second zone which illuminated two lights on the D-pillar ranged from 0.94 m (3'1") at the left corner of detection to 0.86 m (2'10") at center and right corner locations. The respective lateral locations at the corners were 0.86 m (2'10") and 1 m (3'3") from center, left to right.

The third and closest zone to the rear bumper of the Escalade varied from 0.3 m (1'1") at the left corner, 0.4 m (1'4") at the centerline, and 0.36 m (1'2") at the right corner. The corner locations were measured at 0.76 m (2'6") lateral to the centerline. A schematic of these detection zones scaled to the vehicle is included as **Figure 18** of this report.

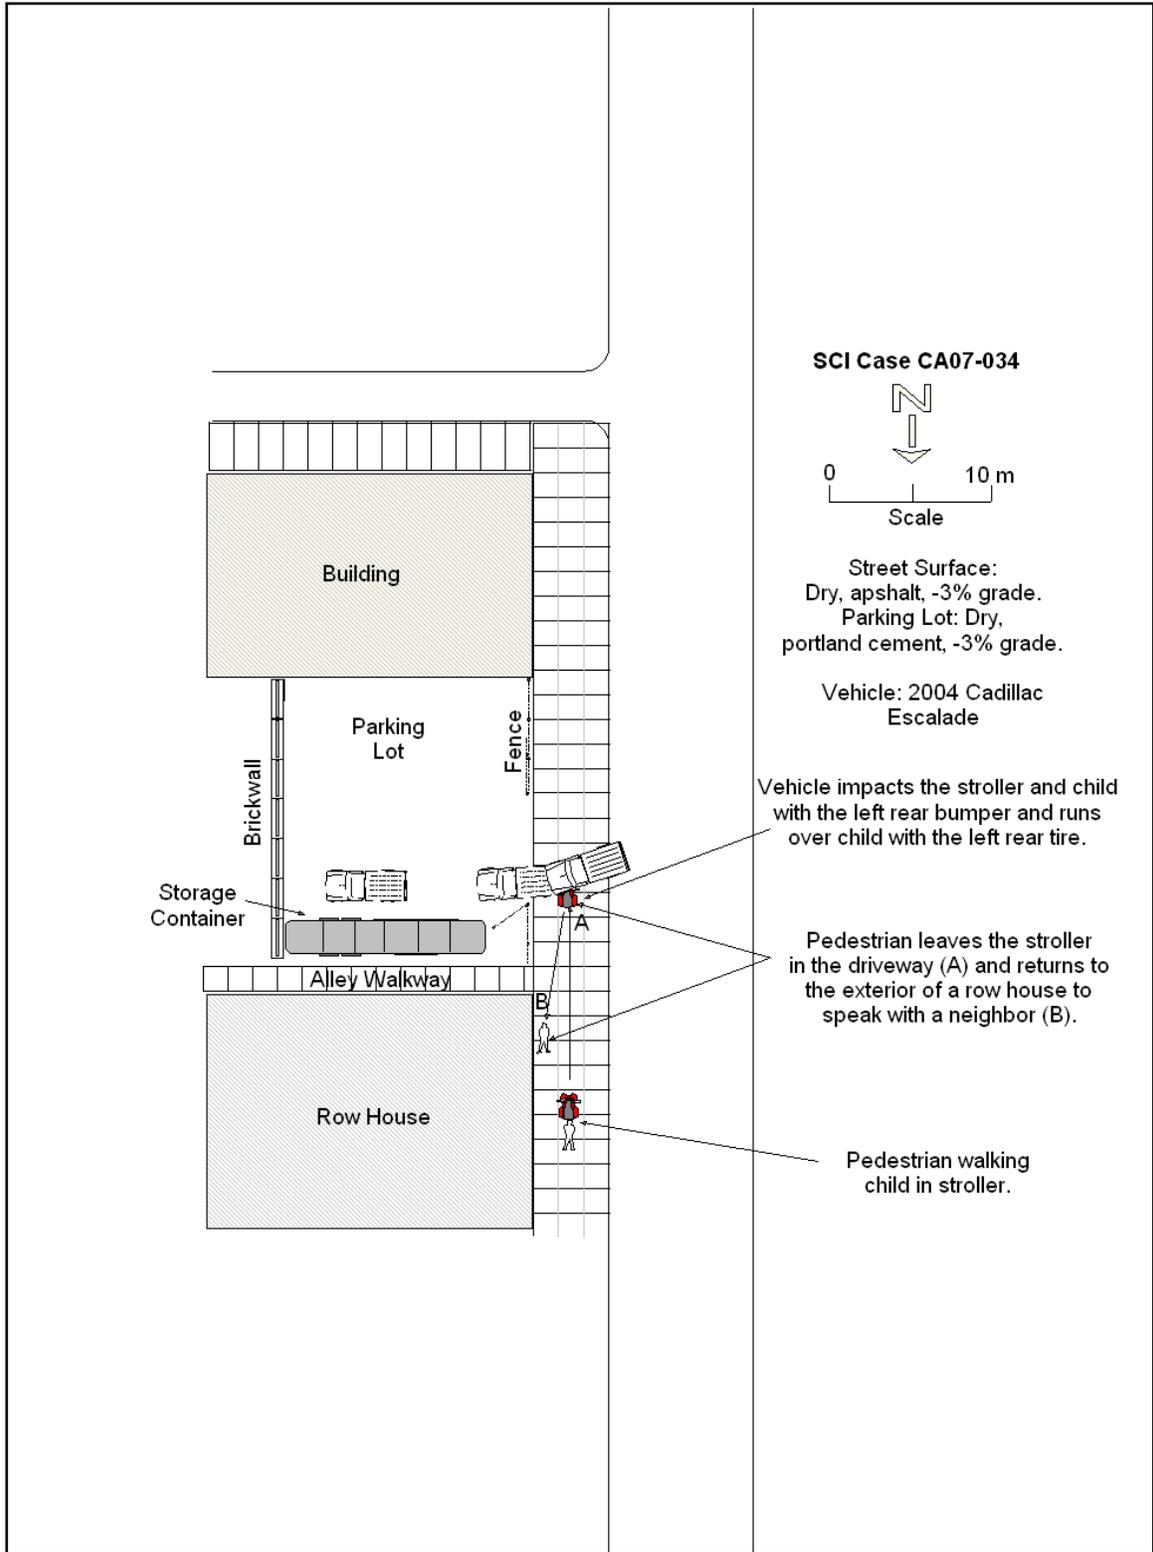
Figure 20. Incident Schematic

street. The gates consisted of a hinged gate at the north side that opened outward of the lot toward the street. This gate opened 180 degrees against the fence. A sliding gate opened toward the building that provided a total opening width of 5.5 m (18') for vehicles entering or exiting the lot. A large storage container that measured 2.4 m (8') in width and 12.4 m (40.7') in length was located within the fenced lot and positioned within 1 m (3') of the north fence line and 2.7 m (8.9') east of the sidewalk. The sidewalk was 4.7 m (15.4') in width and extended from the curb line of the street to the fence. The sidewalk was concrete with longitudinal and lateral expansion score lines. As a result of traffic traveling across the sidewalk to access the parking lot, the sidewalk sloped toward the street with an average grade of 3 percent, negative toward the street. The concrete at the fence line was deteriorated with missing pieces. This area was in the path of the right side tires of the backing Escalade. The surface of the parking lot was concrete and was in a worn and cracked condition. The Escalade was parked adjacent to the storage container with the back of the vehicle exposed to the open gate. The street was surfaced with asphalt and was 8.9 m (29.2') in width. The grade of the street was 3 percent, negative to the south. Immediately north of the parking lot, residential row houses bordered the sidewalk. Due to the parked position of the Escalade in relation to the storage container and the privacy fence, the driver did not have a line of sight to his left prior to backing from the lot. His view to his right was limited by the opening of the gate. A schematic of the Incident Site is attached as **Figure 20**.
