ODI Unintended Acceleration Investigation / Vehicle to Vehicle  
Dynamic Science, Inc. / Case Number: DS07035  
2007 Toyota Camry  
California  
July 2007

1. Report No. DS07035		2. Government Accession No.		3. Recipient Catalog No.	
4. Title and Subtitle ODI Unintended Acceleration Investigation				5. Report Date May 15, 2008

**Dynamic Science, Inc.**  
**Crash Investigation**  
**Case Number: DS07035**

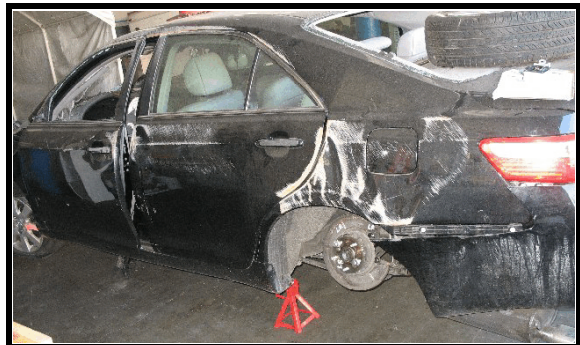
The Camry sustained minor left side damage as a result of an impact with a concrete barrier (**Figure 6**). The direct damage began 54 cm (21.3 in) rear of rear axle and extended forward 327 cm (128.7 in) forward. The direct damage extended vertically into the A-pillar area and along the left roof rail. The Collision Deformation Classification (CDC) for this impact was 12LDAS2.

**Figure 6.** Left side impact with roadside object

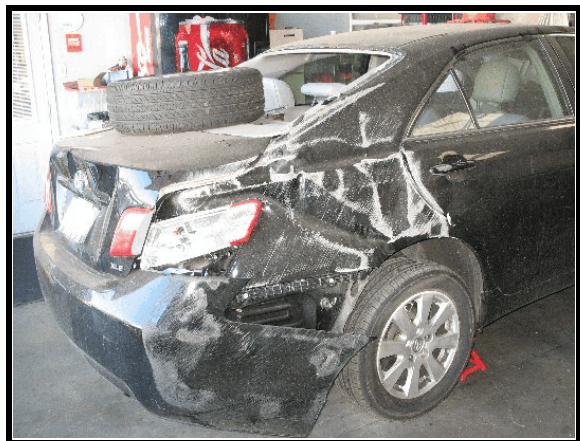
The Toyota Camry sustained minor right side damage as a result of an impact with a concrete barrier or wall (**Figure 7**). The direct damage began 8 cm (3.1 in) forward of the rear axle and extended 113 cm (44.5 in) rearward. The CDC for this impact was 12RZAS2.

**Figure 7.** Right side impact with roadside object

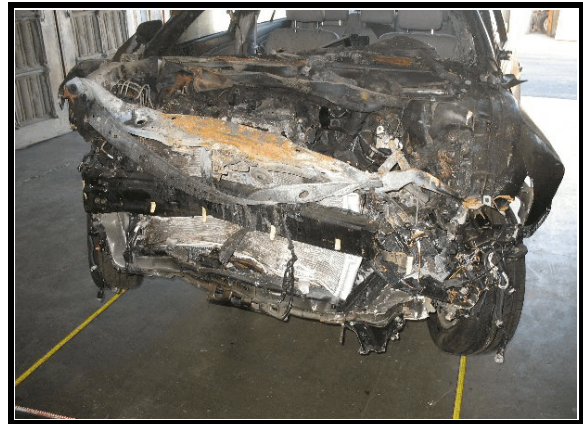
The Camry sustained moderate damage to the front end as a result of the two vehicle to vehicle impacts (**Figure 8**). The two impacts overlapped and could not be separated. The crush profile and CDC encompasses both frontal impacts. Six crush measurements were documented at the bumper level as follows: C1 = 28 cm (11.0 in), C2 = 34 cm (13.4 in), C3 = 37 cm (14.6 in), C4 = 44 cm (17.3 in), C5 = 41 cm (16.1 in), C6 = 40 cm (15.7 in). The combined CDC for these impacts was 12FDEW3.

**Figure 8.** Frontal damage from impacts with two vehicles

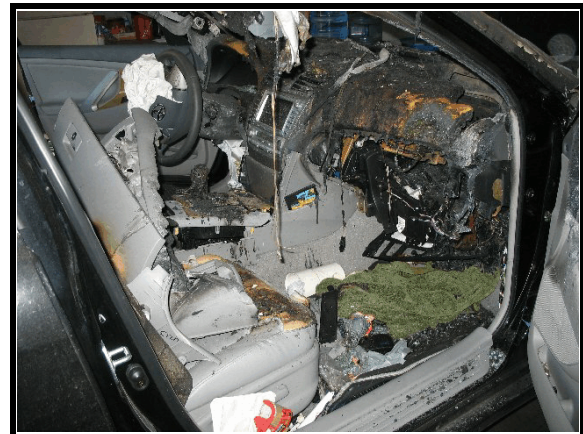
**Figure 9.** Right instrument panel damage

The 2007 Toyota Camry sustained moderate interior damage as a result of occupant contacts, air bag deployments, and the engine fire (**Figures 9-11**). The right instrument panel was burnt and melted. There was scorching damage to the center console, the steering wheel, the front right seat bottom, both A-pillars, and along the windshield header.

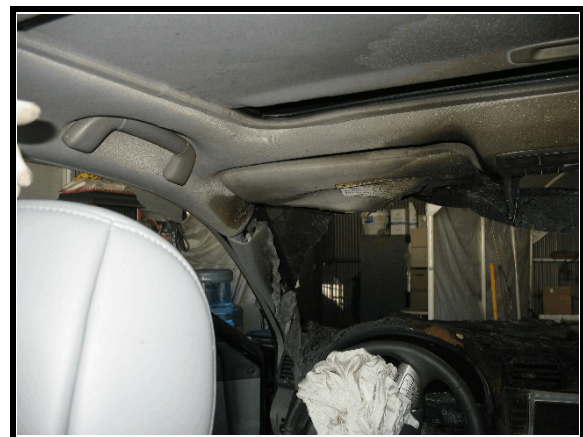
**Figure 10.** Left A pillar/header scorching

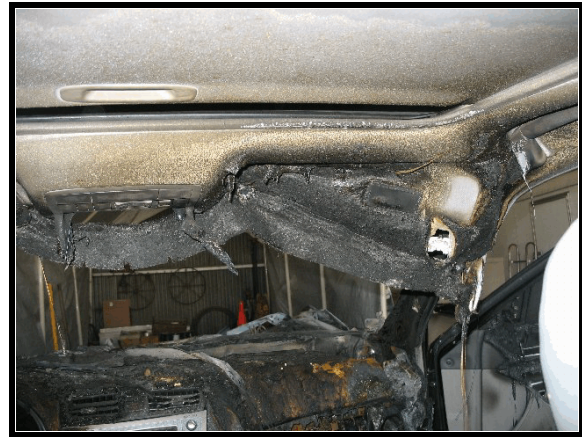
**Figure 11.** Right A pillar/header scorching damage

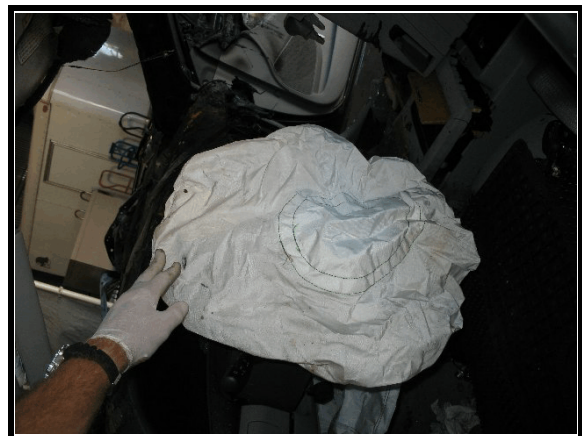
The driver's frontal air bag deployed from the center of the steering wheel hub through H-configuration module cover flaps (**Figure 12**). Each flap measured 8 cm (3.1 in) in height and 12 cm (4.7 in) in width. The deployed frontal air bag measured 60 cm (23.6 in) in diameter in its deflated state. The air bag was tethered by two internal straps. Two circular vent ports were located at the 11 and 1 o'clock aspect on the rear of the air bag. There were no indications of contact or damage to the air bag.

**Figure 12.** Driver's frontal air bag

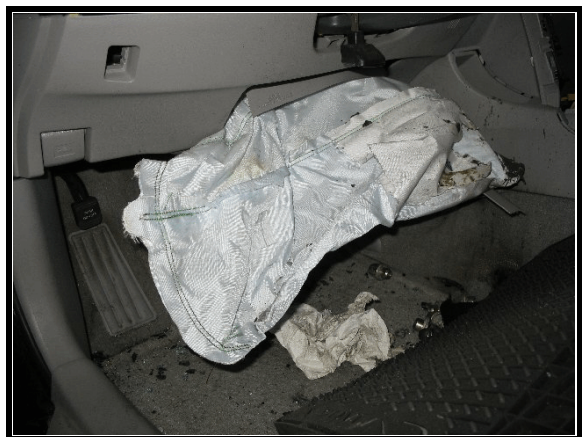
The driver's knee air bag deployed from the lower instrument panel through H-configuration module cover flaps (**Figure 13**). The top flap measured 24 cm (9.4 in) wide by 3 cm (1.2 in) high. The bottom flap measured 24 cm (9.4 in) by 3.5 cm (1.4 in) high. The deployed knee bag measured 52 cm (20.5 in) wide by 24 cm (9.4 in) high. There were no indications of contact or damage to the air bag.

**Figure 13.** Driver's knee air bag

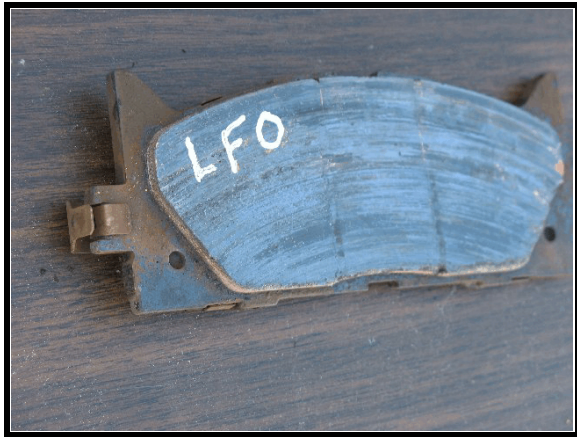
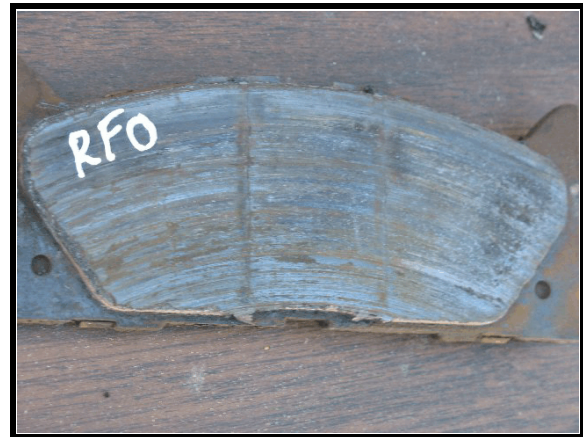
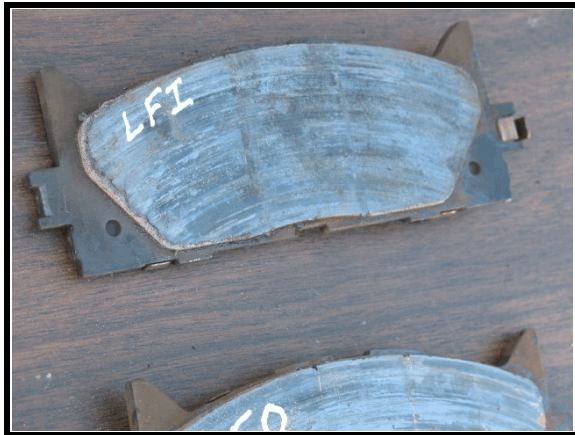
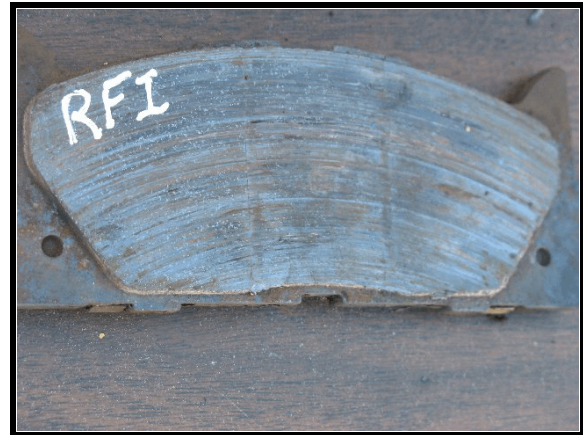
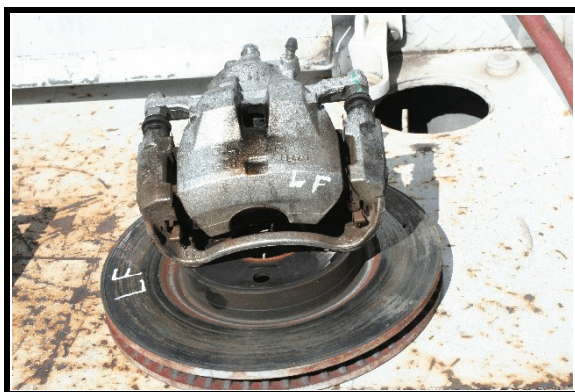
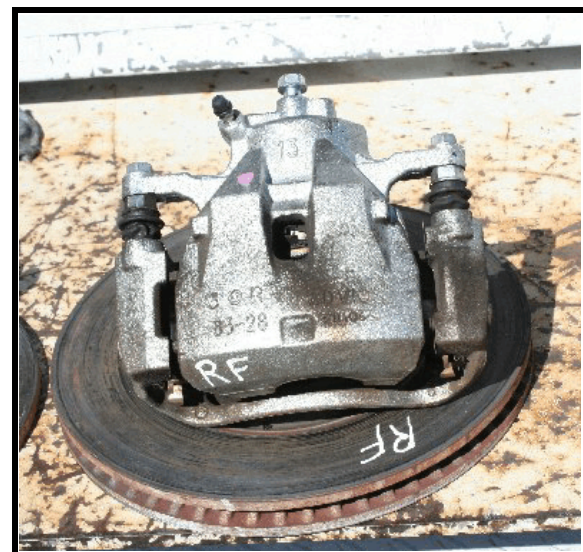
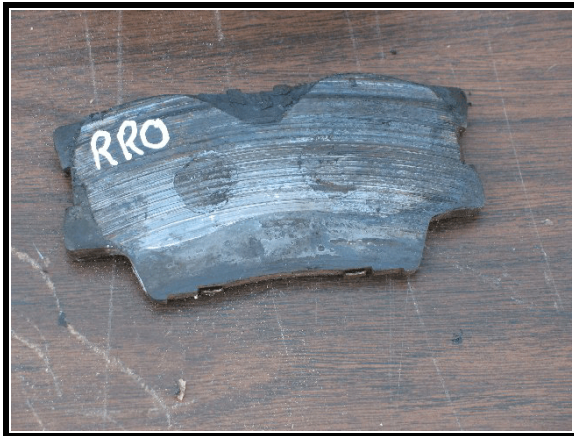
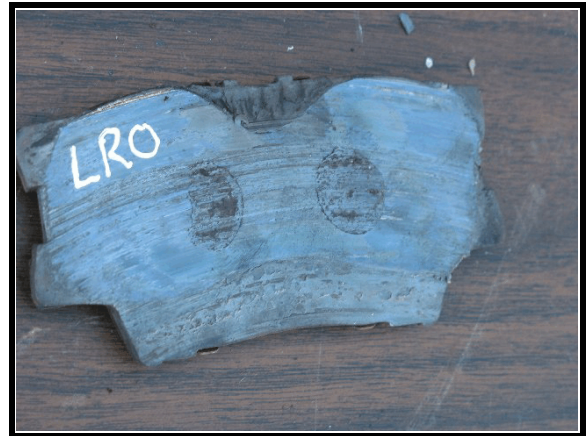
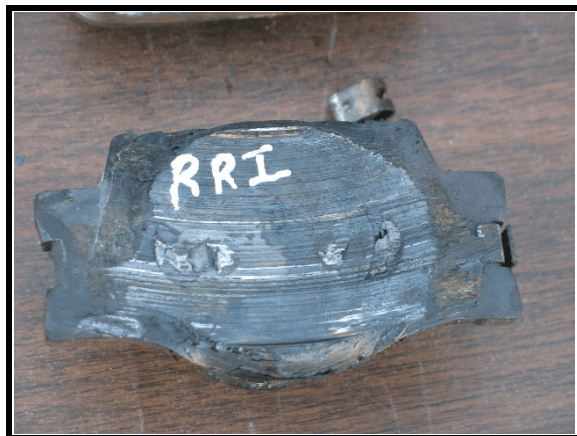
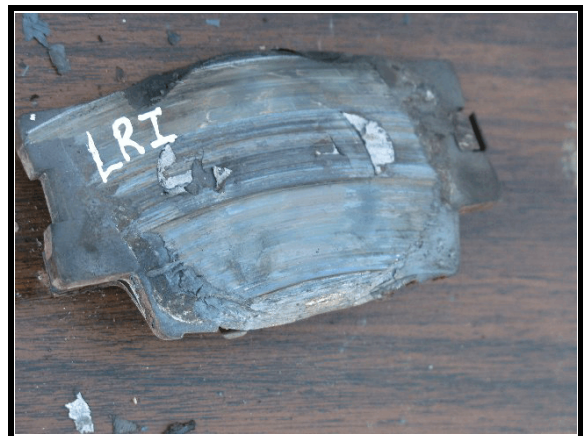
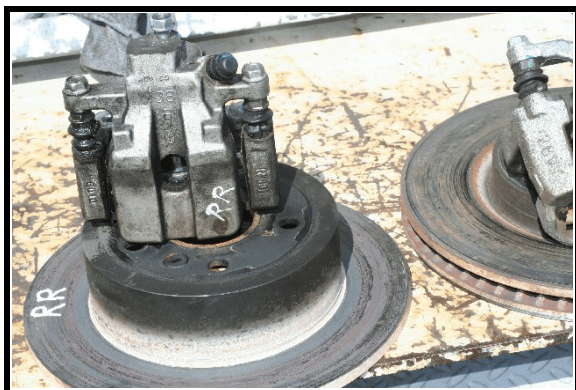
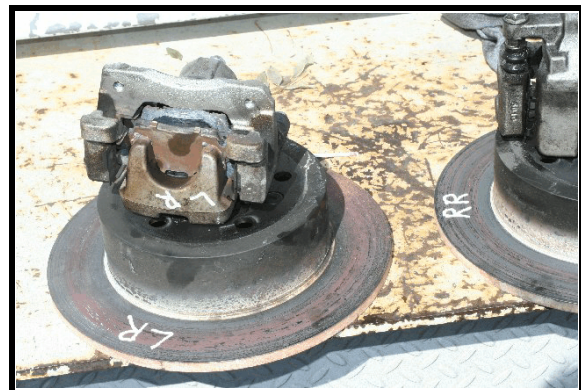
The vehicle brake components were removed by the investigating officer during his initial inspection. The components were brought back to the vehicle for the SCI inspection. All the brake pads exhibited wear that was consistent with the brakes being applied for a long period of time while the vehicle was at speed (**Figures 14-25**). Both rear brakes were degraded to the metal. There were also indications of excessive temperature. According the investigator, brake pressure was still present on the discs.

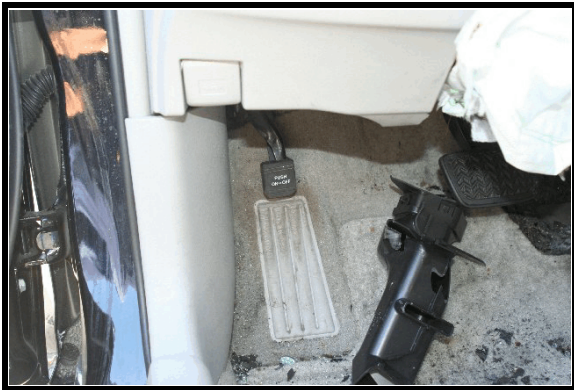
The driver reported that he had applied the parking brake at some point during the crash sequence. The parking brake pedal was found in the fully depressed position during the initial police inspection. Wear patterns were present on both the left and right parking brake pads, indicating that they had been depressed during the crash (**Figures 26-28**).

**Figure 26.** Parking brake in full down position (as found at scene)

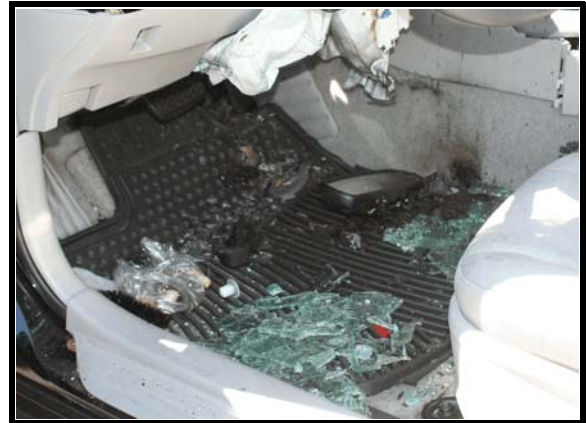
The rubberized mat and the accelerator assembly had been removed prior to the vehicle inspection. The investigating officer had, however, taken photos of the mat and the accelerator assembly prior to their removal. The mat in the police photos appeared to be shifted forward and to the right of its designed location (**Figure 30**). There was some scuffing found on the bottom right of the accelerator pedal that was possibly due to pedal/mat interaction. There was also some scuffing found on the top right portion of the mat. The distance from the rear of the mat to the top right cutout was 58.5 cm (23 in). The distance from the front seat mounting bolt to the bottom of the accelerator pedal in the depressed position was 64 cm (25.2 in). For the accelerator pedal to engage the floor mat, the mat would have to be at least 5.5 cm (2.2 in) forward of the seat mounting bolt. Based on the police image in **Figure 31**, this would appear to be the case.

**Figure 29.** Overview of mat position (police photo)

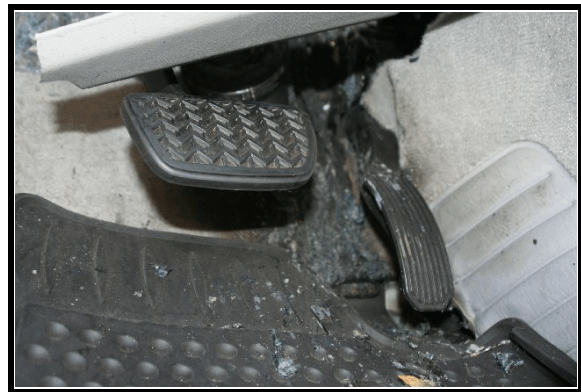
**Figure 30.** Mat position (police photo)

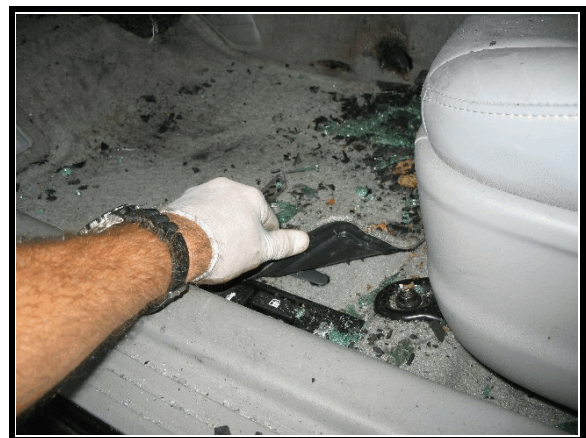
**Figure 31.** Carpet mat and left mat retention device

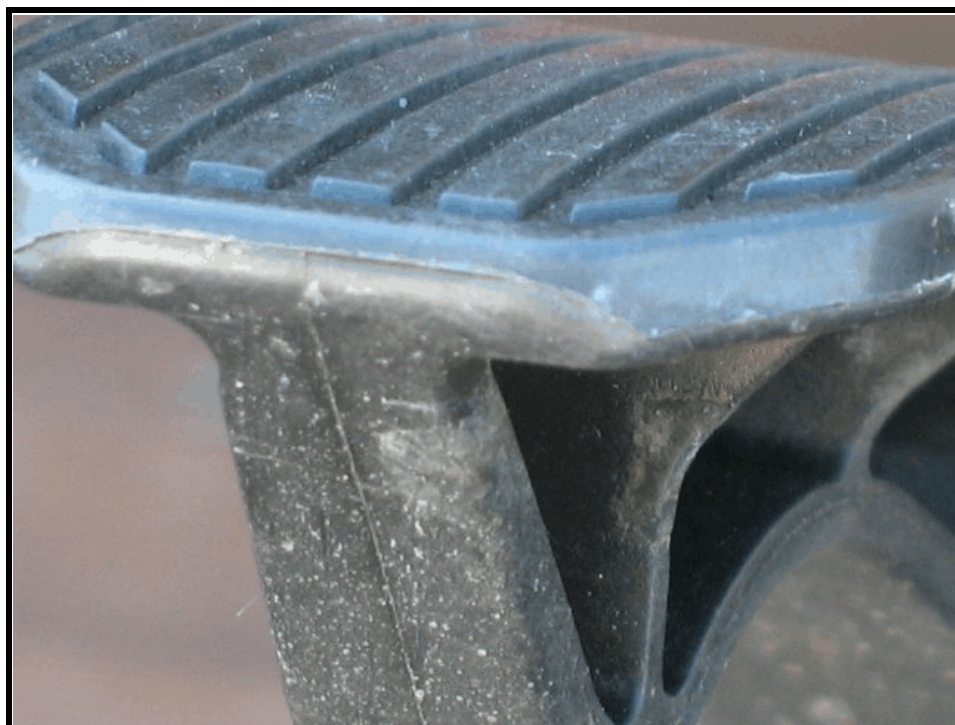
**Figure 33.** Possible mat scuff on accelerator pedal

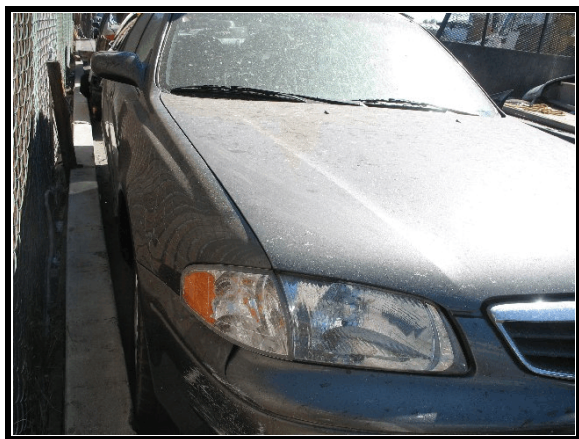
Description:	2002 Mazda 626 four door sedan	
VIN:	Unknown	
Odometer:	Unknown	
Engine:	Unknown	
Reported Defects:	None noted	
Cargo:	Unknown	
Damage Description:	Moderate rear end damage from impact with the Toyota Camry. Minor front end damage from impact with center median.	
CDC:	Impact 1: 06BLEW2 Impact 2: 01FRES1	
Delta V:	Total	Unknown
	Longitudinal	Unknown
	Latitudinal	Unknown
	Energy	Unknown

**Figure 37.** Frontal damage, Mazda 626

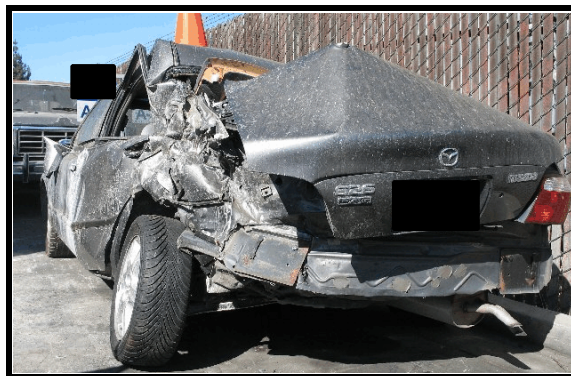
**Figure 38.** Rear damage, Mazda 626

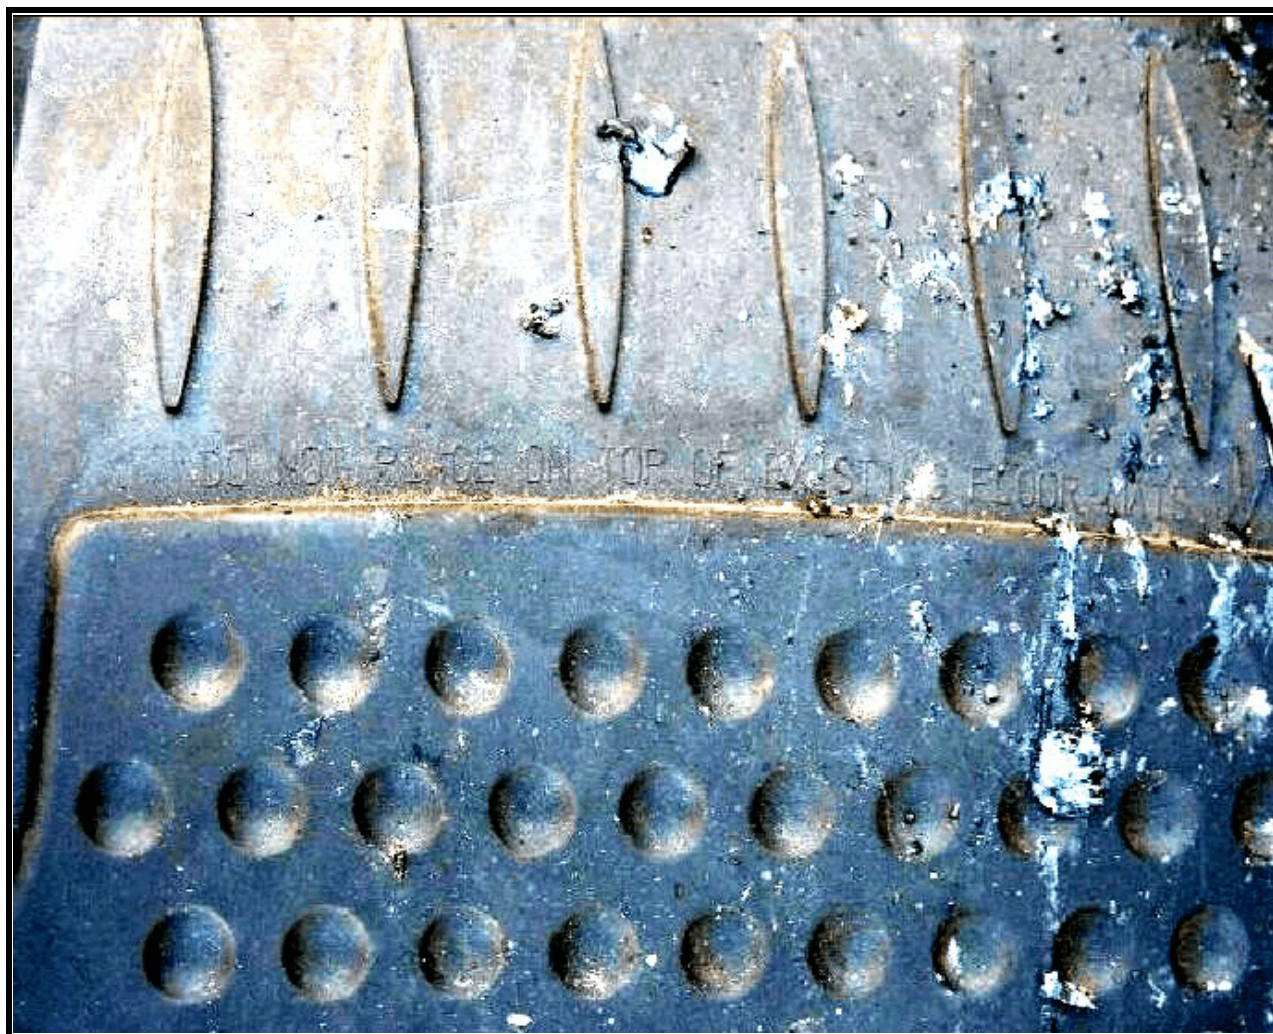
The 2007 Toyota Camry was equipped with a fabric floor mat. The floor mat was secured to the floorboard by plastic retention devices near the front of the driver's seat. A rubberized all-weather mat had been installed on top of the original equipment carpet mat and was unsecured by the two retention devices (**Figure 29**). The all-weather mat had a stamped warning (Attachment 1) that stated the following: DO NOT PLACE ON TOP OF EXISTING FLOOR MATS.

**Figure 39.** Stamped warning on rubberized all-weather mat
