Child Safety Seat Investigation  
Dynamic Science, Inc. (DSI), Case Number DS07036  
1996 Jeep Grand Cherokee  
Arizona  
August 2007

1. Report No. DS07036	2. Government Accession No.	3. Recipient Catalog No.	
4. Title and Subtitle Child Safety Seat Investigation		5. Report Date November 18, 2008

**Dynamic Science, Inc.**  
**Crash Investigation**  
**Case Number: DS07036**

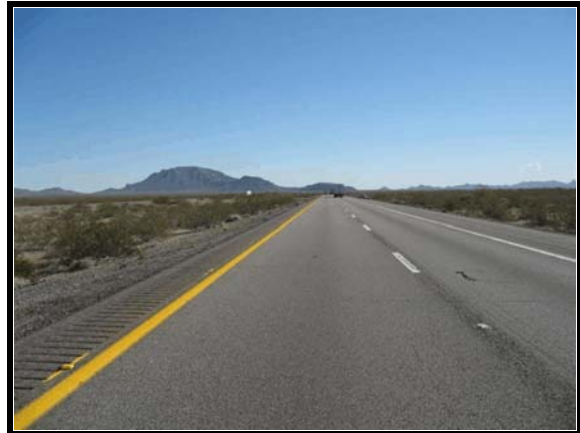
The Jeep was traveling in the left lane and drifted off the north edge of the roadway (**Figures 2-3**).

**Figure 2.** East approach to area of roadway departure

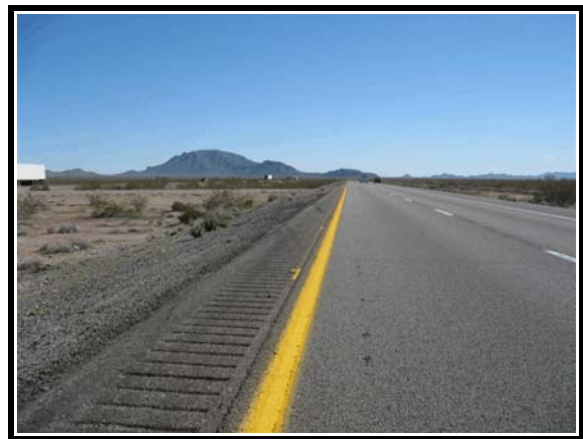
**Figure 3.** Area of roadside departure

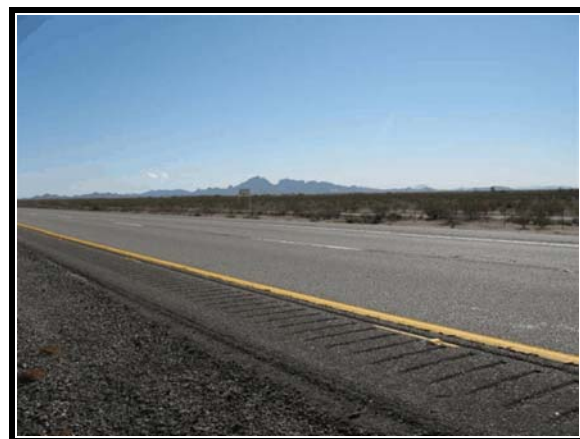
The driver overcorrected to the right and the Jeep and trailer began a clockwise rotation across both eastbound lanes of travel. The Jeep tripped on the roadway and began a left side leading rollover (**Figure 4**). The Jeep rolled 8 quarter turns and came to rest on its wheels and facing west. The final rest position of the Jeep was 7.6 m (25.0 ft) south of the south roadway edge. Between the 5<sup>th</sup> and 6<sup>th</sup> quarter turns, the second row right occupant was ejected. The trailer rolled for an unknown number of turns and came to rest on its right side and facing southeast.

**Figure 4.** Area of rollover

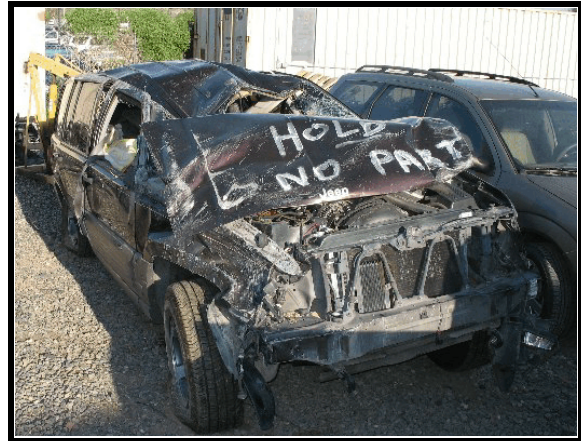
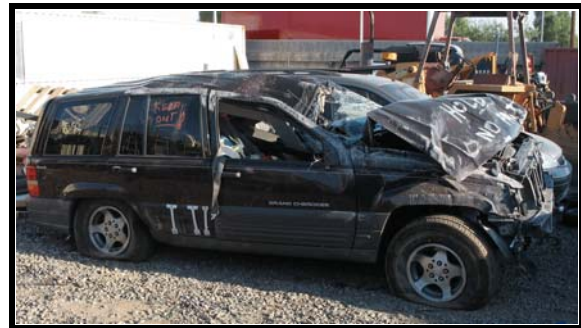
The Jeep sustained moderate damage to the left, right, front, back and top planar surfaces during the rollover (**Figures 5-6**). The front bumper and fascia were detached from the vehicle. The roof and hood were severely buckled. The left front, left rear, and right front doors were jammed shut. The left rear, right rear, and right front tires were flat. The direct damage to the roof began at the right A-pillar and extended laterally 139 cm (54.7 in) to the left. The maximum vertical crush measurement was to the right windshield header. It was located 49 cm (19.3 in) left of the base of the side window and 21 cm (8.3 in) above the base of the side window and measured 27 cm (10.6 in) vertically. The maximum lateral crush measurement was 3 cm (1.2 in). The Collision Deformation Classification (CDC) for the rollover was 00TDDO4.

**Figure 5.** Exterior damage

**Figure 6.** Exterior damage, right side view

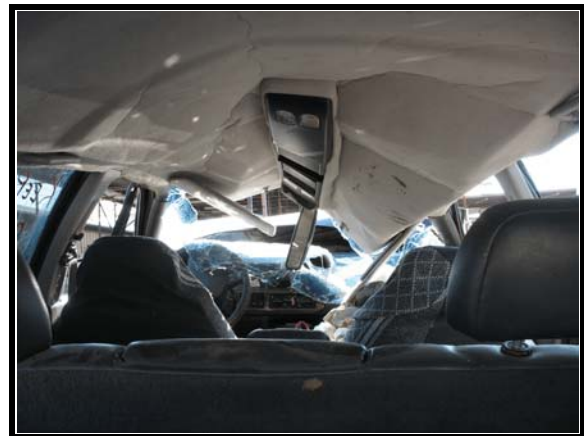
The 1996 Jeep Cherokee sustained moderate interior damage as a result of passenger compartment intrusion (**Figure 7**). The roof, roof rails and windshield header sustained vertical intrusion. The windshield was cracked and holed from impact forces. The left front, right front and second right rear windows were disintegrated from impact forces.

**Figure 7.** Overview of interior damage

Row	Position	Intruded Component	Magnitude of Intrusion	Direction
Front seat	Right	Roof	41 cm (16.1 in)	Vertical
Front seat	Right	Windshield header	37 cm (14.5 in)	Vertical
Front seat	Left	Roof	23 cm (9 in)	Vertical
Second seat	Right	Roof	22 cm (8.7 in)	Vertical
Front seat	Right	Roof side rail	13 cm (5.1 in)	Vertical
Front seat	Left	Windshield header	9 cm (3.5 in)	Vertical
Second seat	Left	Roof	8 cm (3.1 in)	Vertical
Second seat	Right	Roof side rail	4 cm (1.6 in)	Vertical

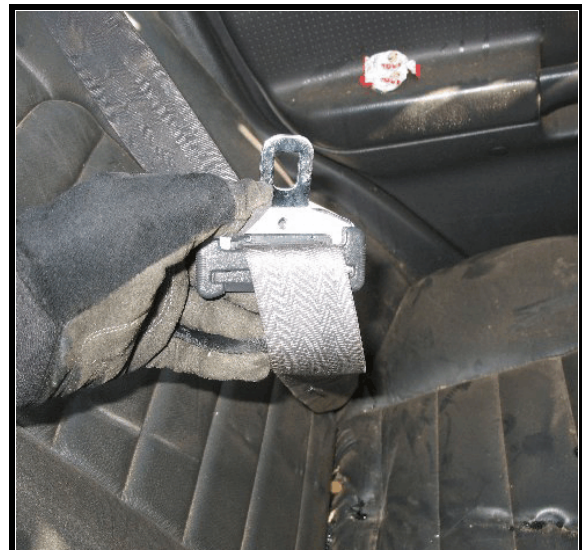
The Jeep Cherokee was equipped with 3-point manual lap and shoulder belts and adjustable head restraints for the four outboard seat positions. The second row center seat position was equipped with a manual lap belt and no head restraint. The lap and shoulder belts were configured with adjustable D-ring anchorages that were in the full down position. The driver's safety belt was configured with an Emergency Locking Retractor (ELR). The remaining outboard safety belts were configured with light weight locking latch plates and ELR retractors. The second row center safety belt was configured with a locking latch plate. The first row lap and shoulder belts were used to restrain the driver and front right occupant. According to the police, the second row left, middle, and right safety belts were used to secure child safety seats. There were no indications of loading to any of the seat belts.

**Figure 8.** Manual restraints, second row left

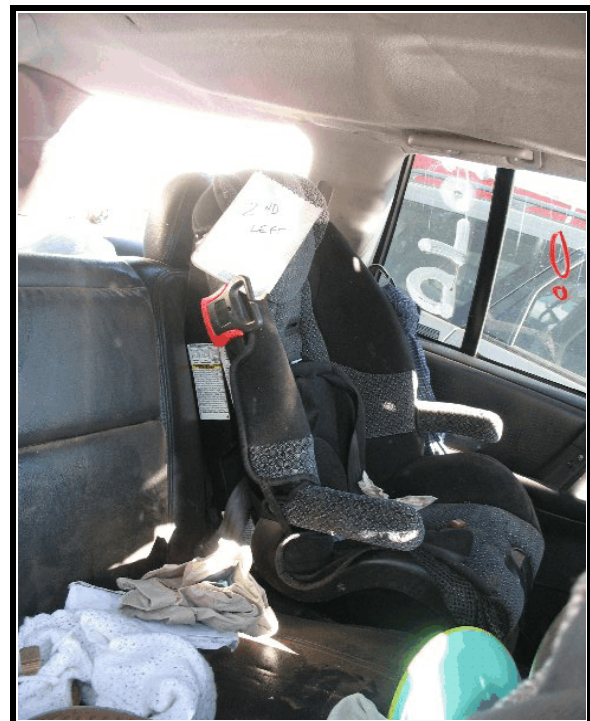
The CSS was found by the investigator secured to the seat by the lap and shoulder belt (**Figure 10**). Measurements were taken of the fore/aft and lateral movement of the anchored child seat. At the time of the inspection there was 15 cm (5.9 in) of fore/aft movement for the top of the child seat, and 6.5 cm (2.6 in) of fore/aft movement at the bottom. There was 30 cm (11.8 in) of lateral movement for the child seat. Both the fore/aft and lateral excursion of the CSS exceeded what was recommended by the manufacturer and by the normal installation conventions.

**Figure 10.** Cosco child safety seat, as found in vehicle

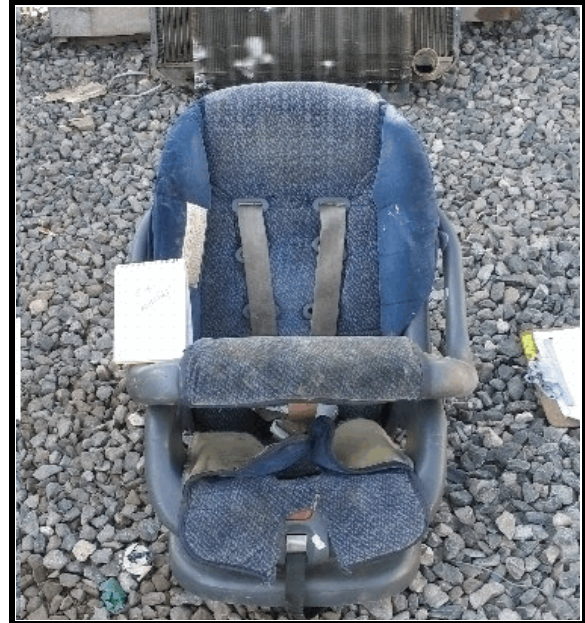
A Dorel/Cosco convertible CSS was used to restrain the second row middle occupant. There was no model number or date of manufacture found on the CSS. Based on appearance, it was determined that the CSS model was either a Touriva or a Regal Ride. Both of these types are based on identical shells. An instruction label on the CSS indicated that the seat was to be used with children who weighed 9-18 kg (20-40 lbs), whose height was 73-102 cm (29-40 in), and who was greater than 1 year of age. It was not known if the child met the weight or height requirements. The CSS was designed to be rear-facing for children who weighed 2.2-15.8 kg (5-35 lbs) and whose height was 48.2-91.4 cm (19-36 in). The CSS was configured with a three-point harness and a padded tray shield (**Figure 11**). The lower harness strap was attached using a latch plate and buckle style closure. The seat was designed with three harness positions. At the time of the crash, the harness was in the top set of slots. The CSS was designed to be used forward or rear facing. The child seat was not equipped with LATCH hardware. To anchor the child seat, the vehicle's safety belt was to be routed through forward facing slots. At the time of the inspection, the vehicle's lap belt was unbuckled. A locking clip was found stowed on the back of the child seat shell.

**Figure 11.** Dorel/Cosco child safety seat

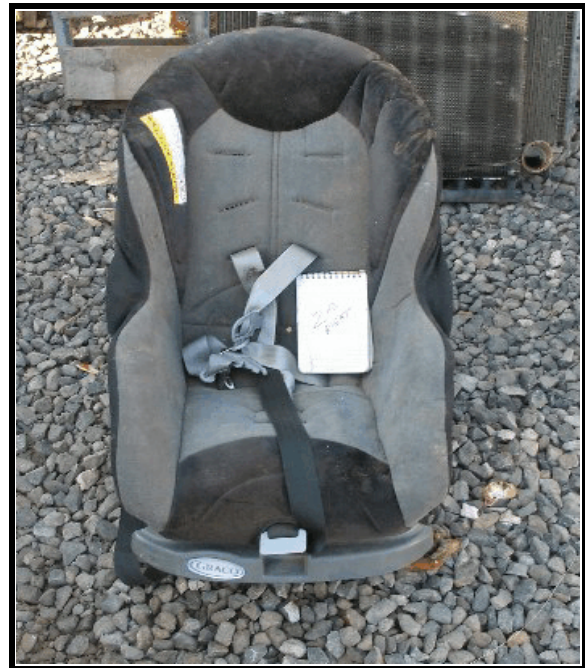
**Figure 12.** Graco Comfort Sport child safety seat

The Graco Comfort Sport convertible CSS was found by the investigator in the cargo area of the Jeep. A locking clip was found stowed on the back of the child seat. The model number was 8C00LNW and the date of manufacture was June 26, 2007. The child seat was configured with a five-point harness and a two-piece harness retainer clip. The lower harness straps were attached using a dual latch plate and buckle style closure. The seat was designed with three harness positions. At the time of the crash, the harness was in the bottom set of slots (**Figure 12**). The Graco was designed to be used rear facing for children weighing 2.2-13.6 kg (5-30 lb), and forward facing for children weighing 9-18 kg (20-40 lb). The Graco was designed for children whose height is 102 cm (40 in) or less. It is not known

if the child met the weight and height requirements. The child seat was configured with a top tether and lower LATCH hardware. The LATCH and tether straps were found stowed in their original positions. When anchored by a seat belt, the belt was to be routed through the rear facing belt paths. The child seat was designed to be secured by a lap belt, lap and shoulder belt, or LATCH. According to one witness, the seat was secured to the vehicle by the vehicle safety belt in the rear-facing orientation. Since the CSS was found in the cargo area of the vehicle, the exact configuration of the CSS placement during the crash could not be determined.
