CRASH DATA RESEARCH CENTER
Calspan Corporation
Buffalo, NY 14225

OFFICE OF DEFECTS INVESTIGATION

**2005 FORD CROWN VICTORIA POLICE INTERCEPTOR
REAR IMPACT CRASH AND FIRE INVESTIGATION**

CALSPAN CASE NO: CA07-037
LOCATION: OHIO
CRASH DATE: NOVEMBER, 2007

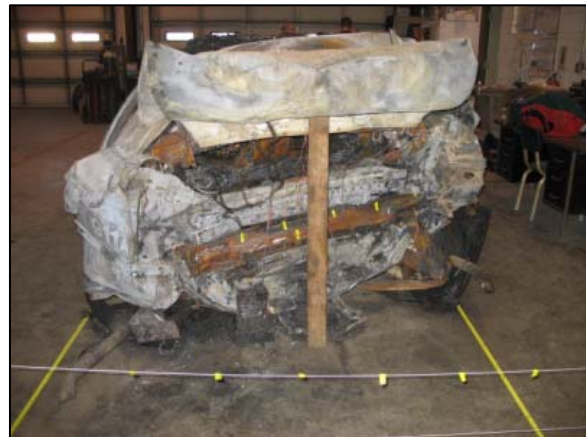
Figure 6 is the rear view of the damaged CVPI. **Figures 7 and 8** are the right lateral and left rear oblique views, respectively. The back plane of the Ford CVPI sustained severe direct and induced damage as a result of the impact. The direct contact began at the left rear bumper corner and extended 152 cm (62 in) to the right rear bumper corner. The dynamics and force of the impact fully compressed the volume of the trunk space forward and through the second row of the interior.

Figure 6: View of the Ford's damaged back plane.

The residual crush profile of the CVPI was documented along the rear bumper reinforcement bar and was as follows: C1 = 106 cm (41.7 in), C2 = 137 cm (53.9 in), C3 = 148 cm (58.3 in), C4 = 151 cm (59.4 in), C5 = 155 cm (61.0 in), C6 = 149 cm (58.7 in). The maximum crush measured 155 cm (61.0 in) and was located 46 cm (18 in) right of the centerline at C5. The trunk latch released during the impact and the lid was displaced forward through the backlight and into contact with the roof. The rear aspect of the roof buckled. The longitudinal deformation of the upper left and upper right corners of the roof measured 13 cm (5.3 in) and 25 cm (10.0 in), respectively. The right quarterpanel was completely buckled into the right C-pillar. The left wheelbase was reduced 30.4 cm (4.8 in). The right wheelbase was reduced 38 cm (15.1 in). The deformation and compression of the impact jammed the left rear, right front and right rear doors of the vehicle in the closed position. The front left door was opened by the driver post-crash. The left front door could not be re-latched at the time of the SCI inspection due to body distortion. The fuel neck disengaged from the crushed left rear quarterpanel during the crash

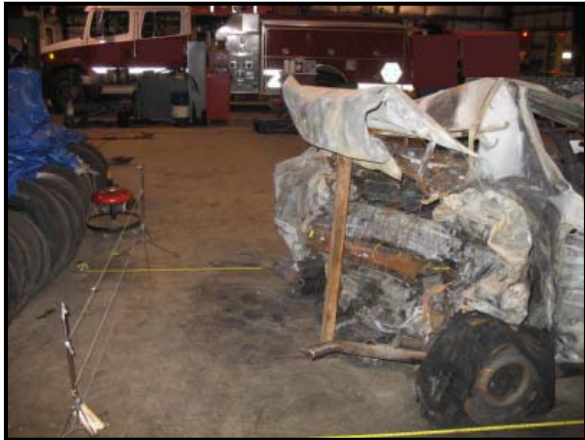
Figure 7: Right lateral view of the deformation.

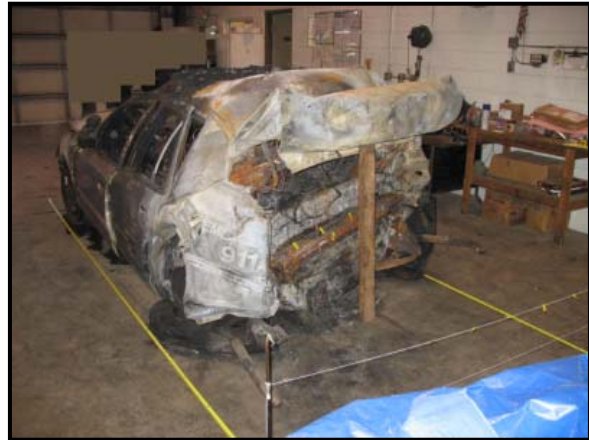
Figure 8: Left rear oblique view of the Ford.

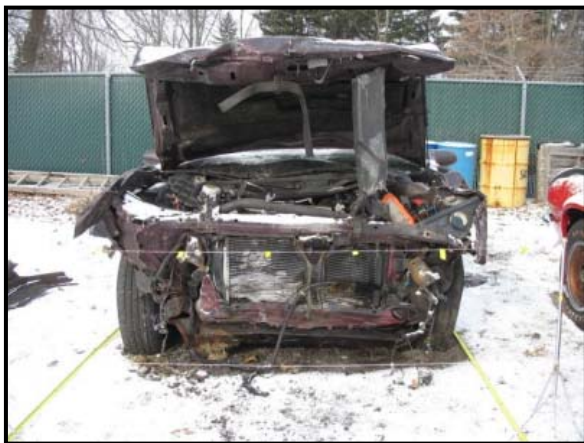
Figures 8 and 9 are the front and front right oblique views of the Cadillac. The vehicle's front plane sustained 157 cm (62 in) of direct contact damage that spanned the entire end width of the vehicle. The nature of the direct damage was indicative of an in-line front-to-rear impact configuration. The front fascia and reinforcement bar separated from the vehicle during the impact. The bumper reinforcement bar was attached to Energy Absorbing Devices (EAD's) fastened to the forward sub-frame of the vehicle. The residual crush of the Cadillac was documented at the EAD's and along the upper radiator support. The residual crush at the left and

Figure 9: Front view of the Cadillac.

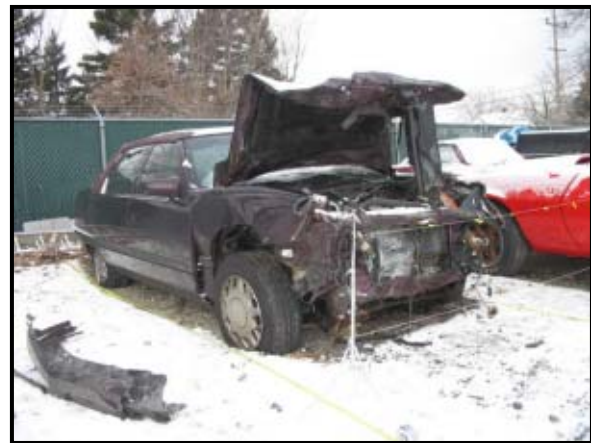
Figure 10: Front right oblique view.

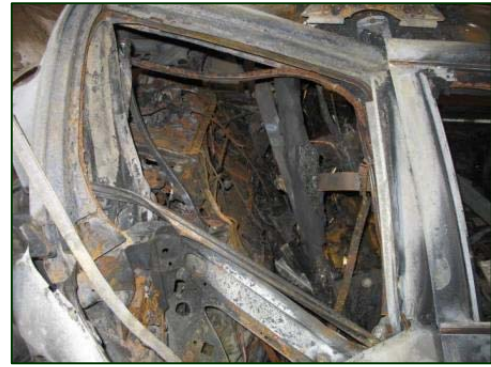
The interior of the 2005 CVPI sustained extensive damage as a result of crash induced intrusion of the rear seat area and the resulting fire. The back of the vehicle was crushed to a depth of 155 cm (61 in) which collapsed the trunk and rear wall of the passenger compartment into the back seat. The frame of the rear seat back intruded forward, nearly consuming the entire rear seating positions, **Figure 11**. The longitudinal distance between the aft edge of the safety cage and the right seat back frame was 10 cm (4 in), and 18 cm (7 in) on the left side.

Figure 11: Intrusion of the right rear seat position.

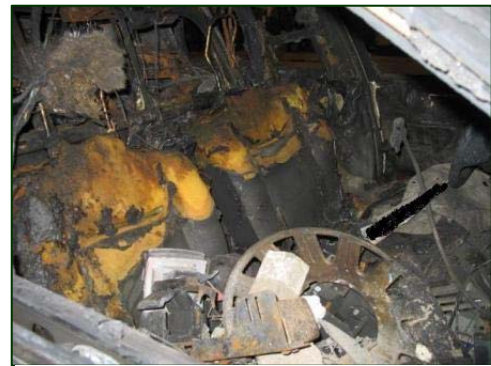
The fire spread rapidly to the passenger compartment and consumed the majority of the flammable materials. Refer to **Figure 12**. The foam padding surrounding the perimeter of the safety cage was charred but remained in place. The rear seat fabric and padding was totally consumed. The upper third of the foam padding on the front seat backs was melted with approximately 50 percent of the fabric covering burned from the foam. The head restraint padding and fabric covering was completely consumed. The leading edge of the fabric on the seat cushions was burned. The soft-edged steering wheel rim was charred but intact. The instrument panel was severely melted and consumed by the fire. The driver and front right air bag modules did not deploy. Both cover flaps were distorted by the heat, but remained intact.

Figure 12: Burned/charred interior surfaces.

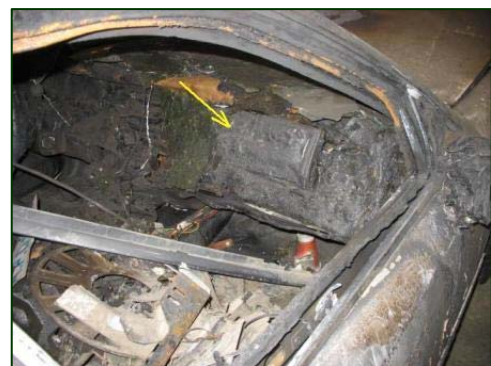
Figure 13: Non-deployed front right air bag.

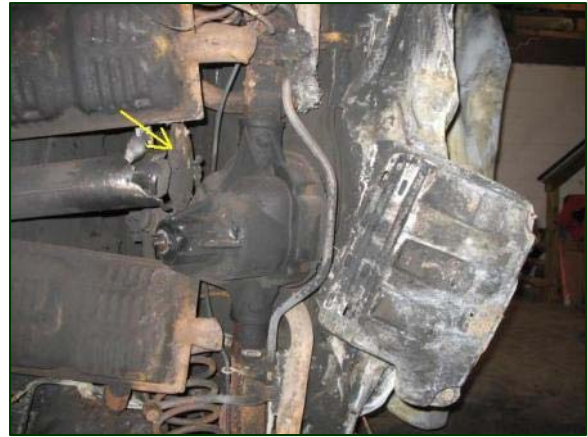
The initial inspection of the undercarriage revealed that the back wall of the fuel tank was crushed by the forward wall of the trunk and against the differential housing. The tank was intact, held in place by the tank straps. The filler tube remained intact and positioned in the tank and at the filler-door location. A positioning bracket attached to the inner fender held the tube in place. No visible punctures of the tank were visible. The fuel pump sending unit was dislodged from the tank and rotated 180 degrees. Refer to **Figure 15**. The unit was held in place by the external braided stainless steel fuel lines. The retainer ring was secured to the pump/sending unit flange by the six bolts.

Figure 15: Separated fuel pump/sending unit.

The Cadillac crushed the rear of the CVPI and the fuel tank which compressed the fuel in the tank that contributed to the separation of the fuel pump sending unit from the tank. The crash-induced fire ensued which engulfed the CVPI as it was displaced forward by the Cadillac. As the CVPI came to rest, the driver unbuckled his safety belt, opened the driver's door and exited the vehicle unassisted. He was able to move away from the vehicle as he remained conscious on the roadside. During the post-crash trajectory of the CVPI, the driver sustained thermal burns of both thighs that extended into the subcutaneous tissue, burns over the forearms, face and scalp. In addition to the facial burns, the driver sustained burns of the corneas.

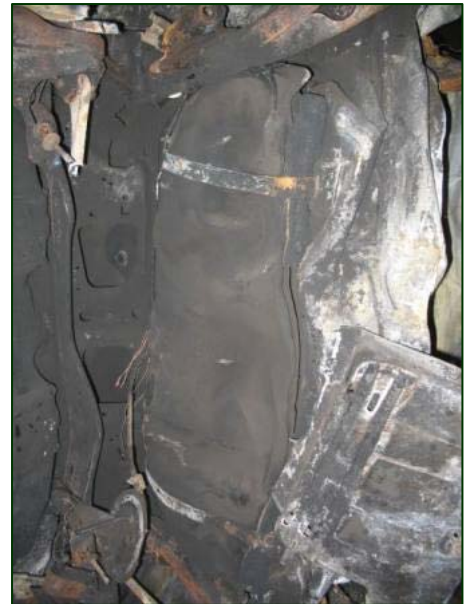
With the axle removed, the forward wall of the fuel tank was in full view, **Figure 16**. The forward wall and bottom aspect of the tank did not exhibit perforations or penetration of the tank. The sending unit mounting point was deformed to a slight oval shape.

Figure 16: Fuel tank with surrounding components removed.

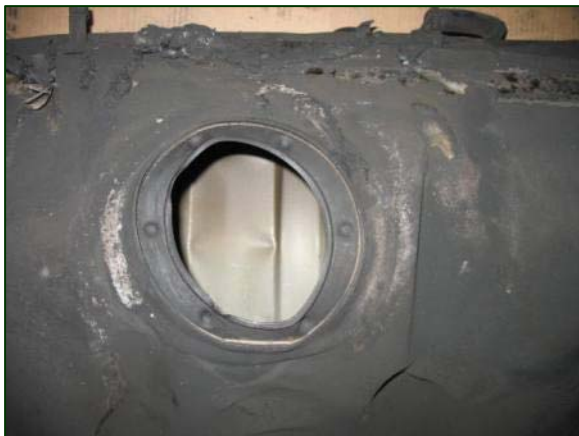
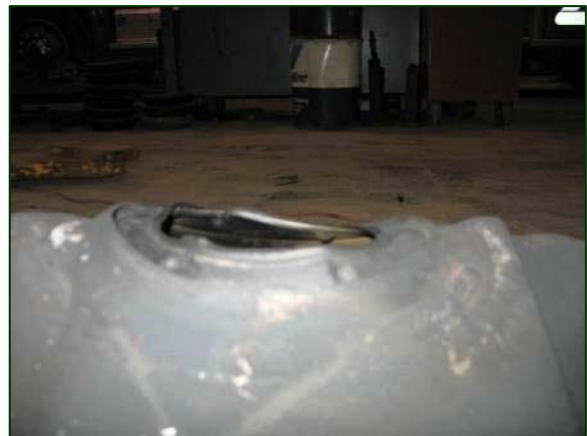
The deformed sending unit opening measured 13x11 cm (5.25x4.25in). The crimp edge was deformed with an outward bowing at the upper right aspect of the opening, **Figures 17 and 18**. As the tank deformed and as the internal pressure increased (hydraulic pressure), the sending unit separated from the tank. The sending unit deformed during the separation, **Figure 19**. The bottom aspect of the tank was crushed to near full-thickness. The mid area of the tank at the sending unit opening was 18 cm (7 in) in depth while the left side remained near original at 20 cm (8 in) in depth. A 2.5 cm (1 in) cut from the left tank strap was noted to the top aspect of the tank and was 17 cm (6.5 in) inboard of the left edge.

Figure 17: Deformed sending unit port.

Figure 18: View across the deformation of the sending unit port.

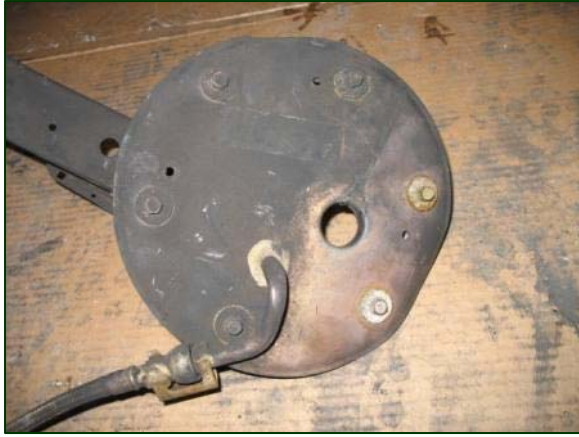
Figure 19: Deformation to the sending unit.

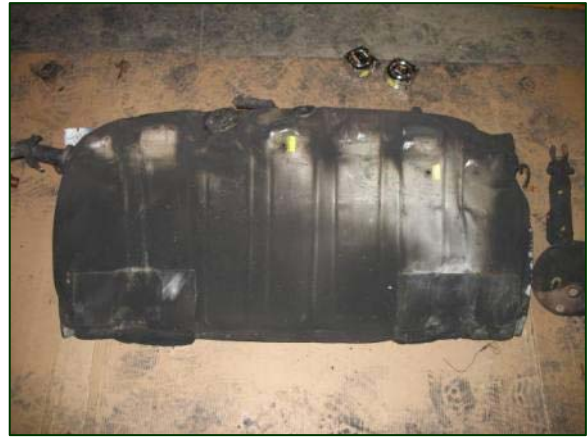
Two additional holes were noted to the upper rear wall of the tank, **Figure 20**. The first hole was slightly elongated with a maximum diameter of approximately 0.6 cm (0.25 in) and was located 2 cm (0.75 in) left of the centerline and 10 cm (3.75 in) below the top aspect of the tank. The second hole was approximately 5 mm (3/16 in) in diameter and was located 29 cm (11.25 in) right of center and 13 cm (5.25 in) below the top surface. A close inspection of the forward wall of the trunk revealed eight puncture holes. These punctures originated in the trunk with two of the holes matching the tank penetrations. The spacing of the trunk punctures measured approximately 8 cm (3.25 in). It was determined that the source of these punctures was the Stop Stick tire puncture system that was positioned laterally in the trunk and crushed against the forward wall of the trunk. There was no other damage or punctures of the tank.

Figure 20: View of the rear wall of the fuel tank.

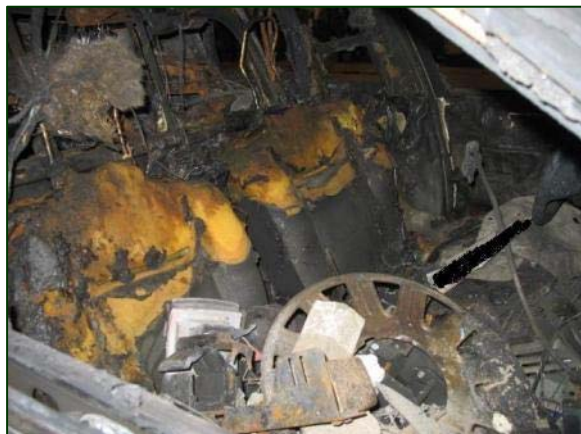
The driver responded to the 6 o'clock direction of force impact by initiating a rearward trajectory with respect to the accelerated vehicle. His back loaded the seat back that was reinforced by the placement of the passenger safety cage, **Figure 21**. His loading force was distributed over a

Figure 21: Interior view and driver's rearward trajectory.

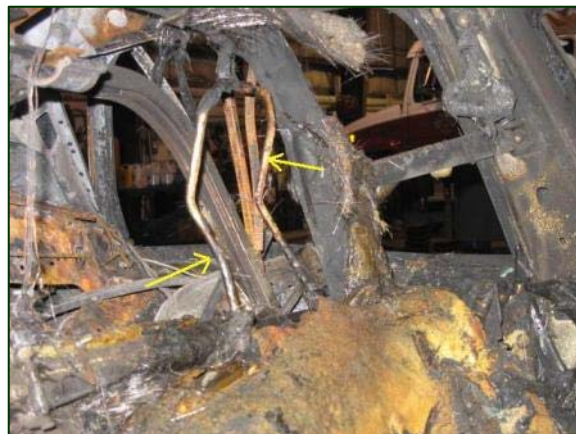
wide body area which mitigated potential injury. The driver's head loaded the adjustable head restraint. Although the fabric and padding was burned from the head restraint, the frame and inboard stalk of the head restraint was deformed rearward. The angle of the upper frame was altered by the loading and the inboard stalk was bowed, indicative of rearward movement, **Figure 22**. The head restraint was backed by the safety cage and protected the driver's head and neck from possible injury.

Figure 22: Driver loading deformation of the head restraint frame.
