Non Deployed Side Air Bag Investigation  
Dynamic Science, Inc. (DSI), Case Number DS07041  
2000 Lexus RX300  
Colorado  
September 2007

**Dynamic Science, Inc.**  
**Crash Investigation**  
**Case Number: DS07041**

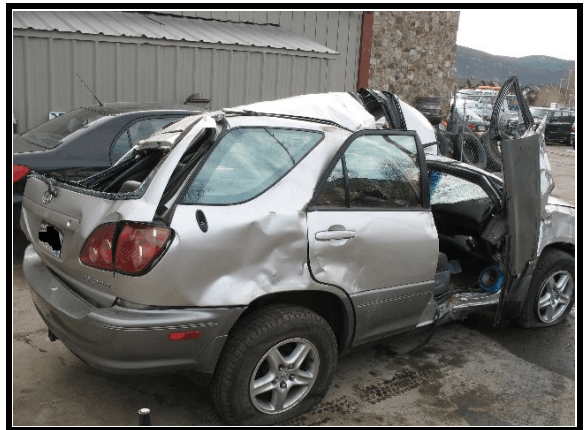
The 2000 Lexus RX300 sustained moderate damage to the top, left side and right side as a result of the rollover sequence. There was contact damage on the roof, primarily along the right roof rail. There was also contact damage to the left and right surfaces (**Figures 6-7**). The maximum crush was located at the right A-pillar and measured 36 cm (14.1 in) laterally and 27 cm (10.6 in) vertically.

The rollover sequence was a right side leading event. During the first roll, the Lexus engaged the right roof area and the right door with the ground and the right front door came open. There was no latch or striker damage. It appears that rods connecting the door handle to the latch may have come apart and released the door. As the vehicle continued to roll down the steep embankment, the speed began to increase. During the second roll, the front right door was pushed vertically to a position 90 degrees from its original position.

**Figure 7.** Right side damage, Lexus RX300

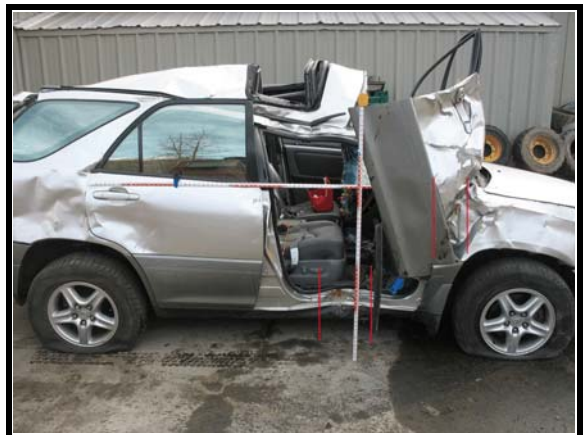
Near conclusion of the third roll, the Lexus contacted the tree with the right side sill and door areas. There were two tree contact areas (**Figure 8**). The first contact was to the sill area (**Figure 9**). The direct contact damage began 62 cm (24.4 in) aft of the frontal axle and extended rearward 26 cm (10.2 in).

**Figure 8.** Right side tree damage

The second tree impact was to the rotated door panel. The direct contact damage began 37 cm (14.6 in) aft of the front axle, ended 52 cm (20.5 in) aft of the front axle, and measured 15 cm (5.9 in) along the side plane. The CDC for the door panel impact was 00RYMN1.

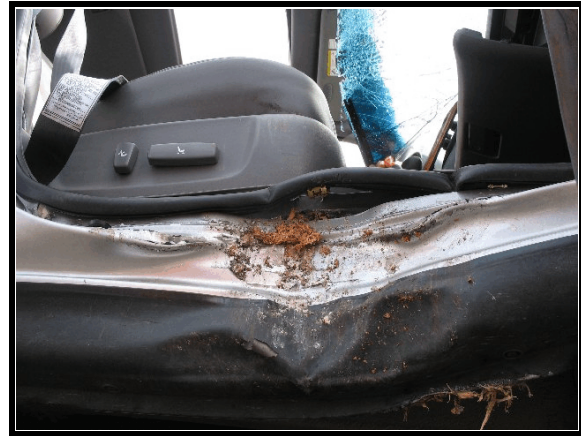
Six crush measurements were documented at the sill level as follows: C1 = 0 cm, C2 = 4 cm (1.6 in), C3 = 8 cm (3.1 in), C4 = 13 cm (5.1 in), C5 = 5 cm (1.9 in), C6 = 0 cm. This was an interrupted roll, and the force direction for this impact was non-horizontal. The CDC for the sill impact was 00RPLN2.

**Figure 9.** Close up of right sill damage

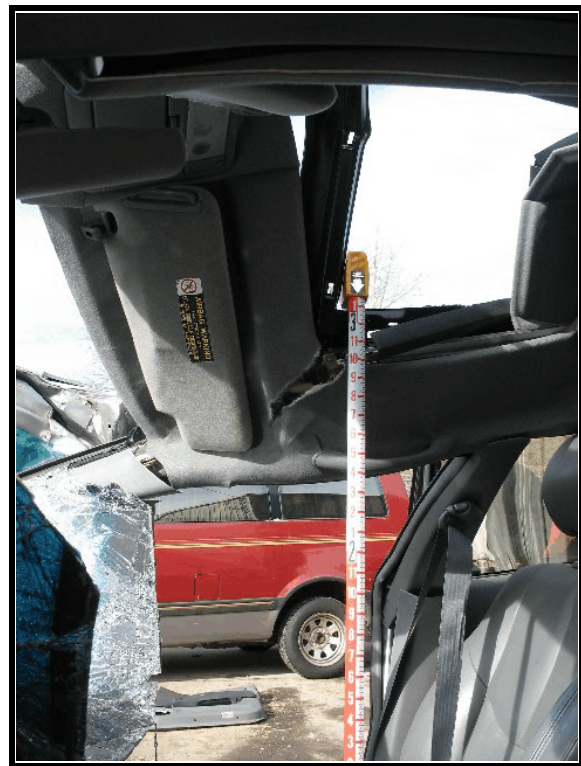
The 2000 Lexus RX300 sustained moderate interior damage as a result of passenger compartment intrusion (**Figures 10-11**). The right roof rail, right roof, right A-pillar, and right B-pillar sustained vertical and lateral intrusion. The left roof rail sustained vertical intrusion. The right front door opened during the rollover sequence and was deformed to a 90 degree angle. The driver's door and the two rear doors were jammed shut. The left side doors were able to be pulled open. The right rear door remained jammed. The inside door panel had separated from the vehicle. It was examined and there was damage due to occupant contact. The forward aspect of the armrest was cracked and scuffed. The damage was 17 cm (6.7 in) wide; the forward most crack measured 8 cm (3.1 in) vertically and the rear most crack measured 5 cm (1.9 in) vertically. The lower window frame area was deformed outward.

**Figure 10.** Right roof rail and A pillar intrusion

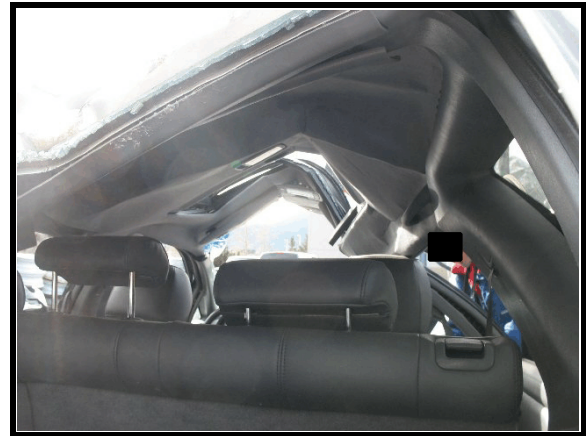
**Figure 11.** Overview of right side intrusion

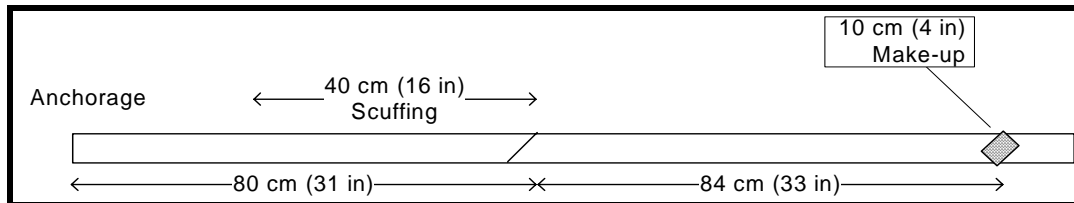
Rescue personnel had cut the webbing on the front right passenger belt. The cut section measured 80 cm (31 in) from the lower anchor (**Figure 12**). There was 40 cm (16 in) of scuffing along the webbing before the cut mark (**Figure 13**). There was a 10 cm (4 in) make-up transfer that was found 164 cm (64 in) from the lower anchor. The make-up transfer was found on the inward facing portion of the webbing (**Figure 14**). The plastic stop button was missing from the belt (**Figure 15**).

**Figure 12.** Front right passenger seat belt webbing

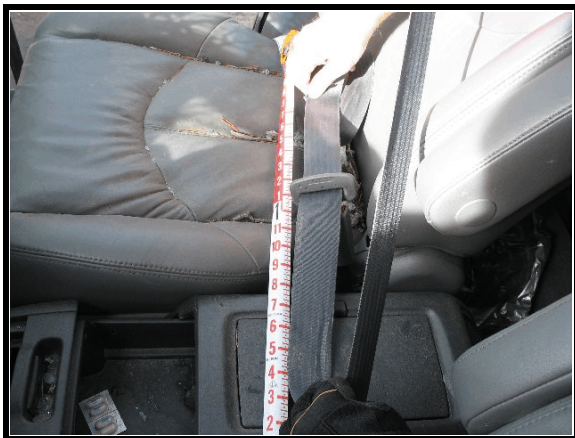
**Figure 13.** Loading to front right passenger seat belt webbing

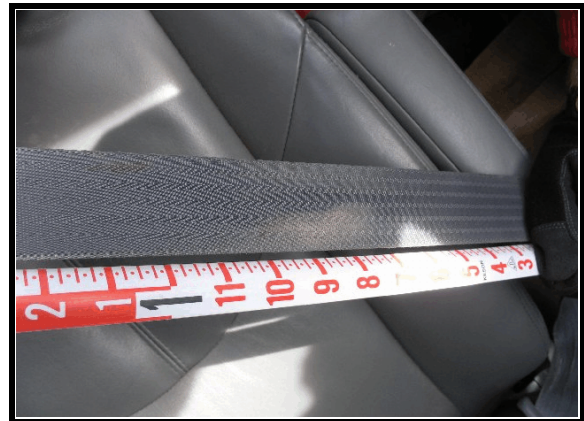
**Figure 14.** Make-up transfer

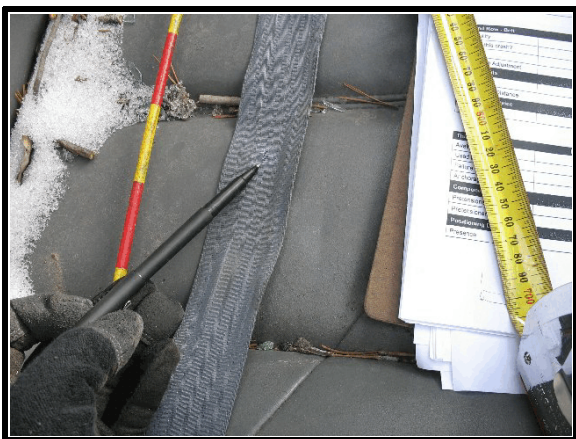
**Figure 15.** Missing stop button on front right passenger seat belt

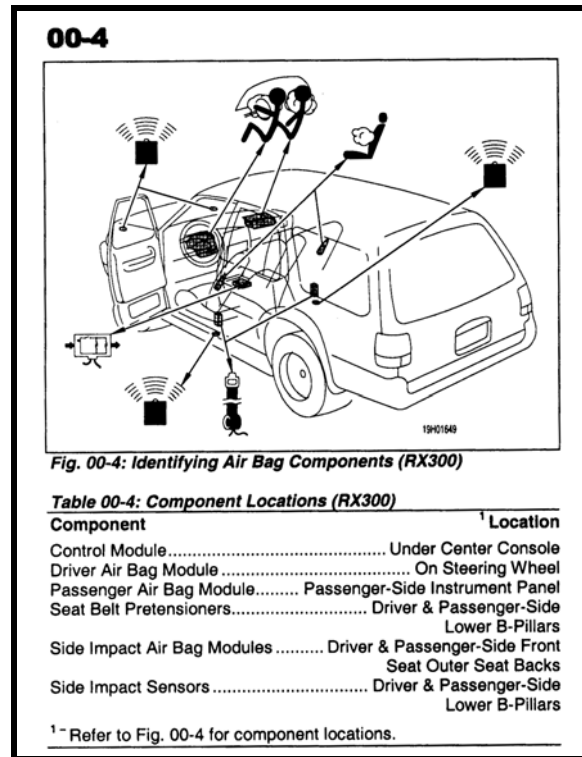
There were no air bag deployments or pretensioner actuations.

Based on the non-horizontal type of impact to the to the right side of the vehicle, it does not appear that the threshold was met for the side air bag deployment. The Lexus struck the tree while in mid-roll and the damage had a large vertical component.

**Figure 17.** Overview of Supplemental Restraint System

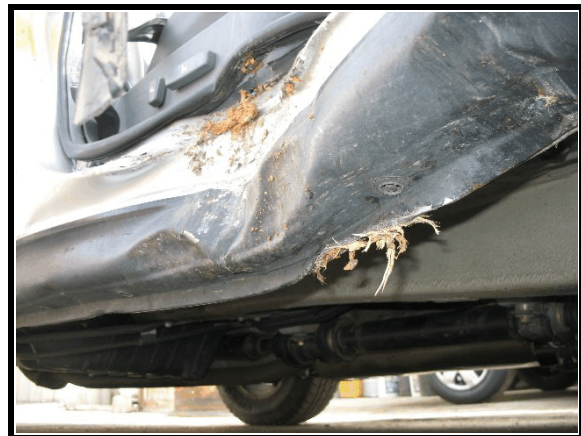
**Figure 18.** Right side impact damage

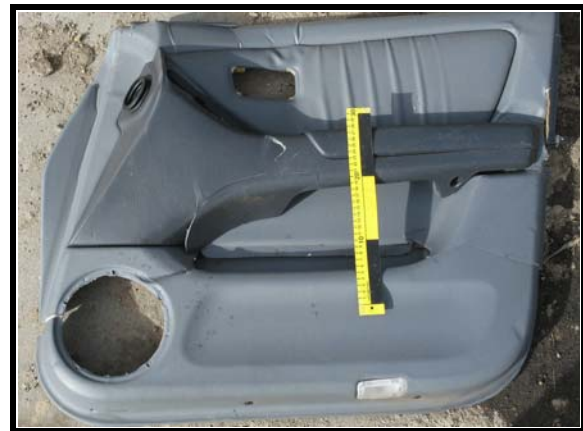
**Figure 19.** Contact to interior door panel/armrest
