**CALSPAN REMOTE SAFETY BELT RELATED
PLACENTAL ABRUPTION CRASH INVESTIGATION
NASS/SCI CASE NO: 2008-09-026C**

**VEHICLE: 2006 MERCEDES-BENZ E350
LOCATION: MARYLAND
CRASH DATE: JANUARY, 2008**

Contract No. DTNH22-07-C-00043

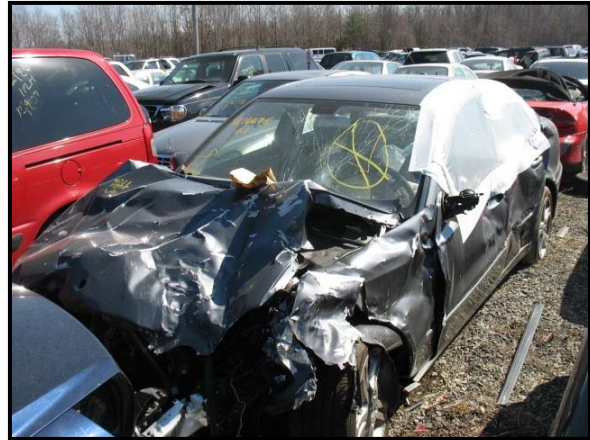
Figure 1: Left front oblique view of the Mercedes.

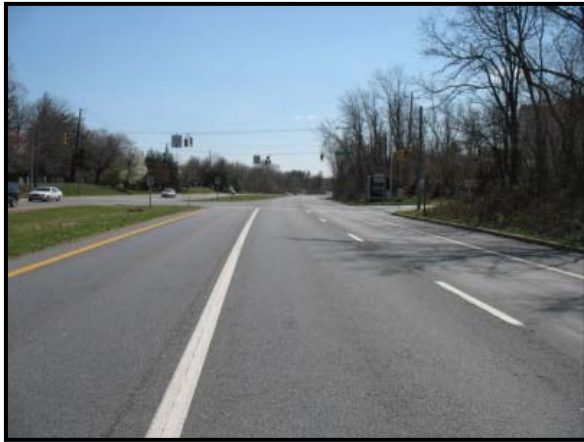
Figure 2: Mercedes trajectory view.

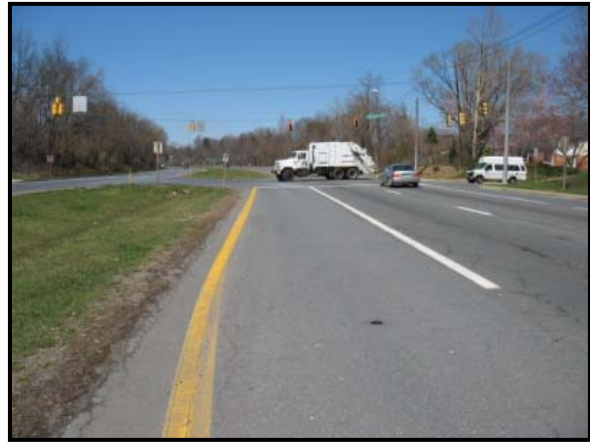
Figure 3: Ford trajectory view.

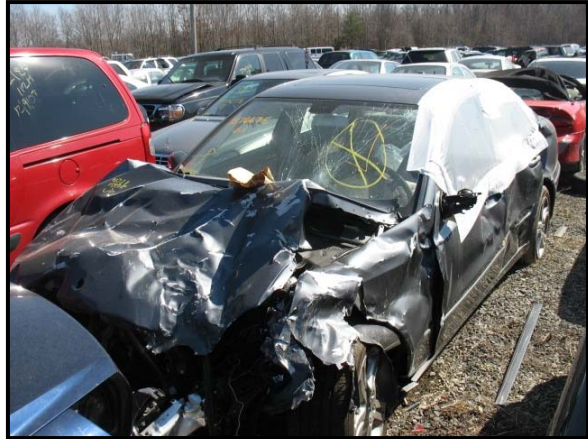
Figure 4 is a frontal view of the Mercedes. The vehicle's front plane sustained direct and induced damage that extended across its entire 150 cm (59 in) end width. The NASS researcher did not measure the frontal crush of the Mercedes due to its tight parked position within the salvage yard. The deformation of the vehicle was estimated at the Zone Center. The maximum crush located at the centerline of the vehicle's bumper was an estimated 47 cm (18.5 in). The Zone Center estimated frontal crush profile was as follows: C1 = 27 cm (10 in), C2 = 44 cm (17 in), C3 = 47 cm (18 in), C4 = 47 cm (18 in), C5 = 41 cm (16 in), C6 = 30 cm (12 in). The bumper fascia separated during the impact. Both fenders buckled and crushed rearward. The hood deformed at its fold points into an inverted V-shape. There was an estimated 10 cm (4 in) reduction in both wheelbase dimensions. The windshield was fractured from the exterior force of the frontal impact. The Collision Deformation Classification (CDC) was 11-FDEW2.

Figure 4: Frontal view of the Mercedes.

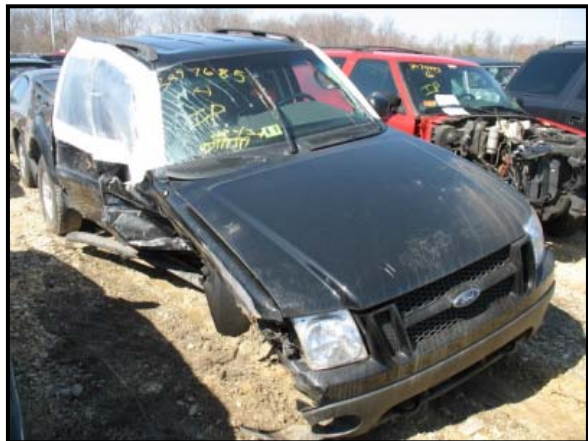
Figure 5 is a right front oblique view of the Ford Explorer. The right plane of the vehicle sustained two regions of impact damage as a result of the intersection impact and subsequent side slap. The direct contact damage (due to the contact with the front of the Mercedes) began immediately aft of the front right corner, 300 cm (118 in) forward of the rear axle. The direct contact extended rearward across the fender and the right doors 156 cm (61.4 in). The front right tire was involved in the direct contact and separated from its suspension. The combined induced and direct primary damage began on the fender and extended rearward 300 cm (118 in). The induced damaged ended 80 cm (31.5 in) forward of the right rear axle. The residual crush measured at the mid-door elevation was as follows: C1 = 2 cm (0.8 in), C2 = 13 cm (5.1 in), C3 = 34 cm (13.4 in), C4 = 33 cm (13.0 in), C5 = 21 cm (8.3 in), C6 = 11 cm (4.3 in). The maximum crush measured 44 cm (17.3 in) and was located on the mid aspect of the front door 229 cm (90.2 in) forward of the rear axle. The CDC of this impact was 02-RYEW3.

Figure 5: Right front oblique view of the Ford.

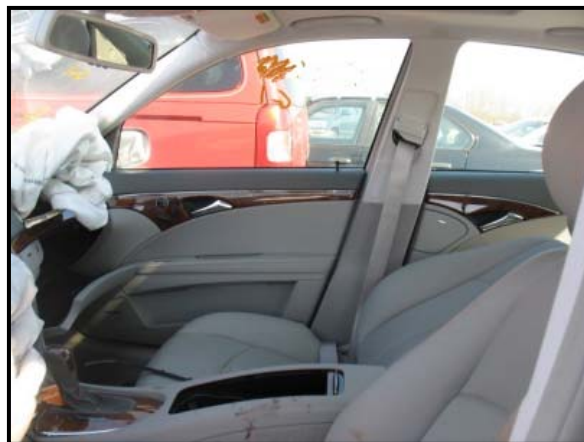
The interior damage to the Mercedes consisted of the deployment of the driver and front right passenger air bags. There was no intrusion or damage to the interior components that was attributed to the exterior force of the crash. There were no identified interior occupant contact points. The center console, the deployed driver air bag membrane and the deployed front right passenger air bag membrane exhibited body fluid evidence. Body fluid evidence generally is not considered to be direct contact evidence and most likely occurred post-crash. **Figure 6** is a left interior view of the vehicle.

Figure 6: Left interior view of the Mercedes.
