On-Site Certified Advanced 208 Compliant Investigation
Dynamic Science, Inc. (DSI), Case Number 2008-81-055B
2004 Honda Odyssey
Washington
May 2008

1. Report No. 2008-81-055B	2. Government Accession No.	3. Recipient Catalog No.	
4. Title and Subtitle Certified Advanced 208 Compliant Investigation		5. Report Date May 5, 2009

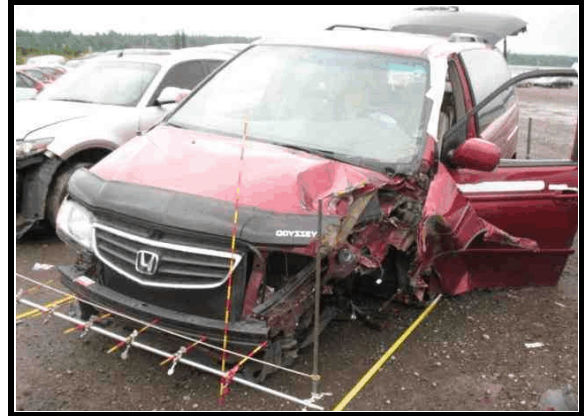
Figure 1. Subject vehicle, 2004 Honda Odyssey

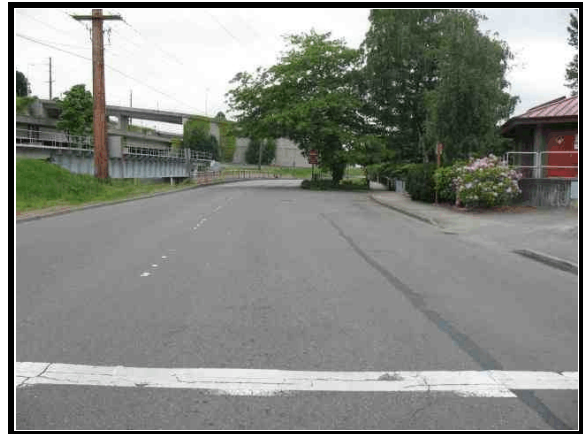
This single vehicle crash occurred on a northbound 3-lane, 1-way divided roadway (**Figure 2**). The travel lanes were separated by raised pavement markers. The asphalt roadway was curved to the right in the southbound direction. Prior to the area of impact, the roadway narrowed into two travel lanes as it approached a bridge overpass. The overpass was bordered by metal bridge rails on either side. At the northern end of the overpass, there was a red "Do Not Enter - Wrong Way" warning sign. It was dark at the time of the crash and overhead streetlights were present and illuminated. The posted speed limit was 40 km/h (25 mph).

Figure 2. Southbound approach to impact with bridge rail

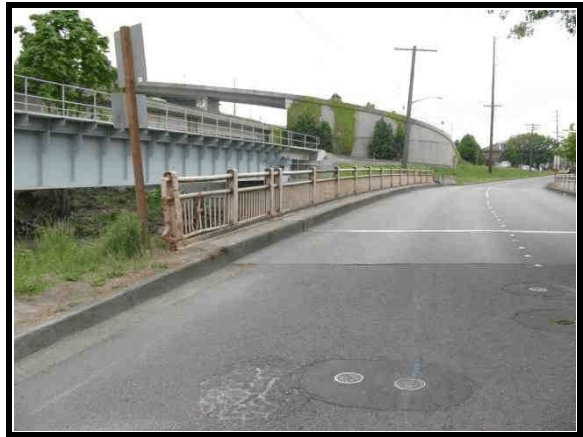
The Odyssey continued to the left until it departed the roadway on the left side and struck the end of the bridge rail (**Figure 3**). The driver's air bag deployed upon impact. The barrier algorithm of the WinSmash program computed a barrier equivalent speed of 24.0 km/h (14.9 mph), based on an estimated crush profile.

Figure 3. Impact with bridge rail

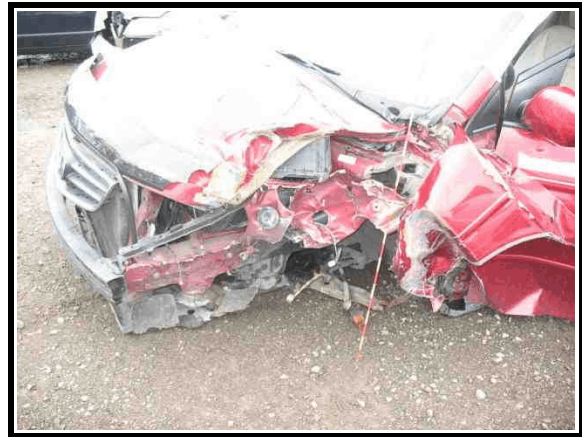
The Honda Odyssey sustained moderate damage as a result of the impact with the bridge rail. The direct damage began at the left front bumper corner and extended 29 cm (11.4 in) laterally across the frontal plane. The damage occurred outboard of the frame rails and per NASS protocol no crush profile was generated.

The damage extended rearward down the left side plane. The left fender was peeled rearward. The left front wheel and tire were fractured and separated from the vehicle.

Figure 4. Left side damage

It was not known if the left front door was jammed shut. The Collision Deformation Classification (CDC) for the impact with the bridge rail was 12FLEE6.

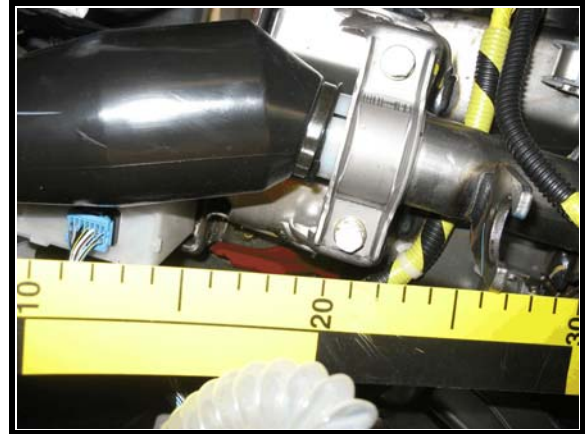
The area beneath the instrument panel was examined to determine if there was any column movement (**Figure 5**). Comparisons were also made between the subject vehicle and an exemplar vehicle, and it was determined there was no column movement.

Figure 5. Area beneath instrument panel and steering column

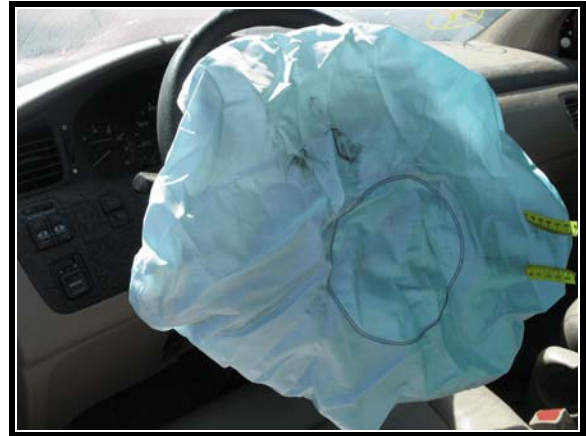
Figure 6. Deployed driver's air bag

The driver's air bag deployed through H-configuration module flaps (**Figure 6**). The top flap was 16 cm (6.3 in) wide by 5 cm (2 in) high; the bottom flap was 16 cm (6.3 in) wide by 7 cm (2.8 in) high. There were two 4.5 cm (1.8 in) circular vent ports at the 11 and 1 o'clock locations on the rear aspect of the air bag. There was a single tether strap affixed to the circular stitching on the face of the air bag. A 4 x 4 cm (1.6 x 1.6 in) blue cloth transfer was located at the right bottom quadrant, 6 cm (2.4 in) from the center of the air bag and 3 cm (1.2 in) from the edge of the bag. There was a black grease smear located just above the center of the air bag face that was not related to an occupant contact. The smear was 10 cm (3.9 in) wide by 3 cm (1.2 in) high.

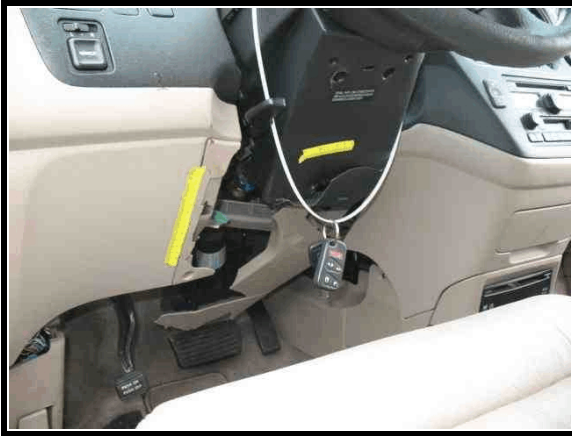
The left lower instrument panel and the steering column were fractured due to occupant contact. A scuff was located on the top of the steering wheel rim.

Figure 7. Left knee contact to lower instrument panel

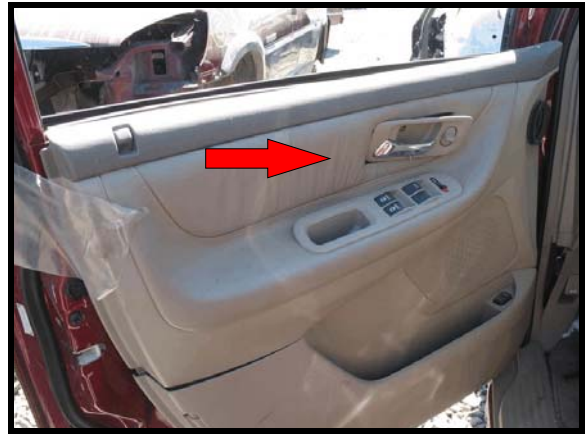
The 36-year-old male driver was seated in an unknown posture and was unrestrained. The seat was adjusted to between the forward most and mid track position and the seat back was slightly reclined. The driver was actively steering to the left prior to impact. At impact, the driver's air bag deployed. The driver initiated a forward trajectory and loaded the deployed air bag. The driver's left knee contacted the lower instrument panel, causing a knee abrasion and laceration (**Figure 7**). The Odyssey rotated sharply in a counterclockwise direction and the driver probably contacted the left door with the left side of his chest before the vehicle came to rest, possibly causing the heart injury (**Figure 8**).

Figure 8. Possible contact to door panel
