ON-SITE NOT IN TRAFFIC SURVEILLANCE BACK OVER INVESTIGATION

CASE NUMBER - IN08001
LOCATION - ARKANSAS
VEHICLE - 2007 HYUNDAI ELANTRA
CRASH DATE - November 2007

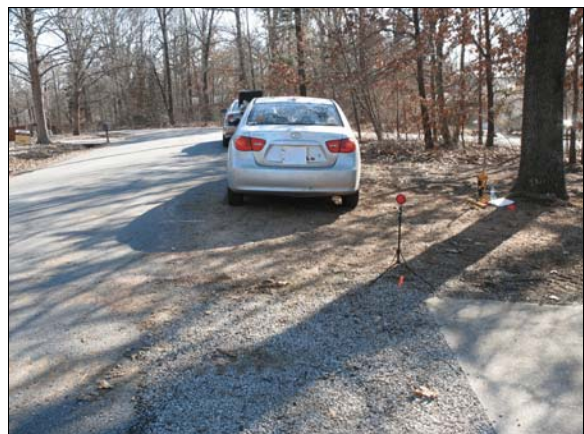
Figure 1: View south with Hyundai parked in same location as at time of incident; red reflector on tripod shows driver reported final rest location of nonmotorist

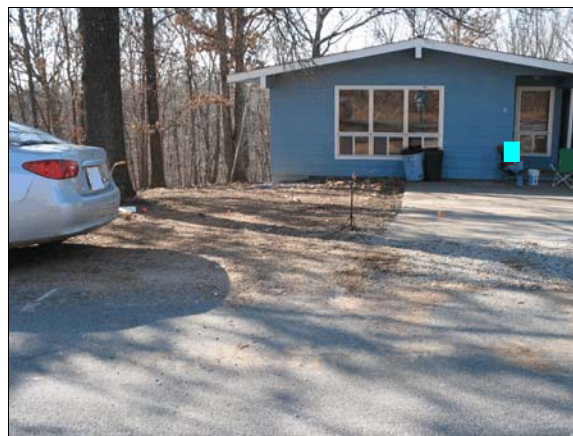
Figure 2: Overview of parked position of Hyundai, driveway and driver's residence

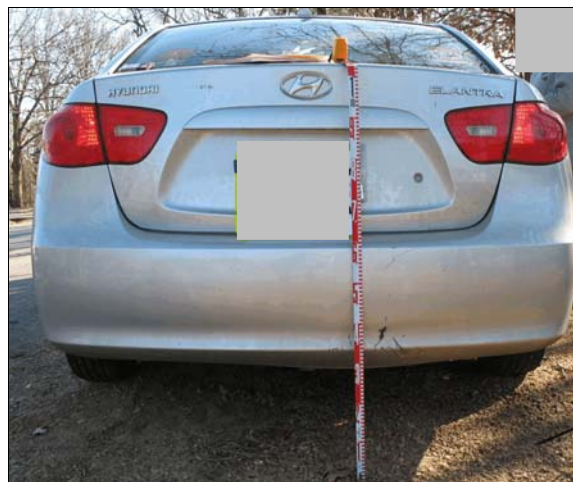
Figure 3: Overview of back of Hyundai, scratches on bumper are not related to this incident, vertical scale in 10th of meter

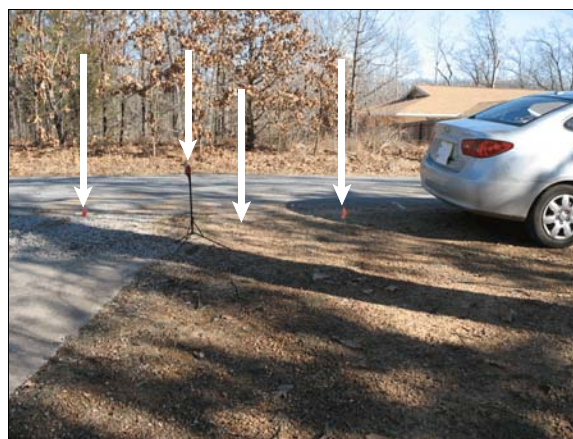
Post-Crash: The Hyundai's driver got out of the vehicle and saw the nonmotorist laying on his left side with his head toward the street (**Figure 4**) bleeding heavily from his head. The driver picked up the nonmotorist and ran into the house yelling for help from his wife. The driver's wife took the nonmotorist and ran outside and began yelling for a neighbor to call 911. The driver ran to a second neighbor's house and told them to call 911. The nonmotorist was transported by ambulance to a local hospital and subsequently airlifted to an urban children's medical center. The nonmotorist survived and was hospitalized for five days and discharged. He sustained skull fractures, a traumatic brain injury, a lacerated right ear and contusions to his head and face.

Figure 4: Overview of scene of incident from front yard of driver's residence; arrows indicate from left to right: 1 driver reported back of Hyundai at initial stop; 2 driver reported final rest position of nonmotorist; 3 approximate location of nonmotorist at impact with bumper; 4 driver reported position of back of Hyundai at final rest; Hyundai in driver reported initial parked position

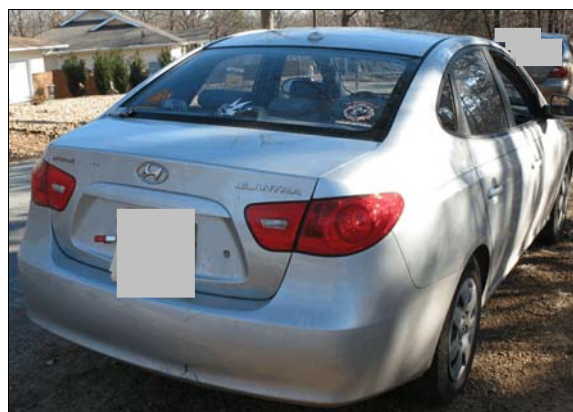
Inspection of the Hyundai Elantra revealed no damage or evidence of contact with the nonmotorist. Some heavy scratches to the back bumper fascia were located to the right of the vehicle's centerline. The driver indicated that the damage was from a previous incident. Based on the police incident report, which indicated the area on the back bumper where the initial impact occurred, the reported contact to the right rear tire, and the Collision Deformation Classification (CDC) guidelines for pedestrian impacts, the CDCs were determined to be: **06-BRLN-1 (180 degrees)** and **12-FRWN-9 (0 degrees)**.

Figure 6: Back right view of subject Hyundai Elantra, scratches on back bumper are not related to this incident

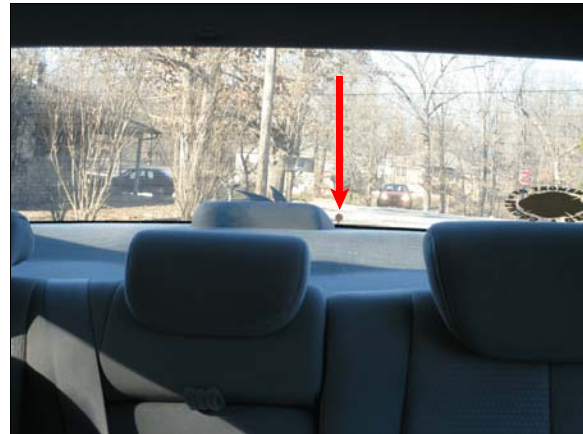
The initial set of observations was made with the driver looking over his right shoulder out of the backlight (Figure 7). The target was moved rearward from the back bumper along the Hyundai's approximate centerline until it came into the driver's view (Figure 7). The target had to be moved rearward from the back bumper 7.1 meters (23.3 feet) before the top of target came into the driver's view. The target was then moved to the right 0.8 meter (2.6 feet) where it became obstructed by the Center High Mounted Stop Lamp (CHMSL). The target became visible again when moved 1.3 meters (4.3 feet) further to the right. When the target was moved 1.9 meters (6.2 feet) further to the right, it dropped out of the driver's sight. This is because the location of the target placed it on the negatively sloped (-10.3 %) driveway. The target was moved further to the right and became visible to the driver through the right rearmost window when moved right an additional 3.6 meters (11.8 feet). The target was then placed back to its initial position at the approximate centerline. When moved 0.3 meter (0.7 foot) to the left of the approximate centerline, it became obstructed by the back left head restraint. From this point, the target was not visible to the driver because it was not normal for the driver to turn his head any further to the right.

Figure 7: View out of Hyundai's backlight from driver's seat; arrow shows target in location where driver could first see it

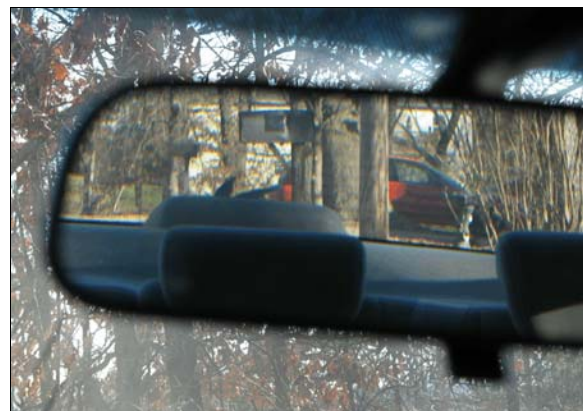
The Hyundai's driver was then asked to view behind the vehicle through the rearview mirror (Figure 8), which he indicated he had not adjusted prior to this contractor's on-site investigation. It was in the same position as at the time of the incident. The target was moved rearward from the back bumper as the driver viewed through the rearview mirror. The target did not become visible to the driver until it was moved rearward 7.3 meters (23.9 feet). The target became obstructed by the (CHMSL) when moved to the right 0.2 meter (0.7 foot) and became visible again when moved right an additional 0.5 meter (1.6 feet). When moved 0.6

Figure 8: Close view through Hyundai's rearview mirror from driver's seat

meter (2 feet) further to the right, the target became obstructed by the back right head restraint. The target did not become visible again when moved further to the right because it went out of the rearview mirror's field of view. The target was returned to the initial location at the approximate centerline and when moved left, was immediately obstructed by the back left head restraint and was not visible again when moved further to the left.

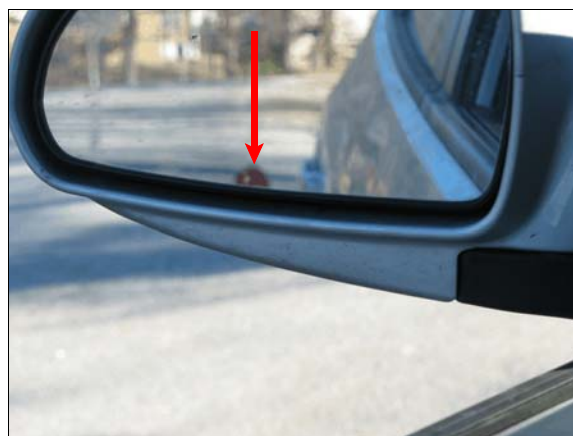
The target was then placed at the back left bumper corner as the driver viewed through the left side view mirror (Figure 9). The driver did not adjust his side view mirrors often and could not recall the last time he had adjusted the side view mirrors. When the target was placed at the back left bumper corner, it was necessary to move the target 0.9 meter (3 feet) to the left before it went out of the mirror’s view. The target was repositioned at the back left bumper corner and moved forward, toward the left side view mirror. The target went out of the mirror’s field of view when moved forward 0.7 meter (2.3 feet) from the bumper corner. The target was then positioned at the back right bumper corner and the same process was repeated for the right side view mirror (Figure 10). When moved laterally to the right 0.9 meter (3 feet), the target went out of the mirror’s field of view. The target was then placed back at the back right bumper corner, and moved 0.9 meter (3 feet) forward where it went out of the mirror’s field of view and the driver could no longer see it.

Figure 9: Close view through Hyundai’s left side view mirror; arrow shows target at location it began to go out of driver’s view as it was moved forward from back left bumper corner

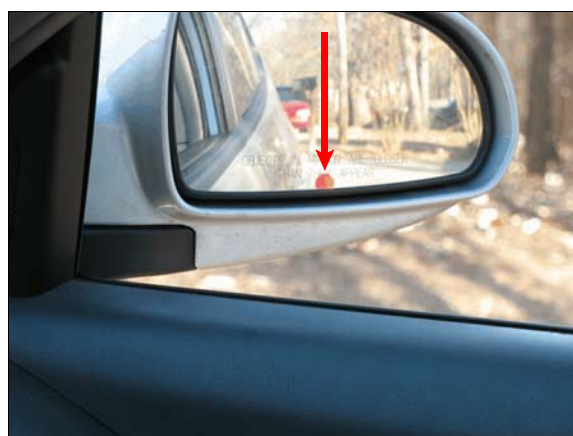
Figure 10: Close view through Hyundai’s right side view mirror from driver’s seat, arrow shows target at location it began to go out of driver’s view as it was moved forward from the back right bumper corner
