Child Safety Seat Investigation
Dynamic Science, Inc. / Case Number: DS08001
1985 Mercedes-Benz 190E
California
January 2008

1. Report No. DS08001		2. Government Accession No.		3. Recipient Catalog No.	
4. Title and Subtitle Child Safety Seat Investigation				5. Report Date February 15, 2009

14. Sponsoring Agency Code	
15. Supplemental Notes					
16. Abstract <p>This on-site investigation focused on a child safety seat that was positioned in the left rear seat position in a 1985 Mercedes-Benz 190E. The Mercedes was being driven by a restrained 33-year-old female and a 3-year-old female was seated in the second row left position in a child safety seat. The Mercedes was traveling northbound at a witness reported speed of 72 km/h (45 mph) and was weaving through slower moving traffic. The other vehicle in this crash was a 2003 Honda Odyssey minivan. There were three occupants in this vehicle. The Odyssey was stopped at the intersection and was facing north. As the Mercedes approached the intersection, the driver lost control of her vehicle. The left side of the Mercedes struck the right rear of the Odyssey. The Mercedes continued past the Odyssey through the intersection, over the n

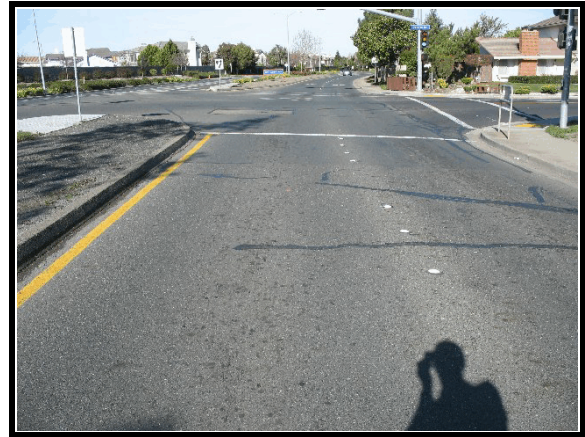
The left side of the Mercedes struck the right rear of the Odyssey (Event 1) (**Figure 3**). The impact severity was moderate. The Missing Vehicle algorithm of the WinSmash program computed a total delta V of 25 km/h (15.5 mph), based on the Mercedes' left side crush profile. The longitudinal and lateral components were -23.5 km/h (-14.6 mph) and 8.6 km/h (5.3 mph), respectively. The Odyssey was pushed forward and to the left. The Mercedes initiated a slight counterclockwise rotation as the vehicle continued past the Odyssey. The driver of the Mercedes steered to the right and the vehicle traveled through the intersection in a northeast direction. The Mercedes traveled over the northeast corner of the intersection (**Figure 4**) and struck several off-road objects. There were at least six objects contacted: a sign pole (Event 2), a traffic pole (Event 3), a fence (Event 4), a curb (Event 5), another curb (Event 6) and a tree/bush (Event 7).

Figure 3. Area of impact with Honda Odyssey

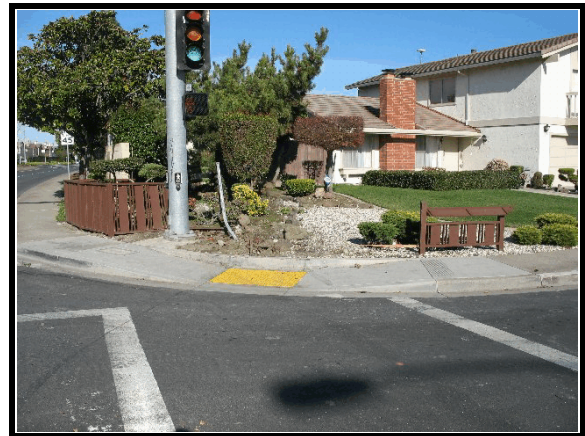
Figure 4. Area of impact with curb, fence, and pole

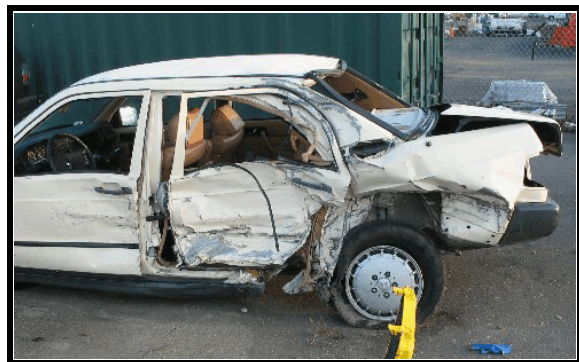
The 1985 Mercedes-Benz sustained moderate left side damage as a result of the impact with the Honda Odyssey (**Figure 5**). The direct damage began 60 cm (23.6 in) aft of the left rear axle and extended 297 cm (116.9in) forward along the left side plane. The maximum lateral crush was located at C2 and measured 25 cm (9.8 in). There was direct contact to the driver's door, the left rear door, the upper C pillar, and the left rear quarter panel. The driver's door and the left rear door were jammed shut. The door was pulled away from the B-pillar which formed an open gap that measured 20 cm (7.9 in) wide by 42 cm (16.5 in) high at the top and 15 cm (5.9 in) wide by 35 cm (13.8 in) high at the bottom. The base of the C-

Figure 5. Left side damage

pillar was pulled away from the door which formed a gap at the bottom that measured 12 cm (4.7 in) wide by 14 cm (5.5 in) high. The anchorage for the second row left seat belt was exposed at this location. Six crush measurements were documented at the mid-door level as follows: C1 = 8 cm (3.1 in), C2 = 25 cm (9.8 in), C3 = 16 cm (6.3 in), C4 = 8 cm (3.1 in), C5 = 4 cm (1.6 in), C6 = 0 cm. The Collision Deformation Classification (CDC) for the impact with the Honda Odyssey was 11LZAW3.

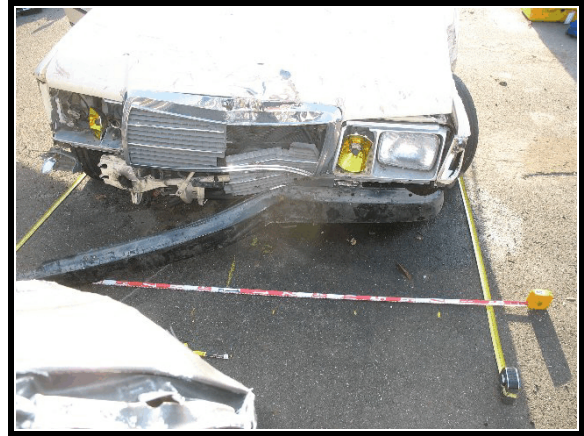
Figure 6. Frontal damage

The Mercedes sustained front end damage from the impact with a metal pole, the tree and the fence. The impacts could not be separated and a single CDC of 12FDEW1 was assigned to describe the damage (**Figures 6-7**). Six crush measurements were documented at the bumper level as follows: C1 = 0 cm, C2 = 5 cm (1.9 in), C3 = 11 cm (4.3 in), C4 = 11 cm (4.3 in), C5 = 4 cm (1.6 in), C6 = 0 cm.

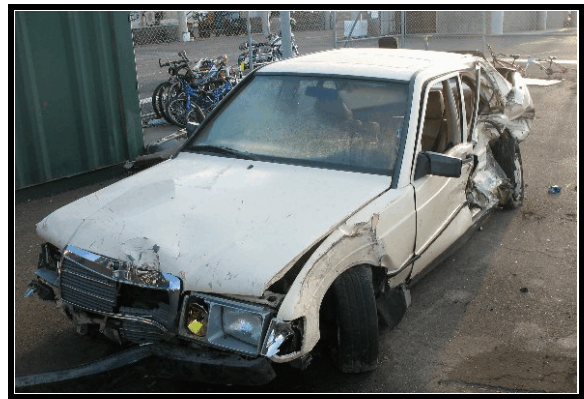
Figure 7. Front and left side damage

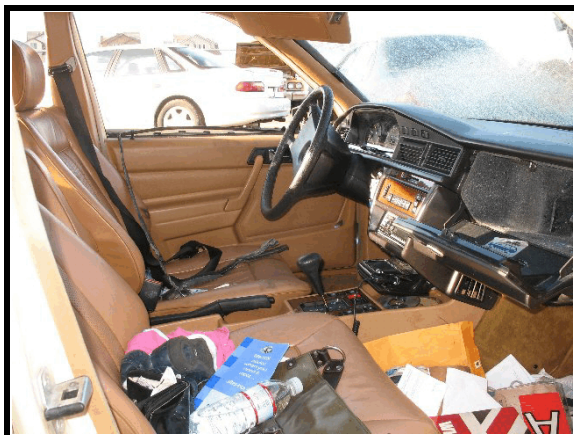
The Mercedes sustained moderate interior damage as a result of passenger compartment intrusion. The left side doors, the B-pillar, the C-pillar, and the sill sustained lateral intrusion. The rear bench seat back was displaced longitudinally (**Figures 8-9**). The specific passenger compartment intrusions were documented as follows:

Figure 8. Driver's seated position

Position	Intruded Component	Magnitude of Intrusion	Direction
RR	Seat back	24 cm (9.4 in)	Longitudinal
MR	Seat back	19 cm (7.5 in)	Longitudinal
LR	Seat back	13 cm (5.1 in)	Longitudinal
LR	Door	11 cm (4.3 in)	Lateral
LR	C pillar	10 cm (3.9 in)	Lateral
LR	Sill	9 cm (3.5 in)	Lateral
LF	B pillar	9 cm (3.5 in)	Lateral
LF	Door	3 cm (1.2 in)	Lateral
LF	Sill	2 cm (0.8 in)	Lateral

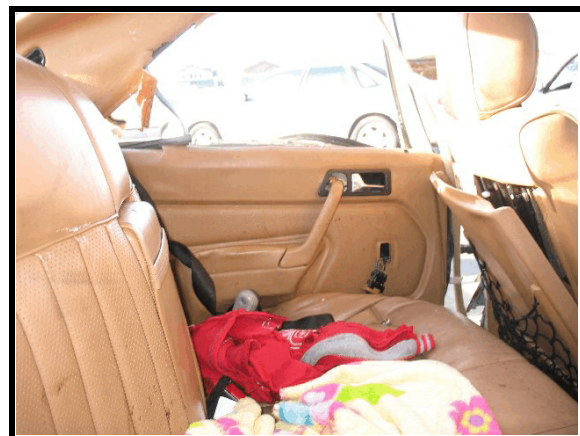
Figure 9. Second row left position

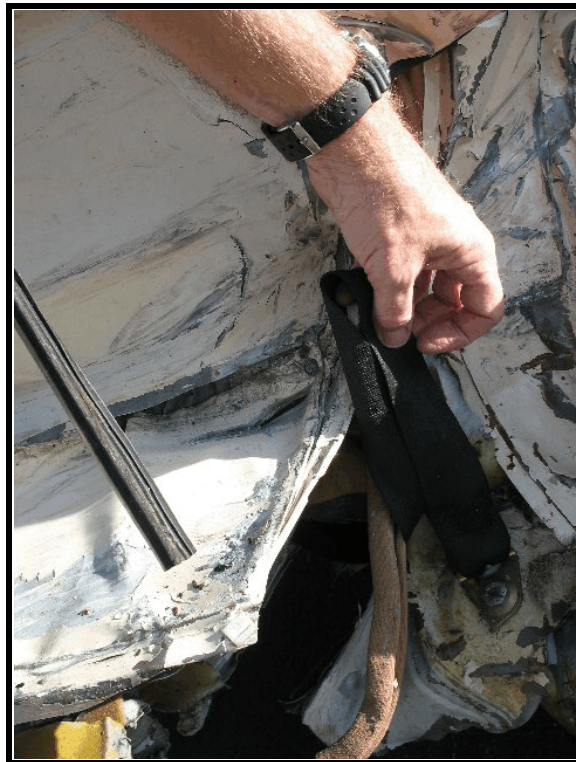
The rear left safety belt was configured with a sliding latch plate and an Emergency Locking Retractor. The rear left safety belt was used to secure a child safety seat. The seat belt anchorage was exposed during the crash but the belt was not damaged (**Figure 10**). There was a 48 cm (18.9 in) area of scuffing located on the seat belt webbing. The left rear latch plate was cracked (**Figure 11**), presumably due to loading.

Figure 10. Second row left seat belt anchorage

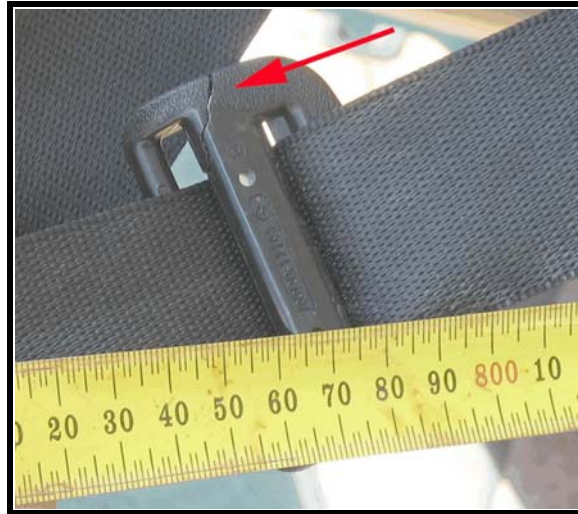
Figure 11. Cracked latch plate

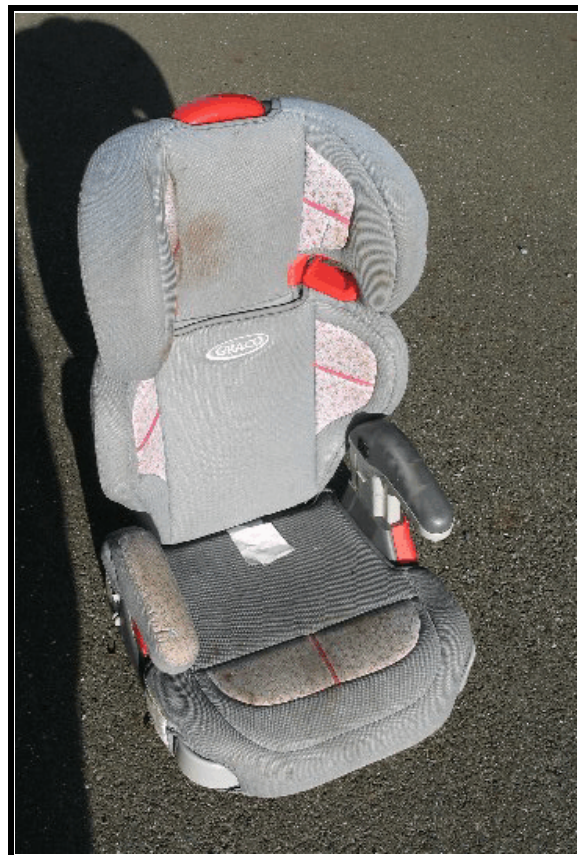
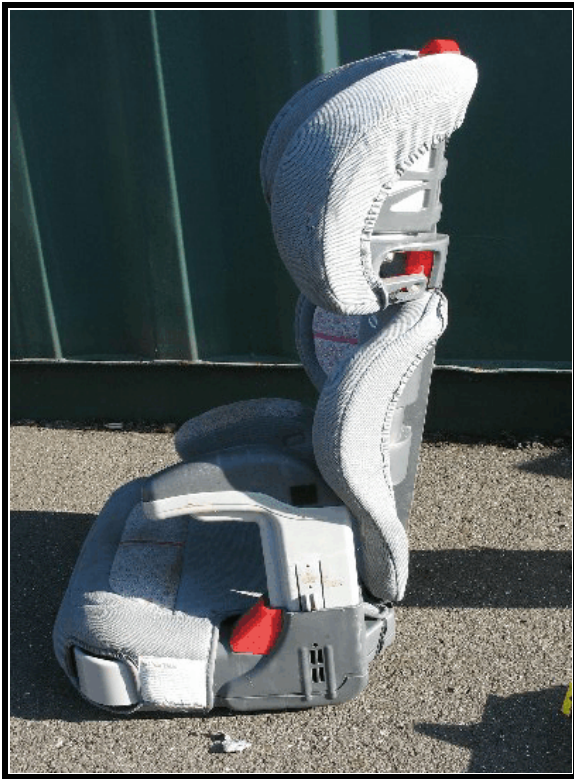
A Graco TurboBooster booster CSS was positioned in the left rear seat of the Mercedes (Figures 12-13). The model number was 8498 KAY and the date of manufacture was March 1, 2007. The seat was designed with adjustable arm rests and seat belt guides. It was not known if the vehicle safety belt was routed through the seat belt guide. The seat was designed to be used with or without the detachable back support. The back support was used in this crash. The recommended use of the seat with the back support in place was follows:

The CSS was damaged during the crash. At the time of the inspection, the back support was no longer attached to the seat bottom. The left arm rest was dislodged and came off the seat. The seat back exhibited signs of crazing due to compression from the left rear door (Figure 14).

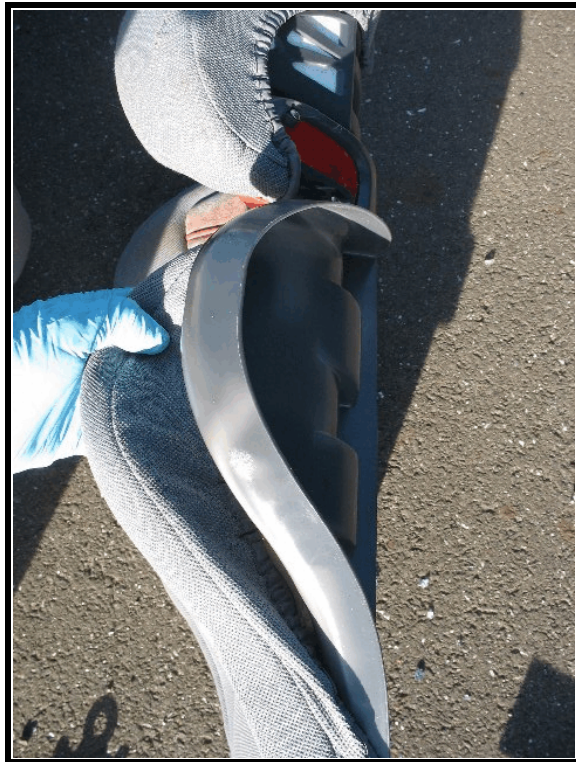
Figure 14. Cracking to left seat back
