# INDIANA UNIVERSITY

### ON-SITE NOT IN TRAFFIC SURVEILLANCE BACK OVER INVESTIGATION

CASE NUMBER - IN08002  
LOCATION - ARKANSAS  
VEHICLE - 2004 HONDA ELEMENT  
CRASH DATE - December, 2007

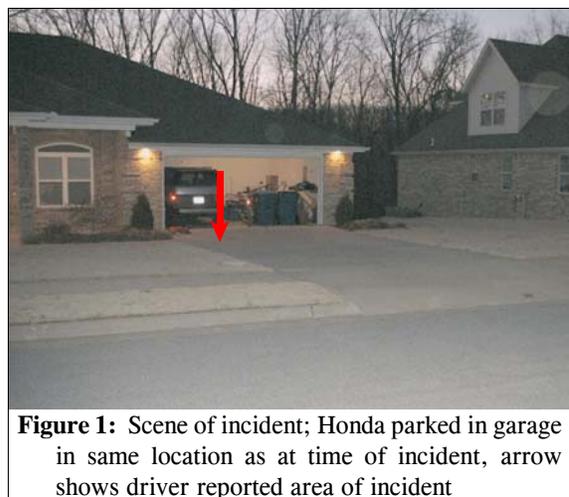
**Figure 1:** Scene of incident; Honda parked in garage in same location as at time of incident, arrow shows driver reported area of incident

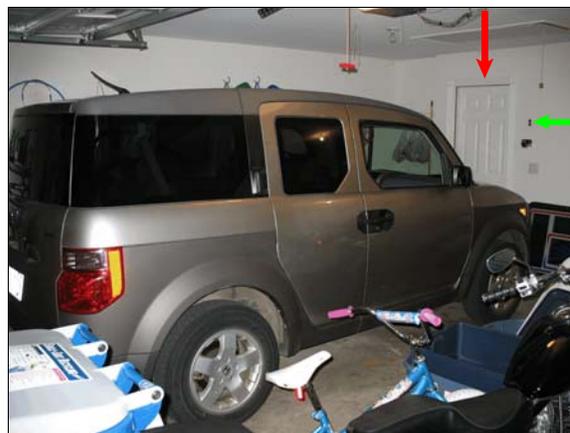
**Figure 2:** Honda parked in garage in same location as at time of incident; red arrow shows door where driver entered garage; green arrow shows button for garage door opener

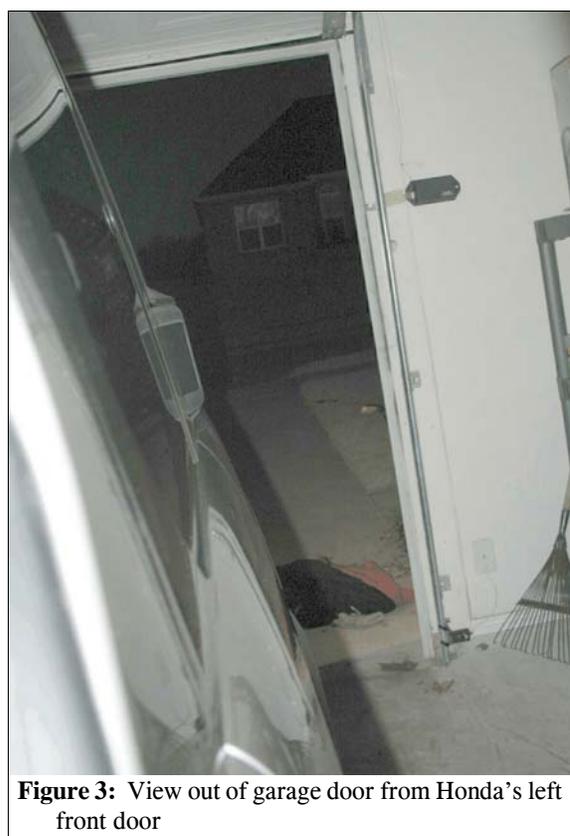
**Figure 3:** View out of garage door from Honda's left front door

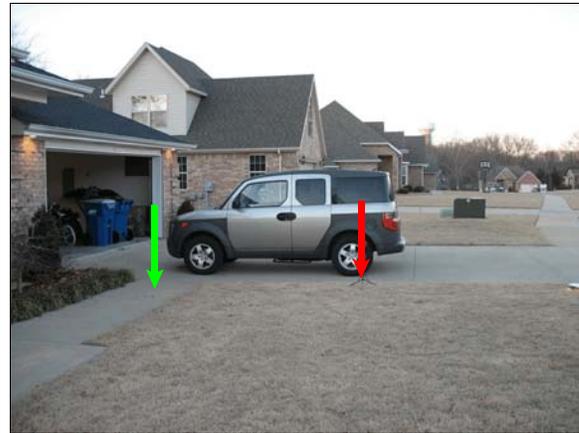
**Figure 4:** Nonmotorist's area of approach, green arrow shows driver reported area where she saw puppy as she backed out of garage; Honda in location where driver stated she exited vehicle after hearing nonmotorist scream; red arrow shows driver reported location of nonmotorist at final rest

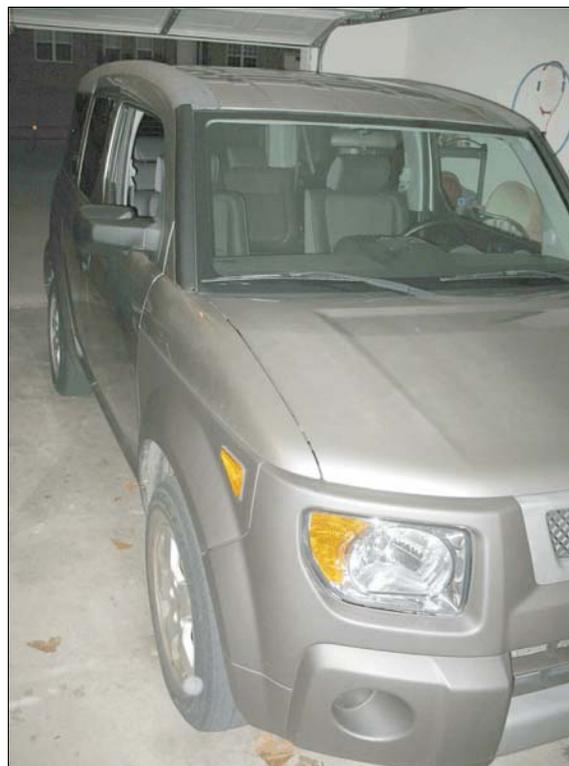
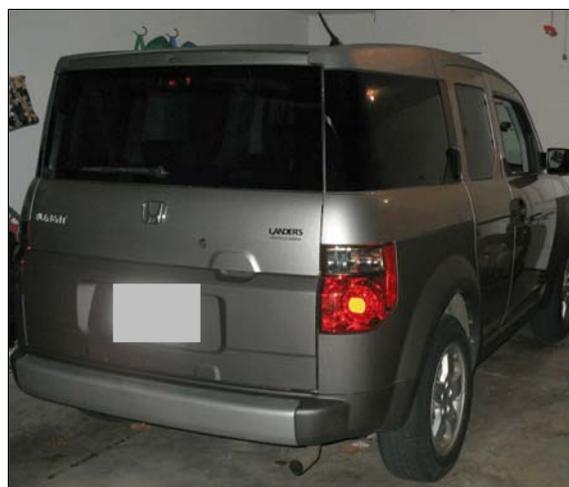
The 2004 Honda Element (**Figures 5 and 6**) was a four wheel drive, four-door sport utility vehicle (VIN: 5J6YH28584L-----) equipped with an automatic transmission and four wheel, anti-lock brakes. The Honda's backlight, rear-most side windows and the left and right rear windows were equipped with original equipment manufacturer (OEM) tinted glazing (AS3). The manufacturer's recommended tire size was: P215/70R16, and the Honda was equipped with tires of this size. The Honda was not equipped with any after market equipment and was not equipped with a back up/parking aid. The Honda's specified wheelbase was 258 centimeters (101.4 inches), the specified rear overhang was 92 centimeters (36.2 inches), and the specified overall length was 430 centimeters (169.3 inches). The measured distance from the ground to the bottom of the back bumper was 37 centimeters (14.6 inches). The height of the beltline was measured as 119 centimeters (46.9 inches).

The Honda Element sustained no visible damage in this incident. The Honda remained at the driver's residence following the incident.

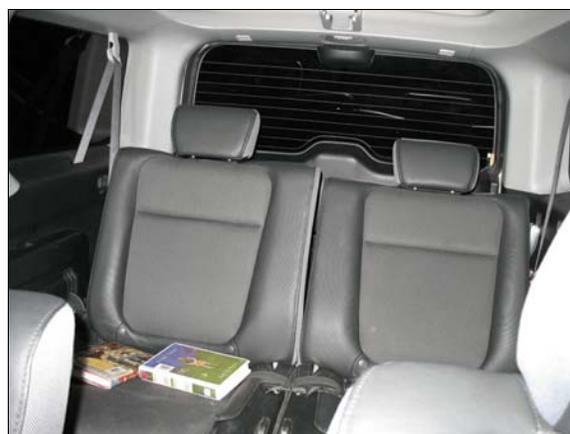
The initial set of observations was made with the driver looking over her right shoulder out of the backlight (**Figure 7**). The target was moved rearward from the back bumper along the Honda's approximate centerline until it came into the driver's view. The target had to be moved

**Figure 7:** View out of back of Honda from driver's seat

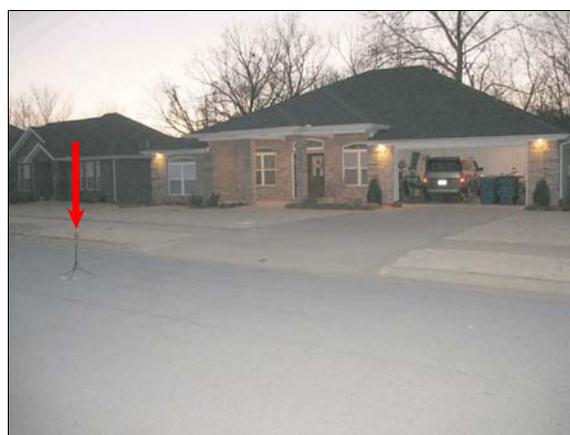
**Figure 8:** Overview of Honda in garage in same position as at time of incident, arrow shows location of target where driver could first see it as she looked over her right shoulder out of backlight

rearward from the back bumper 16.9 meters (55.4 feet, **Figure 8** above) before the top of target came into the driver's view over the top of the Center High Mounted Stop Lamp (CHMSL). The CHMSL is not the focus of the view when looking to the back right. The target was then moved 6.0 meters (19.7 feet) to the right of the approximate centerline where it became obstructed by the back right head restraint. The target was not visible again until it was moved an additional 5.5 meters (18.0 feet) further to the right where it became visible to the driver through the right rear-most window. When the target was moved 2.4 meters (7.9 feet) to the left of the approximate centerline, it became obstructed by the left "D"-pillar. The driver could not see the target beyond the left "D"-pillar because it was not natural for her to turn her head any further to the right.

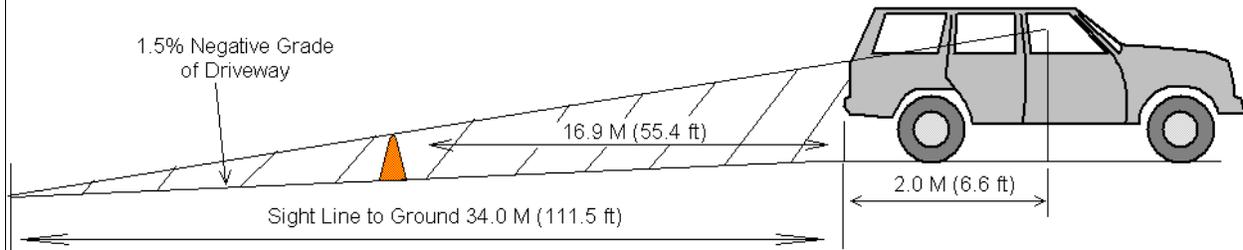
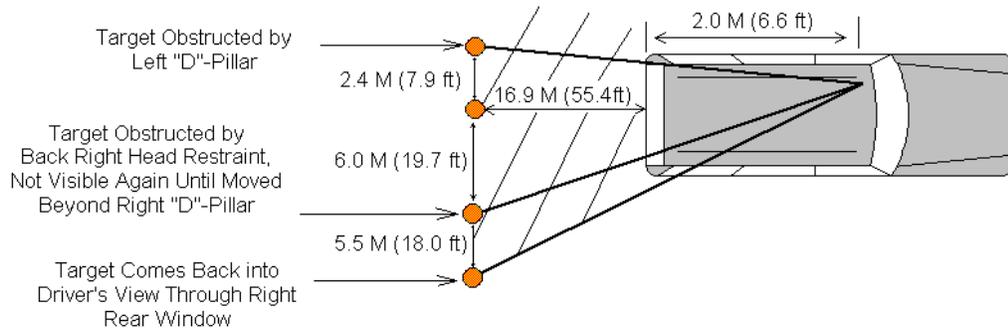
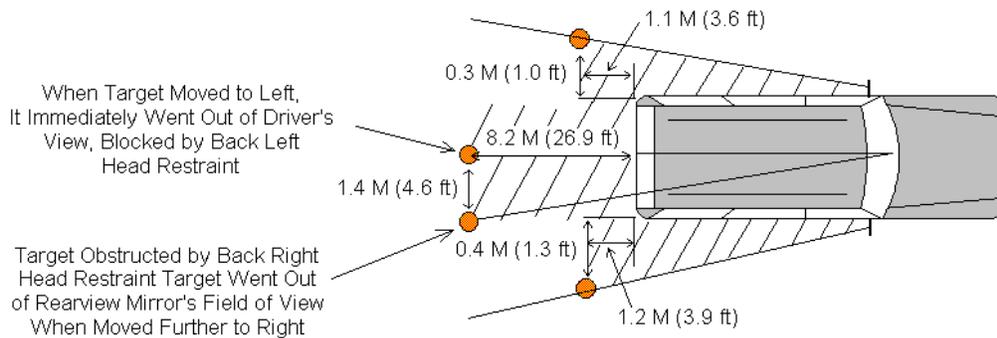
## Nominal Visibility Diagram 2004 Honda Element

1. Distance Back of Honda  
To Point a 71 cm (28 in) High Reference Target  
Comes Into Driver's View as She Looks Over Right Shoulder Out of Backlight

2. Rearview Mirror and Side View Mirror Blind Zones
