**CALSPAN ON-SITE CHILD SAFETY SEAT
CRASH INVESTIGATION**

CASE NO: CA08002

VEHICLE: 2000 HONDA CIVIC LX

CRASH DATE: JANUARY 2008

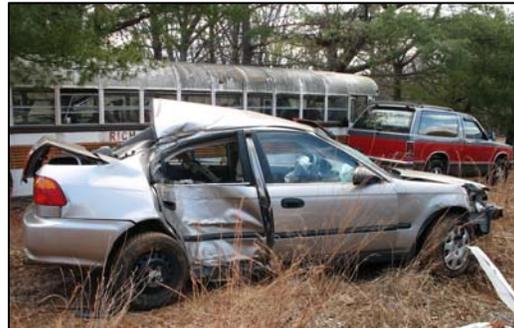
Figure 1 - Damaged 2000 Honda Civic.

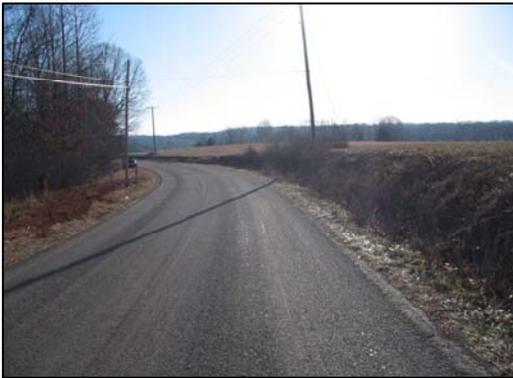
The female driver of the Honda was operating the vehicle in an eastbound direction on the two-lane roadway and was negotiating the 281 m (923 ft) radius left curve (**Figure 2**). She had recently left her home, which was located approximately 1 km (1/2 mile) from the crash site, and was traveling on an errand with her 2-year old daughter. The driver related during the SCI interview that she allowed her daughter to strap herself into the CSS in the right rear position of the vehicle, who then informed her mother when she was done. After realizing that the child never acknowledged that she was done, the driver looked into the second row, noticed that the internal harness was not latched, and then reached into the second row to assist the child. As the driver was attempting to latch the harness, the Honda drifted off the right roadside and began tracking along the grassy shoulder. The driver overcorrected by initiating a left steering input and the vehicle began to rotate CCW into a full broadside yaw and off the left roadside. The vehicle rotated CCW approximately 90 degrees and traveled toward the tree line. The right side tires dug into the dirt and grass and created yaw marks leading to the point of impact. A 7 m (23 ft) long yaw mark, attributable to the right rear tire, and a 3.7 m (9.5 ft), attributable to the front right tire, were documented during the SCI scene inspection. Both marks were slightly curved in orientation and dissipated near the point of impact. **Figure 3** is an overall view of the crash location.

Figure 2 - Eastbound approach of the Honda.

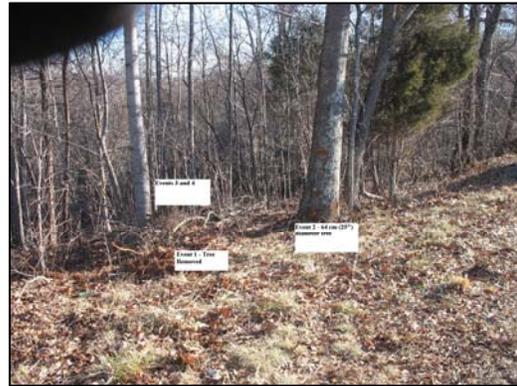
Figure 3 - Overall view of crash site (events encapsulated).

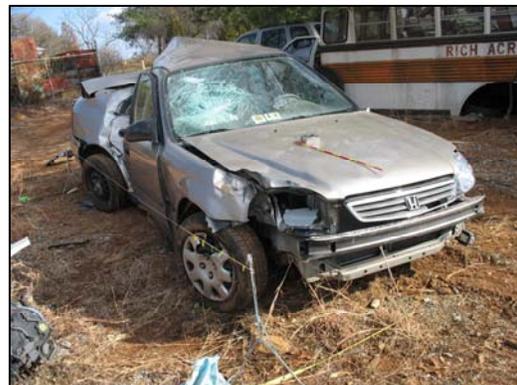
The 2000 Honda Civic sustained moderate damage to its right side as a result of multiple tree impacts. The initial impact (**Figure 4**) was to the right fender where the direct damage began at the bumper corner and extended 56 cm (22") rearward. The combined direct and induced damage extended from the same point to 61 cm (24") rearward. The maximum crush was located 49 cm (19.3") rear of the bumper corner and was 25 cm (10") in depth. Six equidistant crush measurements were documented along the vehicle's mid-door level and were as follows: C1 = 5 cm (2"), C2 = 25 cm (10"), C3 = 21 cm (7.5"), C4 = 19 cm (7.5"), C5 = 20 cm (7.9"), C6 = 13 cm (5"). The Collision Deformation Classification (CDC) for this impact was 03-RFEW-3.

Figure 4 - Right side of Honda Civic.

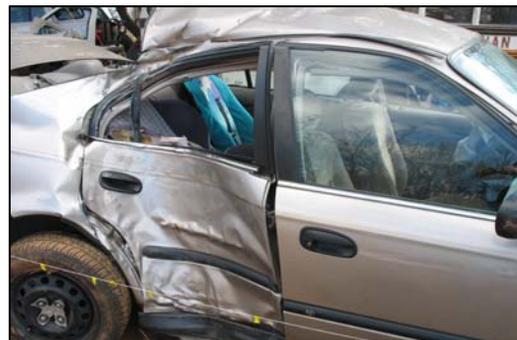
The secondary tree impact to the right side resulted in moderate damage to the Honda's right side in the area of the right rear door and C-pillar (**Figure 5**). The direct contact damage began 70 cm (27.5") aft of the front right axle and extended rearward 77 cm (30.3"). The combined direct and induced damage began 68 cm (26.8") rear of the front right axle and extended rearward a distance of 99 cm (39").

Figure 5 - Damage to right rear door area.

The maximum crush was located 149 cm (58.6”) aft of the front left axle and measured 40 cm (15.7”) in depth. The impact fractured the right rear window and resulted in the intrusion of the door panel and the C-pillar. The intrusion subsequently fractured the backlight glazing and caused the roof to deflect upwards. Six equidistant measurements were taken along the vehicle’s mid-door level and were as follows: C1 = 0 cm, C2 = 12 cm (4.7”), C3 = 38 cm (15”), C4 = 37 cm (14.6”), C5 = 29 cm (11.4”), C6 = 20 cm (7.9”). The CDC for this secondary impact was 02-RPAW-3.

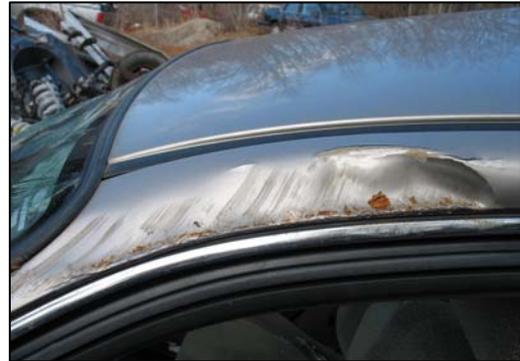
After the Honda was redirected from the second tree, the vehicle rotated CW approximately 90 degrees and the left side tires dug into the soft soil, which caused the vehicle to overturn. The rollover was classified as trip-over due to the ground yielding to the tires. As the Honda overturned, the left side roof side rail, rear door panel, and window glazing struck a third tree. The abrasions on the left roof side rail (**Figure 6**) began 118 cm (46.5”) forward of the left rear axle and extended forward 33 cm (13”). The maximum crush on the roof side rail was 1 cm (1.5”) and was located 118 cm (46.5”) forward of the left rear axle. The abrasions on the door panel began 76 cm (30”) forward of the left rear axle and were 11 cm (4.5”) in length. The abrasions on the left rear glazing were found 74–86 cm (29-34”) forward of the left rear axle and were 18-33 cm (7-13”) above the beltline.

Figure 6 - Damage to left roof side rail.

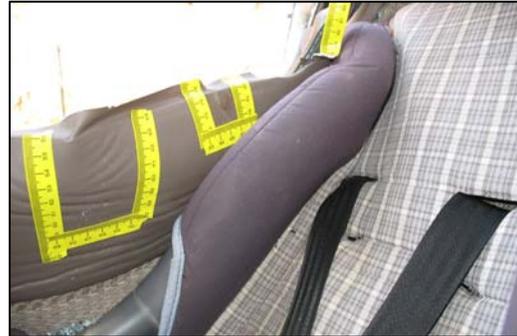
Three areas of probable occupant contact were documented during the SCI inspection in the region of the second row door panel (**Figure 7**). The most notable was an area of whitish substance transfer along the beltline that was 8 cm (3") longitudinally and 8 cm (3") vertically and began 45 cm (17.7") aft of the rear aspect of the B-pillar. The transfer was coarse in nature and was likely a result of the shell of the CSS compressing against the intruded panel. The triangular quarter window frame in the second row right position contained a blood transfer and a black substance transfer. The transfer was 53-58 cm (21-23") in length and was located 5 cm (2") below the framing for the backlight header. A small scuff was located at the beltline further rear of the whitish transfer; however, considering the intrusion and the presence of the CSS, the source of this potential contact point was not determined.

Figure 7 - Areas of probable occupant contact.

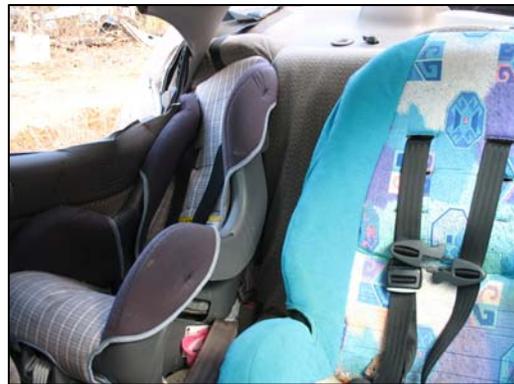
Figure 8 is a front view of the forward facing CSS installed and in use at the time the crash. A second forward facing CSS was installed in the left rear position of the vehicle. The CSS was not being utilized at the time of the crash. It should be noted that the position of the CSS in relation to its location and its installation by the belt system, was not altered by the emergency personnel after the crash. The CSS was an Evenflo Tribute 5 DLX Model No.: 2573018, manufactured in August 2005. The CSS (**Figure 9**) was installed in the second row right position of the Honda by the vehicle's 3-point lap and shoulder belt. The CSS was labeled for use by children in the following circumstances:

Figure 8 - Post-crash position of CSS.

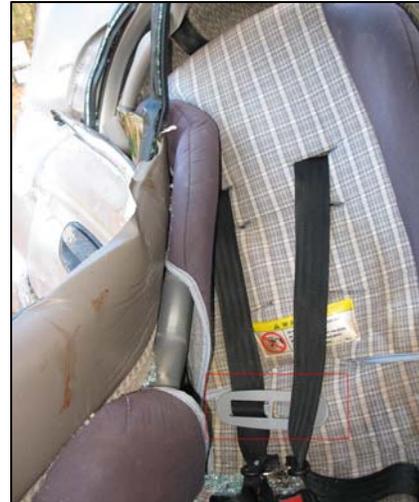
The manufacture's labels were intact and legible. The instruction manual was present and the locking clip was in place on the back of the shell. **Figure 10** illustrates the CSS in its post-impact position.

The CSS was configured with a 5-point harness system. The harness was routed through the top slots and the harness straps were in good condition. The length of the right and left straps was 24 cm (9.5") and 23 cm (9.25"), respectively. The CSS was designed with a 13 x 5 cm (5.5 x 2") chest retainer clip. The right harness strap was threaded through the clip. The left harness strap was not threaded at the time of the inspection, refer to **Figure 10**. There was no loading evidence on the harness straps or retainer clip.

Figure 10 - View of intrusion against CSS shell (chest retainer clip encapsulated).

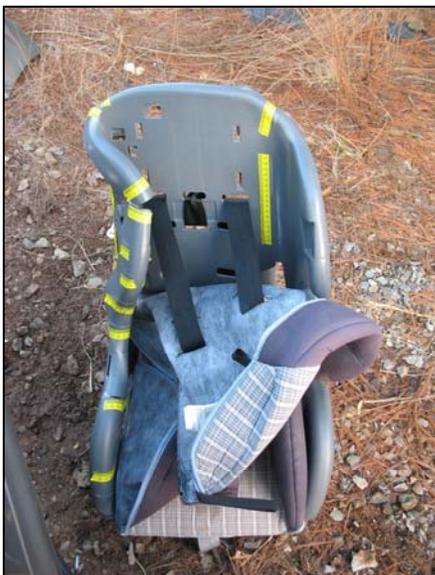
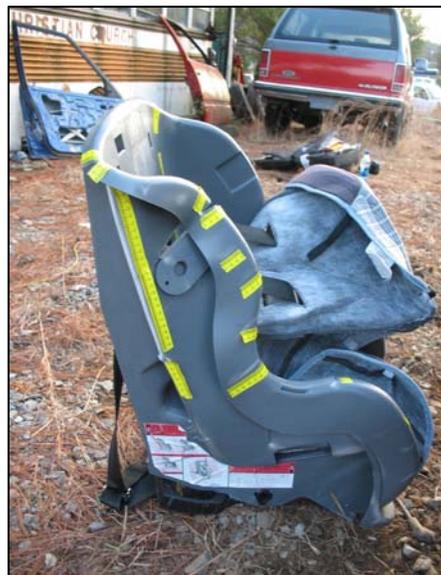
The shell of the CSS sustained severe damage as a result of the intrusion of the right rear door panel and the C-pillar, both of which compressed and fractured the CSS. The width of the CSS seatback was compressed 9.5 cm (3.75") from its original design specifications. In addition, the shell sustained multiple fractures and stress marks down its right side. The damage began 19 cm (7.5") below the top aspect of the CSS and extended downward 50 cm (20") to the footer area, refer to **Figures 11 and 12**.

Figure 11 - Frontal view of damaged CSS.

Figure 12 - Right side view of damaged CSS.

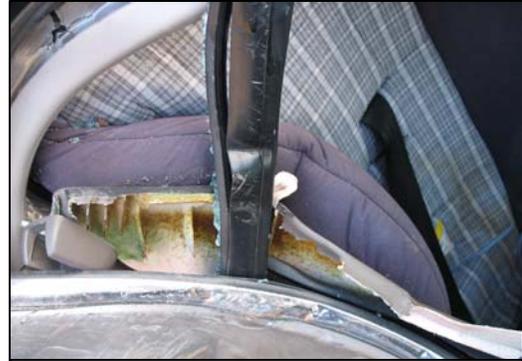
After departing the roadway, the vehicle struck a small diameter tree and then a larger 64 cm (25") diameter tree with its right side. The right side structure in the area of the door panel and C-pillar intruded into the occupant space and the child responded to the 2 o'clock direction of force by moving slightly right in her CSS. The child's head struck the intruded triangular quarter window frame (**Figure 13**). From the contact to the window frame, the child sustained bilateral vault skull fractures, an anterior basilar skull

Figure 13 - Intruded door panel and quarter window frame against CSS shell.

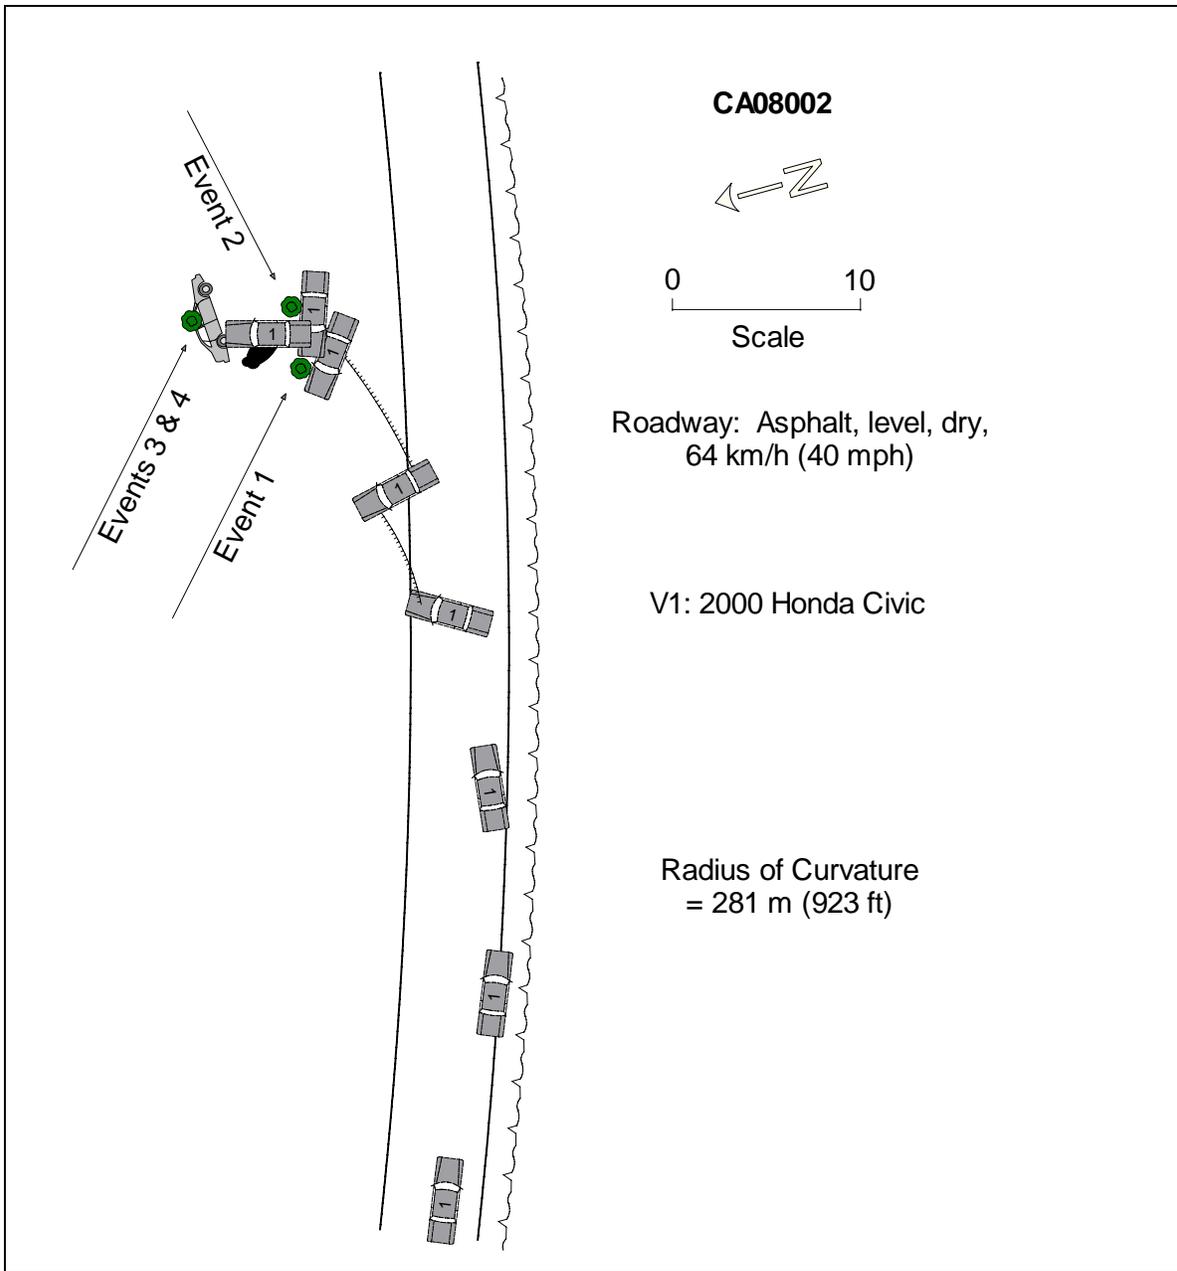
Figure 14 – SCI Crash Schematic

This single vehicle crash occurred during daylight hours of January 2008 in the state of Virginia. At the time of the crash, the weather was clear and the asphalt roadway surface was dry. The east/west roadway consisted of one lane in each direction and was devoid of lane markings. The roadside environment consisted of a grassy embankment area that ran contiguous to agricultural fields on the south roadside and an undeveloped tree line on the north roadside. Beyond the immediate tree line on the north roadside was steep decline. A drainage ditch was present along the south roadside 1.5 m (5 ft) outboard of the road edge. The rural roadway was windy in configuration and experienced a 281 m (923 ft) radius of curvature to the left at the area of the crash. The posted speed limit for the east/west roadway was 64 km/h (40 mph). The Crash Schematic is included as **Figure 14** at the end of the narrative report.
