**AIR BAG NON-DEPLOYMENT CRASH INVESTIGATION**

**SCI CASE NO.: CA08003**

**VEHICLE: 2001 HYUNDAI ELANTRA**

**CRASH DATE: JANUARY 2008**

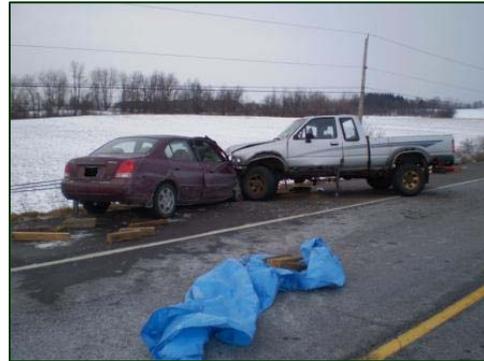
**Figure 1. On-Scene image of the vehicles at final rest.**

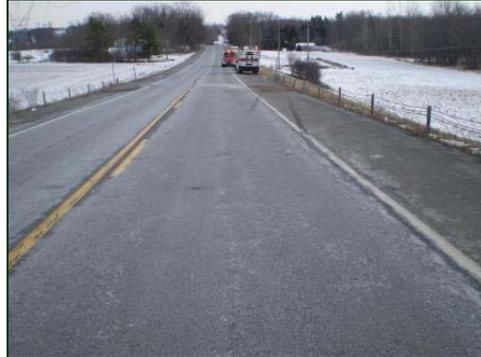
This crash occurred on a rural two-lane road during daylight hours. At the time of the crash, the asphalt road surface was dry and the skies were cloudy. In the vicinity of the crash site, the roadway was straight with the east and west travel lanes having negative grades that transitioned to a sag area (**Figure 2**). The travel lanes were 3.7 m (12') in width and were bordered by 3 m (10') asphalt shoulders with cable guardrail systems paralleling the outboard edge of the shoulders. The posted speed limit was 89 km/h (55 mph).

**Figure 2. Eastbound view of the crash scene.**

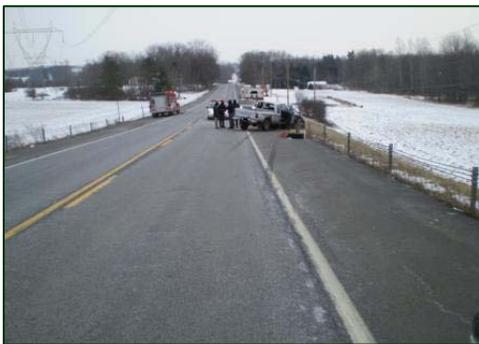
The driver of the Toyota was traveling in an easterly direction and observed the Hyundai encroach into his lane of travel. He applied a right steering input and braked with sufficient force to lock the front wheels of the vehicle. The Toyota skidded in a tracking attitude onto the south (right) shoulder (**Figure 3**). Although the front tire skid marks were not visible at the time of the SCI inspection, the police documented skid mark lengths of 23.5 m (77') from the left front tire and 26.8 m (88') from the right front tire.

**Figure 3. Trajectory of the Toyota and the pre-crash skid marks.**

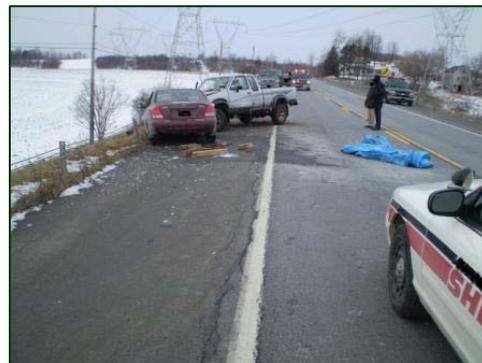
**Figure 4. Trajectory of the Hyundai from pre-crash to impact to final rest.**

The vehicles impacted in an angled head-on configuration on the south shoulder of the roadway (**Figure 4**). The directions of force were within the 12 o'clock sector for both vehicles with improved force directions of 10 degrees for the Hyundai and -10 degrees for the Toyota. The impact crushed the front right bumper corner of the Hyundai to a depth of 74 cm (29.5") and the upper radiator support to a depth of 89 cm (35"). The damage extended across the full frontal plane of the Hyundai with a crush value of 17 cm (6.6") at the left bumper corner (**Figure 5**). The front right bumper corner of the Toyota crushed to a maximum depth of 51 cm (20.25"). The damage algorithm of the WINSMASH program computed total delta V's of 69 km/h (43 mph) for the Hyundai and 60 km/h (37 mph) for the Toyota. The specific longitudinal and lateral components were -68 km/h (-42 mph) and -12 km/h (-7 mph) for the Hyundai and -59 km/h (-37 mph) and 10 km/h (6 mph) for the Toyota. The redesigned frontal air bags did not deploy and the retractor pretensioners did not actuate in the Hyundai.

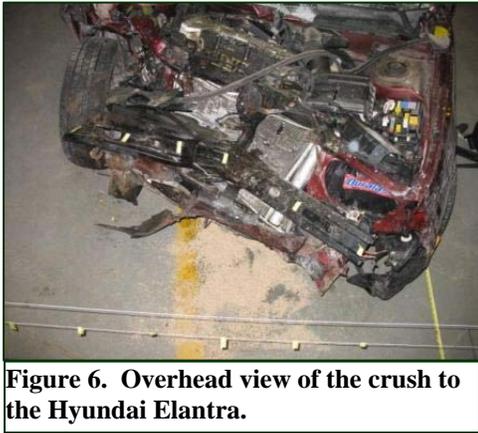
**Figure 6. Overhead view of the crush to the Hyundai Elantra.**

The Hyundai Elantra sustained severe frontal damage from the head-on impact with the Toyota pickup truck. The frontal damage was documented using a frontal reference line that represented the original length of the vehicle. The front reference line was set 450 cm (177.3") forward of the undamaged back plane of the vehicle.

The direct contact damage extended across the full width of the vehicle and measured 108 cm (42.5) in width along the face of the hood. The bumper fascia was separated by crash damage. The bumper beam and the upper radiator support were crushed rearward

and profiles were documented at these levels. Maximum crush at the bumper beam was 74 cm (29.25") located at the right corner. The upper radiator support was crush rearward 89 cm (35") at the C5 location, 38 cm (15") right of the vehicle centerline. The crush profile at the level of the bumper beam was as follows: C1 = 17 cm (6.6"), C2 = 40 cm (15.9"), C3 = 67 cm (26.25"), C4 = 71 cm (28"), C5 = 72 cm (28.5"), C6 = 74 cm (29.25"). The profile at the upper radiator support was as follows: C1 = 10 cm (3.75"), C2 = 54 cm (21.25"), C3 = 74 cm (29.25"), C4 = 80 cm (31.5"), C5 = 89 cm (35"), C6 = 83 cm (32.6"). The direct contact damage extended onto the upper right A-pillar. The hood latch held during the crash and was released during the SCI inspection. Both hood hinges remained intact. The hood was removed during the inspection to gain access to the engine compartment. The Collision Deformation Classification (CDC) for this event was 12-FDAW-6.

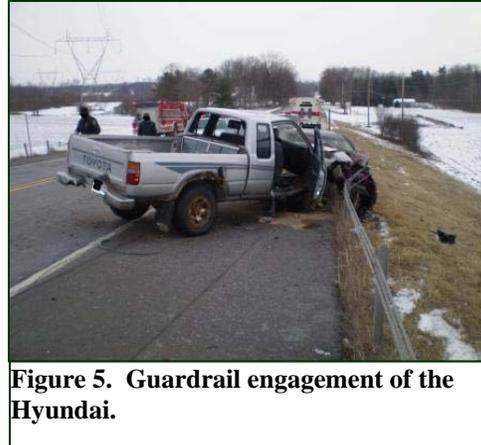
**Figure 5. Guardrail engagement of the Hyundai.**

The left side of the Hyundai engaged the cable guardrail as the vehicle continued forward and rotated CW following the impact with Toyota. At final rest, the cables were tensioned across the left front fender of the vehicle. The left rear door sustained 5 cm (2") of crush from contact with an I-beam guardrail post. The direct contact damage on the left side of the Elantra began 37 cm (14.5") forward of the left rear axle and extended 315 cm (124") forward to the corner of the left front fender. The CDC for this event was 10-LYEW-1.

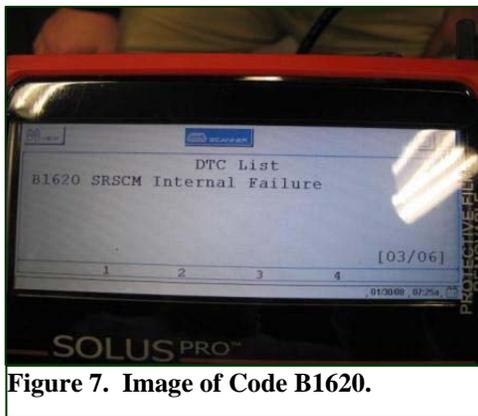
| 3. | B1620 | SRSCM Internal Failure | 03/06 | <b>(Figure 7)</b> |

**Figure 7. Image of Code B1620.**

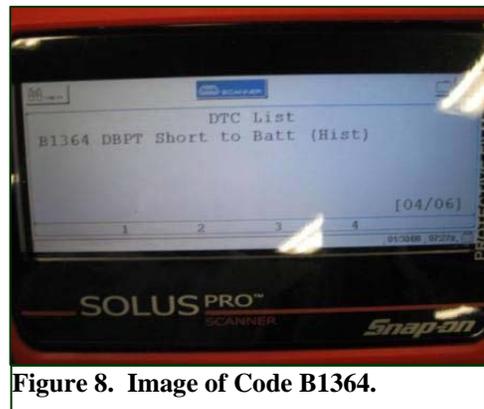
| 4. | B1364 | DBPT Short to Batt (HIST) | 04/06 | <b>(Figure 8)</b> |

**Figure 8. Image of Code B1364.**

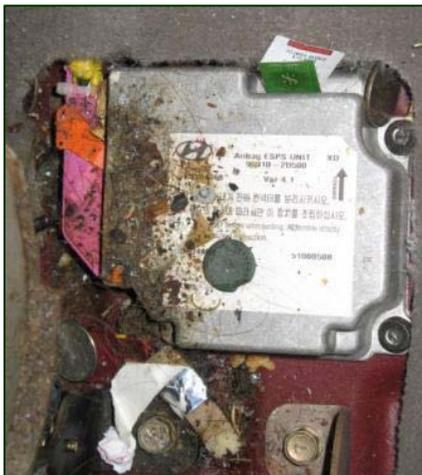
The ACM was fully visible following the removal of the console. The left third aspect of the ACM was stained with a sticky brown substance with hair, coins, and a wax medallion stuck to the top cover (**Figure 9 and 11**). A purple multi-pin connector was fully engaged and secured to the left side of the ACM. This connector was stained with the same substance noted above. The ACM was secured to the center floor with four 10 mm bolts at the corner of the unit. These bolts were tight and were subsequently removed.

**Figure 9. ACM and connector as found in vehicle.**

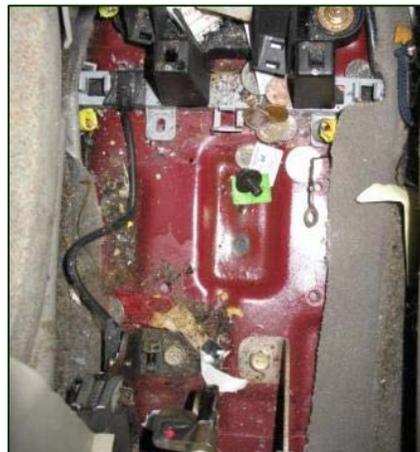
**Figure 10. Condition of console floor with ACM removed.**

With the ACM removed, the floor area under the module appeared to be in good condition with no areas of rust or corrosion (**Figure 10**). The back side of the ACM was clean and free of corrosion (**Figure 12**). Numerous objects had fallen between the console and the emergency brake lever and were scattered around this area. None of these objects were positioned between the connector and the ACM.

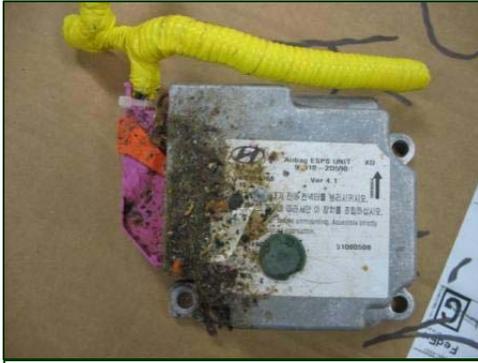
**Figure 11. Removed ACM and pin connector.**

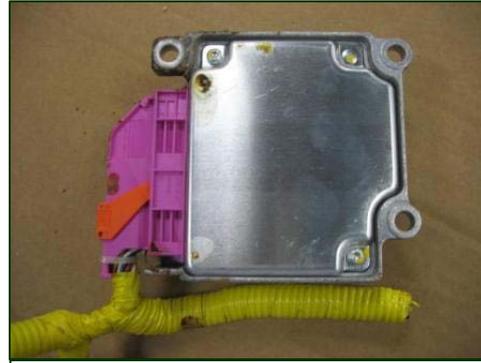
**Figure 12. Back side of the ACM.**

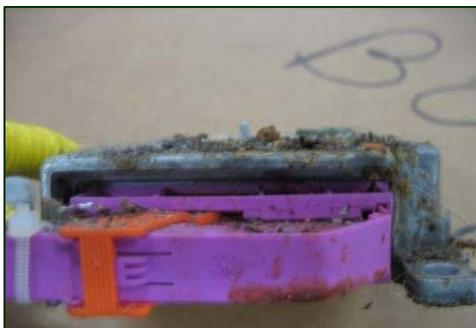
The purple-colored pin connector was removed from the ACM. This was accomplished by rotating a cam lever to disengage the connector and removing the connector from the ACM (**Figure 13**). Minimal effort was required to disengage the connector from the ACM. Inspection of the connector and the pin port of the ACM revealed surface corrosion (green in color) to the mid area of the pins (**Figure 14**). No pins were bent or damaged.

**Figure 13. Purple connector.**

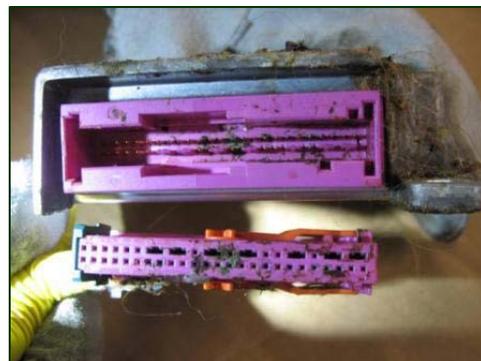
**Figure 14. Corrosion at mid point of connector and pins.**

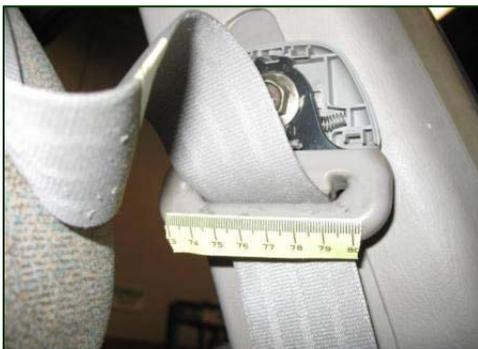
Although the driver's latch plate was unbuckled post-crash, significant loading evidence was present on the belt webbing and hardware to confirm usage at the time of the crash. Frictional abrasions were present on both sides of the latch plate with a matching transfer on the belt webbing. The belt abrasion began 69 cm (27") above the lower outboard anchor point and was 15 cm (6") in length. A small 0.6 cm (0.25") cut was present on the bottom edge of the belt webbing within the frictional abrasion transfer. Body fluid was present on the lap belt webbing from the transfer to the outboard anchor.

Driver loading of the belt system was also present at the D-ring as evidenced by a 10 cm (4") long full-width plastic transfer. The plastic transfer on the webbing had the feel of coarse-grit sandpaper. The transfer was located 118-128 cm (46.5-50.5") above the floor anchor. The full-width of the D-ring was heavily abraded.

**Figure 15. Frictional abrasion on belt webbing and D-ring.**

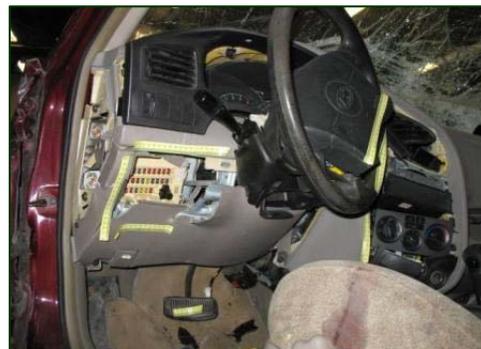
The driver loaded the lower aspect of the steering wheel rim. His loading force deformed the steering wheel spokes that resulted in 8 cm (3") of forward displacement of the lower steering wheel rim. A separation of 4 cm (1.5") was noted between the non-deployed air bag module cover and the steering wheel hub between the lower spokes. The wheel rim was not deformed. The loading of the wheel was transmitted into the energy absorbing steering column, resulting in 6 cm (2.5") of left shear capsule separation. The top of the soft-edged steering wheel rim was abraded to a flat surface; however, this abrasion did not appear to be crash related. Within the abrasion, was a small puncture that may have resulted from facial contact (tooth) by the driver.

His knees and lower legs engaged the rearward intruding instrument panel and knee bolster. His left knee fractured the plastic fuse box cover and the mid instrument panel (**Figure 16**). The driver's right knee fractured the mid panel right of the steering column. He sustained multiple abrasions and contusions over the knees. The loading force was transmitted through the femurs resulting in an induced fracture of the right pelvis to the ilio-ischial ramus. The driver's inguinal area engaged the lower steering wheel rim resulting in abrasions, a laceration, and contusion of the lower abdomen.

**Figure 16. Driver loading of the steering assembly and the mid instrument panel.**

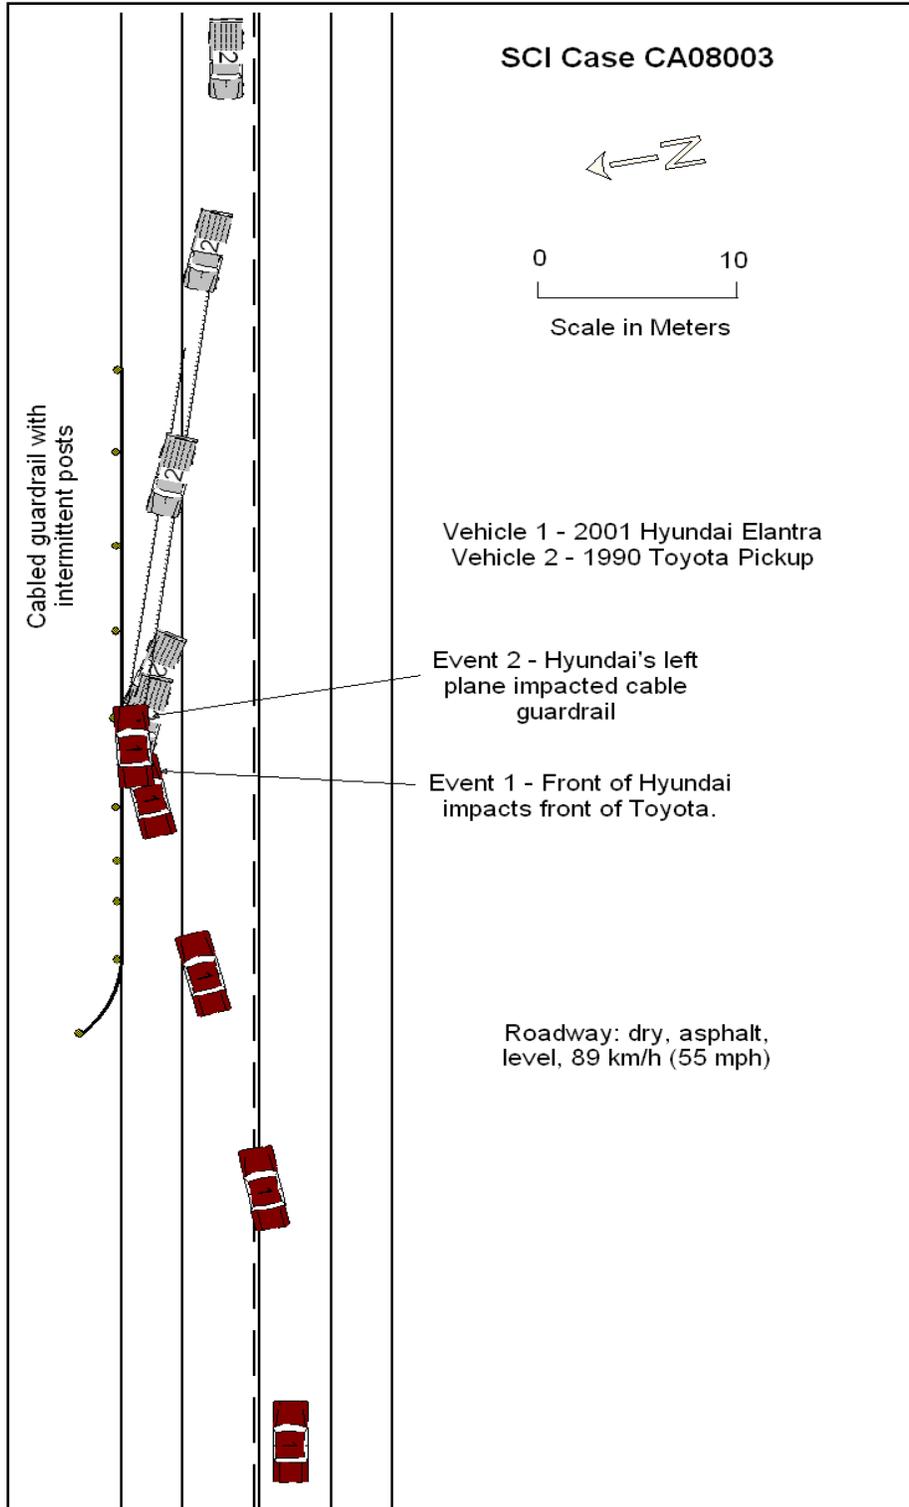
*Figure 17: Scene Schematic*

There was no physical evidence at the crash site to support avoidance action by the driver of the Hyundai. The Crash Schematic is included as **Figure 17** of this report.
