TRANSPORTATION RESEARCH CENTER

ON-SITE CHILD SAFETY SEAT INVESTIGATION

CASE NUMBER - IN08003
LOCATION - NEBRASKA
VEHICLE - 2000 TOYOTA CAMRY LE
CRASH DATE - December 2007

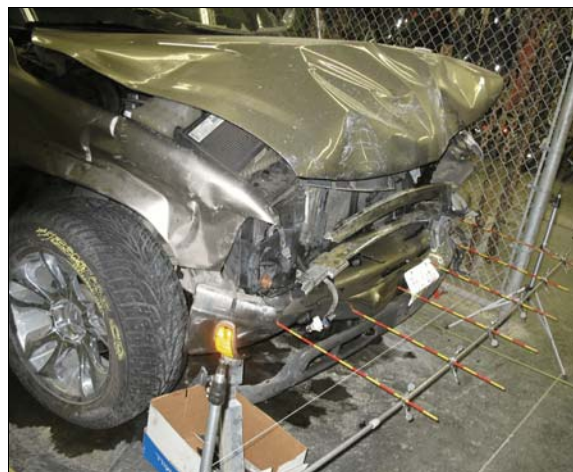
Figure 4: Front right view of damage to front of Chevrolet due to impact with left side of Toyota; each stripe on rods in 5 cm (2 in)

Exterior Damage: The Chevrolet's impact with the Toyota involved its front end. The front bumper, hood, grille, radiator, both turn signal and headlamp assemblies, and the right fender were directly damaged. The direct damage began at the front left bumper corner and extended 171 centimeters (67.3 inches) across the front end. The crush measurements were taken at the bumper level and the residual maximum crush was measured as 40 centimeters (15.7 inches) occurring at C₁ (**Figure 11**). The table below shows the vehicle's front crush profile.

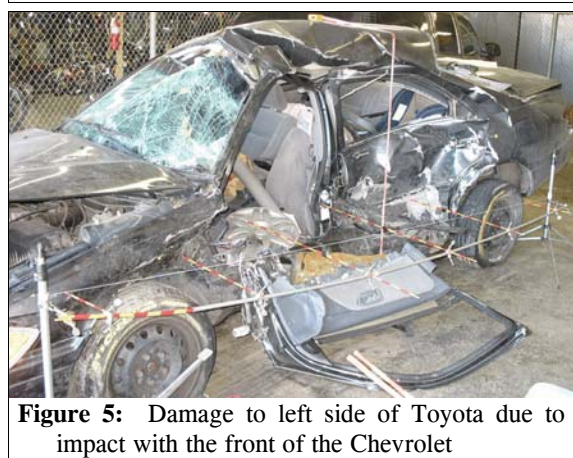
Exterior Damage: The Toyota’s impact with the Chevrolet involved the left side of the vehicle (Figure 5). The Toyota’s left fender, left front door, left rear door and a small portion of the left quarter panel were directly damaged. The direct damage began 16 centimeters (6.3 inches) rear of the left rear axle and extended 240 centimeters (94.5 inches) forward along the left side. The crush measurements were taken at the mid-door level and the residual maximum crush was measured as 76 centimeters (29.9 inches) occurring at C₃ (Figure 6). The table below shows the vehicle’s left side crush.

Figure 5: Damage to left side of Toyota due to impact with the front of the Chevrolet

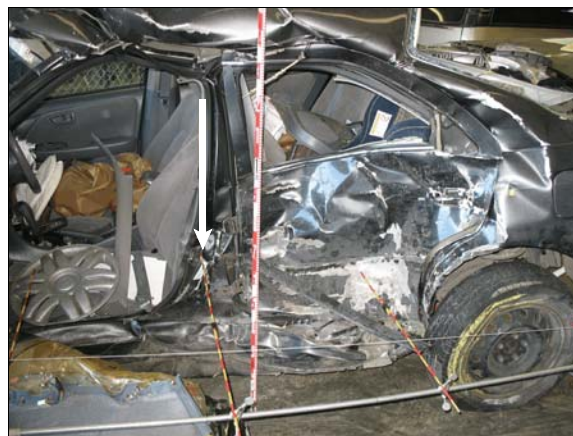
Figure 6: Arrow shows location of maximum crush; vertical scale is graduated in meters and tenths of meter

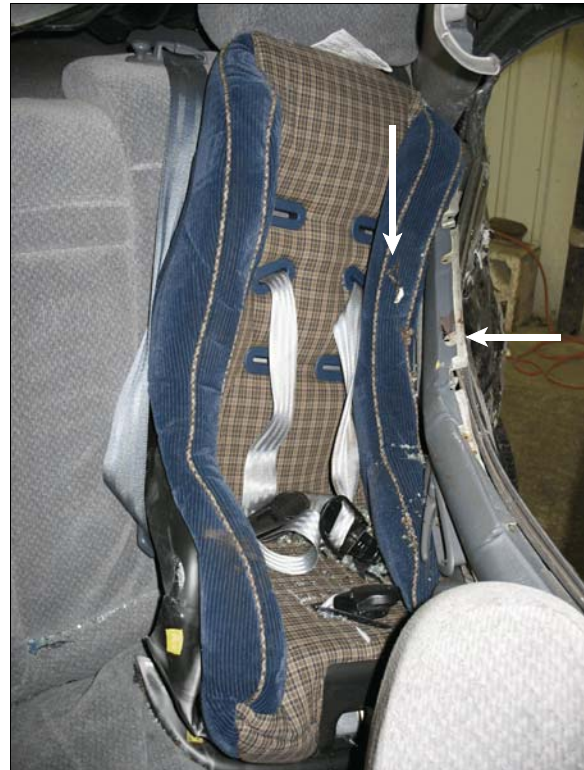
Figure 7: Cosco Touriva CSS entrapped in Toyota's back left seat position; left arrow shows blood and tissue transfer on left side surface of CSS; right arrow shows blood and scuff marks on left rear window sill

The CSS was found in the vehicle entrapped between the intruded left rear door and the seat back (**Figures 7 and 8**). It was still secured in the vehicle by the lap-and-shoulder belt, which had been routed through the belt guides on the back of the CSS. The CSS was constructed of a one piece plastic shell, which was fitted with a cloth covered foam pad. The left side of the shell was deformed to the right and broken, scratched, and scuffed in several places (**Figure 9**). There were also blood and tissue transfers on the left side surface of the CSS (**Figure 7**). The shell at the base of the right side was also broken and there were cracks in the right side of the seat (**Figure 10**). The harness strap and buckle were intact and undamaged.

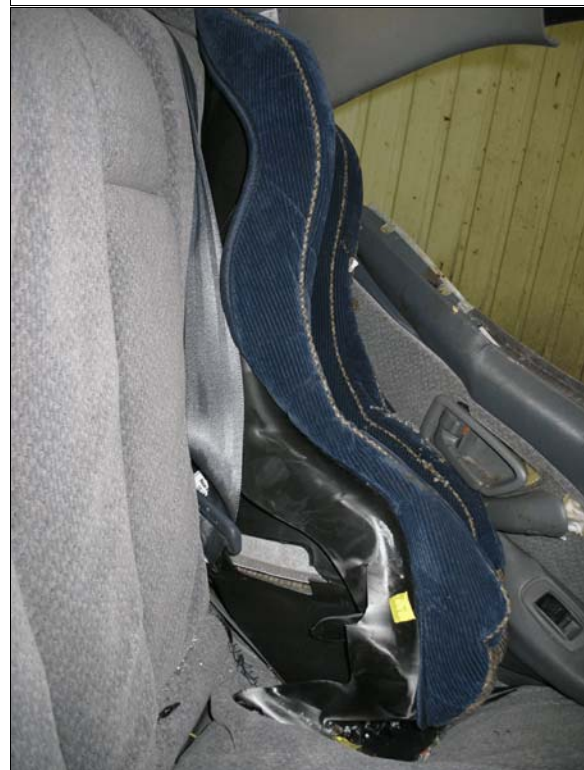
Figure 8: Right side view of CSS in Toyota's second row left seat position

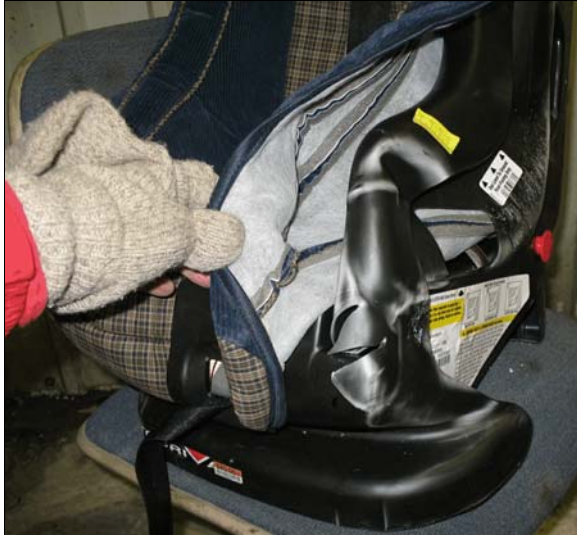
Figure 9: Damage to left side of child safety seat

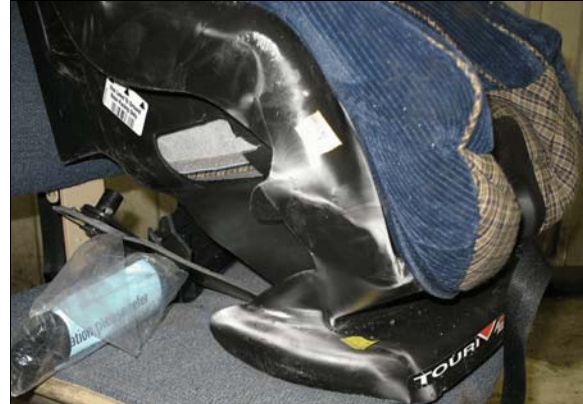
Figure 10: Damage to base and right side of child safety seat

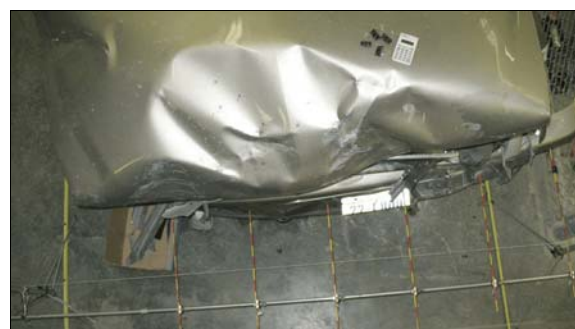
Figure 11: Top view of crush to front of Suburban
