CALSPAN ON-SITE CERTIFIED ADVANCED 208-COMPLIANT VEHICLE

SCI CASE NO: CA08006

VEHICLE: 2006 KIA SPECTRA

CRASH DATE: JANUARY 2008

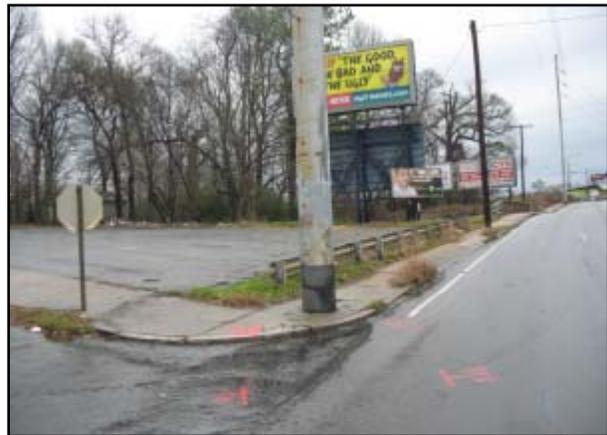
The Kia departed the northeast quadrant of the intersection. The left front tire mounted the barrier curb as the left front area engaged the 51 cm (20") diameter steel utility pole (**Figure 3**). The resultant direction of force was 12 o'clock. The impact speed was computed by the damage and trajectory algorithm of the WINSMASH program at 37.0 km/h (22.9 mph). The vehicle crushed to a depth of 55 cm (21.5") that resulted in a damage algorithm calculated total delta-V of 37.0 km/h (22.9 mph). The longitudinal and lateral components were -37.0 km/h (-22.9 mph) and 0 km/h respectively. Due to the offset left impact, the Kia rotated approximately five degrees counterclockwise and came to rest partially engaged against the struck pole.

Figure 3. Northeast view of impact with the utility pole and final rest location of the Kia.

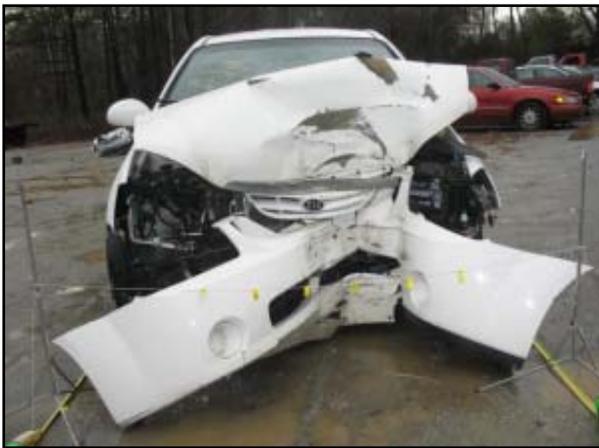
The 2006 Kia Spectra sustained moderate severity frontal damage as result of the crash with the pole. The direct contact damage on the bumper fascia began 18 cm (7") right of the vehicle's center line and extended 48 cm (19") to the left. The maximum crush was located on the bumper beam 13 cm (5") left of the vehicle's centerline and was 55 cm (21.5") in depth. The impact deformed the front bumper system to a U-shape resulting in a combined induced and direct contact damage length (Field L) of 83 cm (32.5"). Six equidistant crush measurements were documented along the bumper beam of the vehicle and were as follows: C1 = 24 cm (9.3"), C2 = 49 cm (19.3"), C3 = 55 cm (21.5"), C4 = 38 cm (14.8"), C5 = 22 cm (8.8"), C6 = 0 cm. **Figures 4 and 5** are frontal and lateral views of the residual crush profile. The Collision Deformation Classification (CDC) for the pole impact was 12-FYEW-3. The crush was offset to the left which resulted in 5 cm (2") of compression of the left wheelbase and an elongation of the right wheelbase of 5 cm (2").

Figure 4. Overall view of the frontal crush of the Kia Spectra.

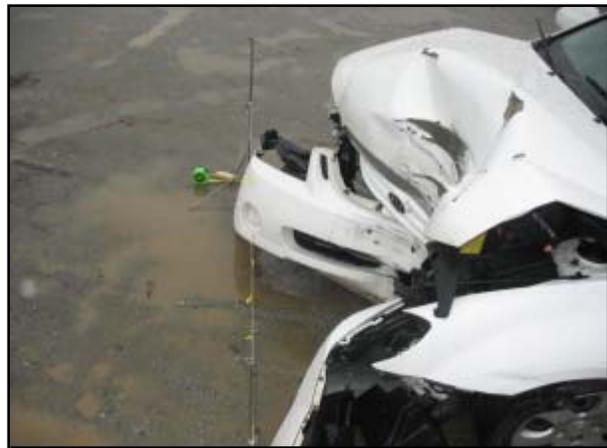
Figure 5. Lateral view of the crush to the frontal plane of the Kia Spectra.

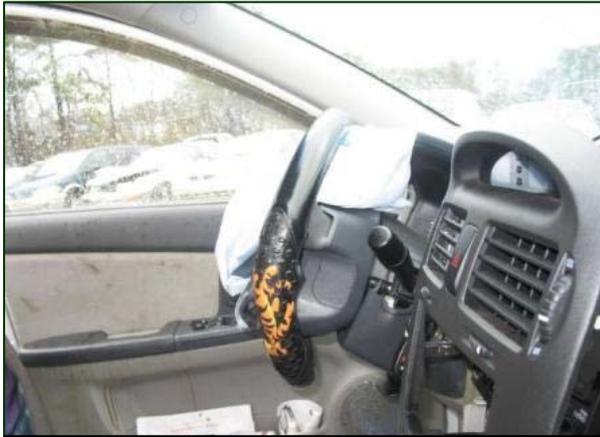
The Kia sustained moderate interior damage from occupant contact and passenger compartment intrusion. The occupant contact points consisted of bending of the steering wheel rim from a combination of contact from the child reinforced by loading from the driver. The left aspect of the steering wheel rim was deformed forward 4 cm (1.6") with 8 cm (3.1") of bending at the bottom aspect (**Figure 6**). During this loading, the steering column was compressed 5 cm (2") and the steering wheel flange was deformed downward. The driver's left knee contacted the left aspect of the lower left instrument panel/knee bolster at the fuse box cover. This contact was evidenced by a 15 cm (6") denim fabric transfer, a fracture of the plastic panel, and separation the fuse box cover (**Figure 7**). The contact was located from 56 cm to 71 cm (22" to 28") left of the vehicle's centerline. A second area of contact was present on the right aspect of the knee

Figure 6. Lateral view of the bending to the lower steering wheel rim.

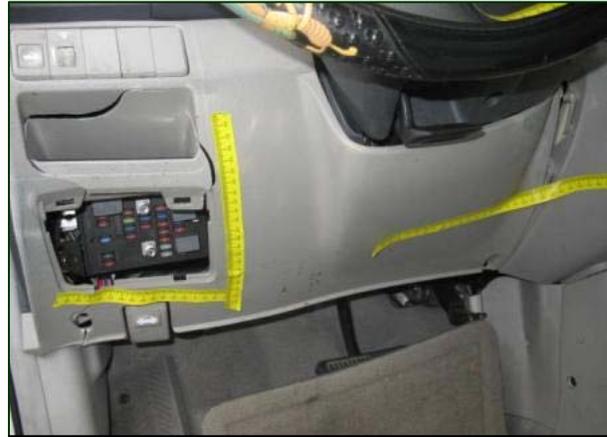
bolster from 11 cm to 23 cm (4" to 9") left of center. This contact fractured the adjacent mid instrument panel and contained a blue fabric transfer.

Figure 7. Knee contacts to the knee bolster/lower instrument panel.

The driver's knees contacted the lower instrument panel/knee bolster. The knees fractured the lower panel with denim fabric transfers surrounding the contact areas. The extent of her injury is unknown.

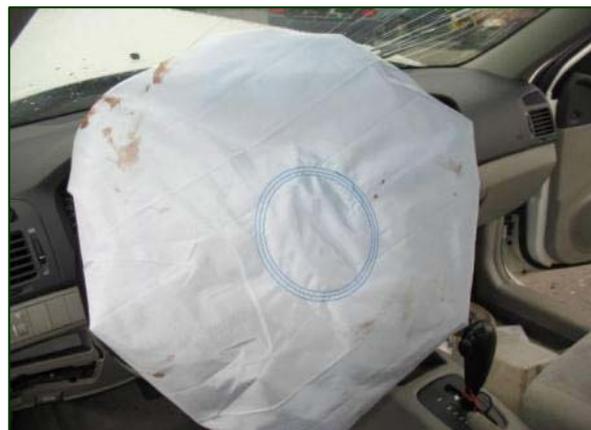
Figure 8. Deployed driver's CAC air bag.

As a result of the collision with the large diameter pole, the driver's frontal air bag system deployed. The air bag was conventionally mounted within the steering wheel hub and concealed by I-configuration cover flaps. The cover flaps measured 13 cm (5.1") in height. The left and right cover flaps measured 11 cm (4.3") and 6 cm (2.4") in width, respectively. The disparity in width measurements occurred due to the tear pattern of the cover flaps. At the center of the tear flaps was a circular shaped Kia logo. During the deployment, the logo remained attached to the left cover flap. The air bag membrane measured 56 cm (22") in diameter in its deflated state (**Figure 8**) and was vented by two ports located at the 11 and 1 o'clock positions on the rear panel of the air bag. Two wide-band tethers controlled the deployment excursion of the air bag. These tethers were vertically opposed at the 12 and 6 o'clock positions. The tethers were sewn to the face of the air bag membrane using a circular stitch pattern centered on the face of the membrane. The maximum rearward excursion documented at the center of the air bag membrane measured 32 cm (12.6").

The air bag membrane contained numerous areas of body fluid splatter and a black vinyl transfer. The body fluid transfers were located throughout the four quadrants and on the front and rear panels of the membrane. The heaviest concentration of body fluid was located on the left aspect of the membrane from the 11 o'clock sector to the 7 o'clock sector. These transfers varied in size from 2-12 cm (0.8-4.7"). Two spots of body fluid were noted on the face of the air bag membrane located near the center line above the tether stitching and at the 6 o'clock sector. The black transfer that also contained body fluid was present on the right aspect of the air bag membrane. This transfer measured approximately 17 cm (7") in height and 5 cm (2") in width. No apparent damage or malfunctions were present to the air bag components.

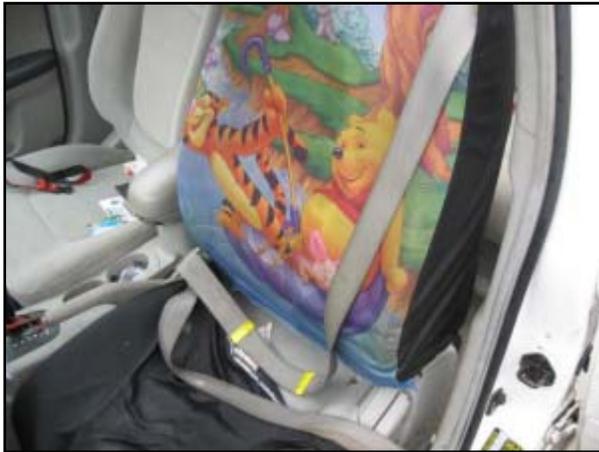
As a result of the crash, the driver's retractor mounted safety belt pretensioner actuated locking the safety belt in the used position. The SCI inspection revealed 198 cm (77.9") of spooled out webbing on the driver's seat. During the crash, the driver loaded the safety belt system. Due to the driver loading, frictional abrasions occurred to the webbing as it spooled through the sliding latch plate. A distinct abrasion/loading pattern was present on the webbing from the contact with the latch plate which was located 102-117 cm (40-46.0") above the floor anchor. The movement

of the webbing resulted in full width frictional abrasions on the latch plate. The shoulder belt webbing was gathered at the D-ring from a combination of the actuation of the pretensioner and loading by the driver. Also present on the webbing was body fluid and dirt that was located on the lap belt portion of the safety system. **Figures 9 and 10** depict the driver's safety belt and loading evidence.

Figure 9. Driver's safety belt system.

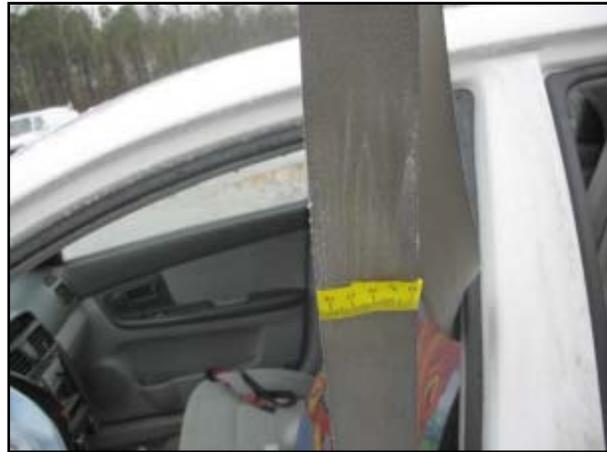
Figure 10. Loading abrasions from the latch plate.

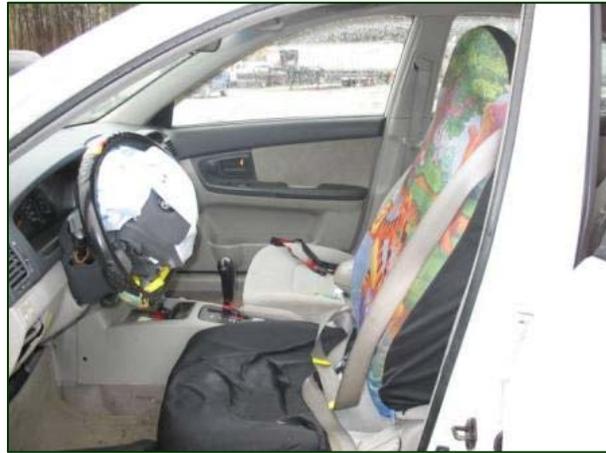
During the driver's forward trajectory, she loaded the child passenger and compressed the child against the lower steering wheel rim. The steering wheel rim was deformed forward at the lower aspect. Additionally, the steering column was compressed and steering wheel flange was deformed. **Figure 11** is a lateral view of the driver position and loading of the steering wheel rim.

Figure 11. Lateral view of the driver's position and loading deformation of the steering wheel rim.
