**CALSPAN ON-SITE CERTIFIED ADVANCED 208-COMPLIANT VEHICLE
CRASH INVESTIGATION**

SCI CASE NO. – CA08007

VEHICLE – 2007 HONDA CIVIC

CRASH DATE – DECEMBER 2007

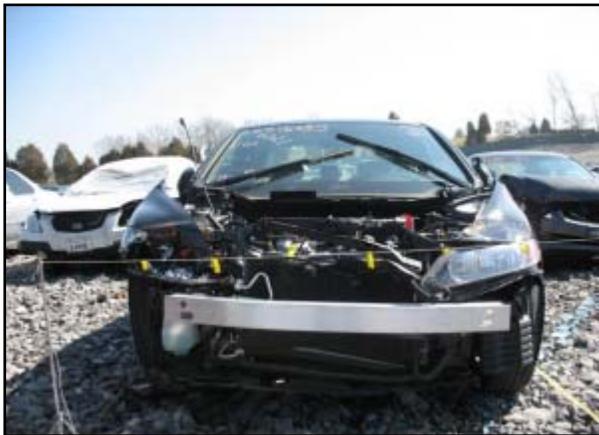
The 2007 Honda Civic sustained moderate severity frontal damage as result of the front-to-rear impact with the Ford. The damaged components involved the front bumper fascia, bumper beam, upper radiator support, right headlight assembly, and the fenders. During the crash sequence, the front of the Honda underrode the rear bumper of the Ford. This underide resulted

in contact to the top of the hood, fenders, and crush of the upper radiator support. **Figures 3 and 4** are views of the frontal deformation.

The front bumper fascia could not be located; therefore, the direct contact damage was measured at the level of the hood. The direct damage measured 144 cm (56.7") and began on the top of the left fender and extended onto the right fender. Due to the underride, crush profiles were documented at the bumper beam and upper radiator support. Although a crush profile was measured, no residual crush was present at the bumper beam.

The maximum crush at the upper radiator support was located at the right end and measured (34 cm (13.5")). The crush profile at this component was as follows: C1 = 24 cm (9.5"), C2 = 20 cm (7.8"), C3 = 23 cm (9.0"), C4 = 25 cm (9.8"), C5 = 27 cm (10.8"), C6 = 34 cm (13.5"). The Collision Deformation Classification (CDC) for this impact was 12-FDEW-2.

Figure 3. Overall view of the frontal damage.

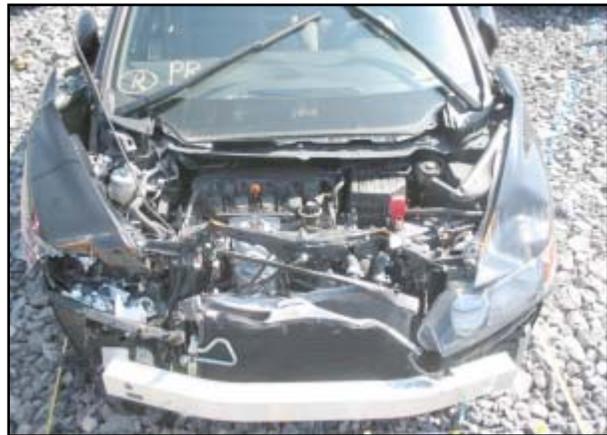
Figure 4. Overhead view of the upper radiator crush.

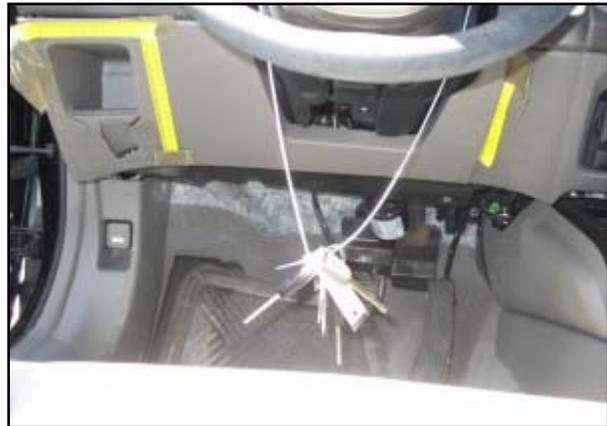
The interior of the Honda sustained minor damage that was attributed to occupant contact points. The occupant contact points consisted of two knee strikes to the knee bolster (**Figure 5**) and right aspect of the steering column. The left knee strike was located from 21-33 cm (8.3-13.0") left of the center of the steering column. This contact was evidenced by fractures to the plastic component. The right knee strike consisted of a scuff mark on the right aspect of the steering column and slight deformation of the knee bolster. This contact began 8 cm (3.0") right of the center of the steering column and extended 15 cm (6.0") right of this referenced point. This crash did not result in a reduction of the passenger compartment.

Figure 5. Knee strikes to the left instrument panel.

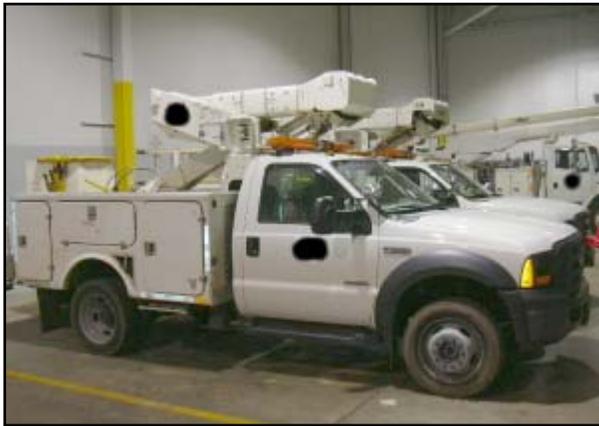
The 2006 Ford F550 sustained minor severity damage as result of the front-to-rear crash with the Honda. This vehicle was repaired prior to the assignment of the case (**Figure 6**). The damage assessment was based on the images that were provided by the vehicle owner to the SCI investigator. The direct contact damage was contained to the center and right aspects of the steel rear bumper. Minor deformation was apparent at these locations with the majority of the crush occurring to the step bar (**Figure 7**). Also noted was deformation to the hydraulic connections that were located on the right side of the vehicle immediately forward of the bumper. Although not coded in the EDS, a Truck Deformation Classification (TDC) was assigned for this impact. The TDC was 06-BZEW-1.

Figure 6. Repaired 2006 Ford F550.

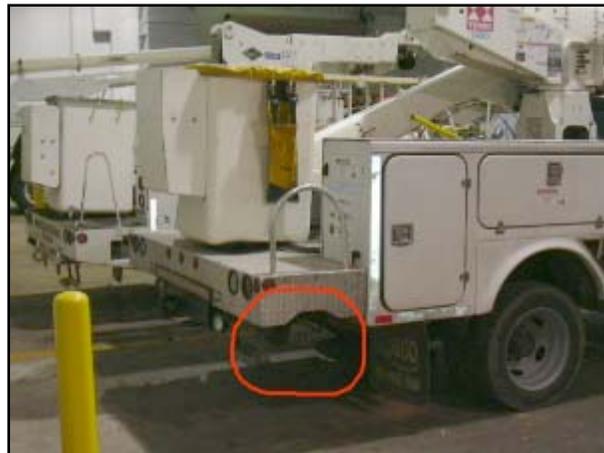
Figure 7. Step bar and hydraulic connections.

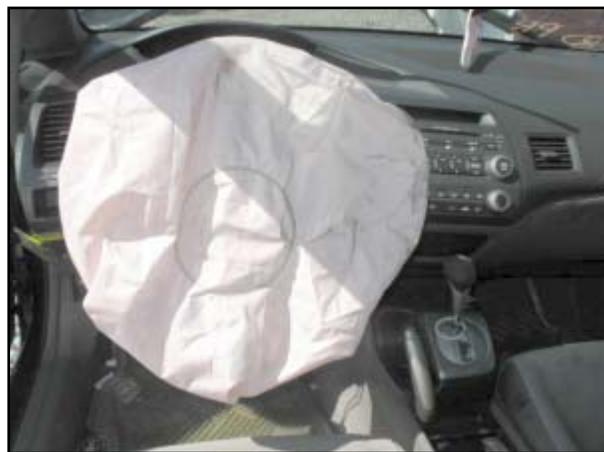
As a result of the crash, the driver's frontal air bag deployed (**Figure 8**). The driver's air bag was conventionally located in the center of the steering wheel hub and was concealed by three cover flaps. The top cover flap measured 6 cm (2.5") in height and 13 cm (5.0") in width. The total width of lower cover flaps measured 13 cm (5.0") with a height of 10 cm (3.8"). The centers of the lower cover flap contained a circular cutout for the Honda insignia. The driver's air bag membrane measured 56 cm (22") in diameter in its deflated state. The air bag contained two tethers at the 12 and 6

Figure 8. Deployed driver's frontal air bag.

o'clock positions and was vented by two vent ports at the 11 and 1 o'clock positions. There were no damage or occupant contact points present on the air bag membrane.

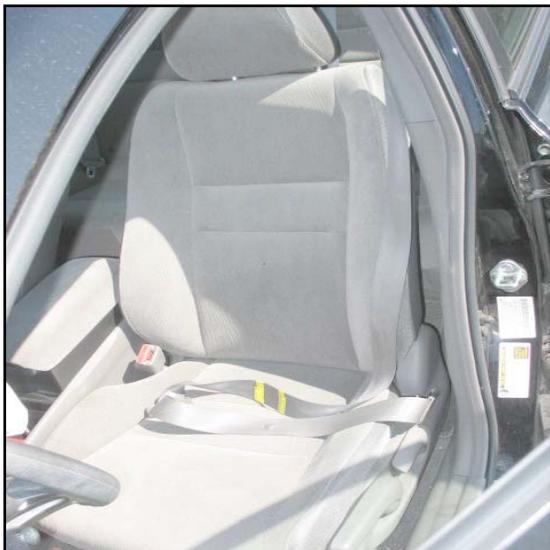
The 2007 Honda Civic was equipped with manual 3-point lap and shoulder safety belts for the five seating positions. The driver's safety belt was configured with continuous loop webbing, sliding latch plate, height adjustable D-ring that was in the full-down position at the time of the SCI inspection, an Emergency Locking Retractor (ELR), and dual pretensioners. The pretensioners were both buckle mounted and retractor mounted. The driver utilized the safety belt during the crash, as evidenced by frictional abrasions on the latch plate, a transfer on the webbing, and actuation of the dual pretensioners. The driver utilized the safety belt during the crash, as evidenced by frictional abrasions on the latch plate, a transfer on the webbing, and actuation of the dual pretensioners. The actuation of the retractor pretensioner locked the safety belt webbing in the used position (**Figure 9**). The buckle stalk was compressed 5 cm (2") from the actuation of the buckle mounted pretensioner (**Figure 10**). A light colored transfer and fraying of the outer edge of the webbing was noted during the examination of the safety belt. The fraying occurred as the webbing passed through the latch plate. The transfer and the fraying were located 78-80 cm (30.5-31.5") above the plastic sleeve near the anchor point.

Figure 9. Driver's safety belt restricted in used position due to actuated retractor pretensioner.

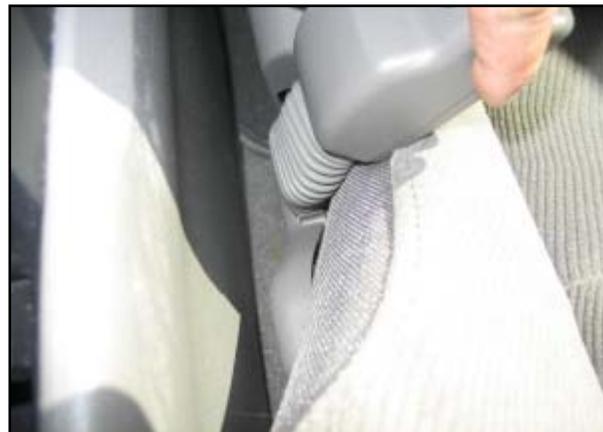
Figure 10. Actuated driver's buckle pretensioner.
