Child Safety Seat Investigation
Dynamic Science, Inc. / Case Number: DS08008
2001 Jeep Grand Cherokee
California
February 2008

14. Sponsoring Agency Code	
15. Supplemental Notes				
16. Abstract This on-site investigation focused on a booster seat that was installed in the second row left position of a 2001 Jeep Grand Cherokee. The Jeep was occupied by an unrestrained 27-year-old female and a 2-year-old female second row left passenger, restrained in the child seat. This two-vehicle crash occurred in February 2008 at 1140 hours in a rural area of California. The Jeep was traveling westbound. The other vehicle was a 2007 Chevrolet Silverado that was being driven by an unrestrained 41-year-old female. The Chevrolet was traveling eastbound and traveled partially onto the south gravel shoulder. The driver of the Chevrolet overcorrected in an attempt to get back in her lane and the vehicle began a counterclockwise rotation. The Chevrolet traveled into the westbound lane of travel. The Chevrolet and the Jeep collided in an angled head-on configuration. The Jeep subsequently struck a barbed wire fence, rolled over onto it left side, and caught fire. Both drivers were fatally injured. The

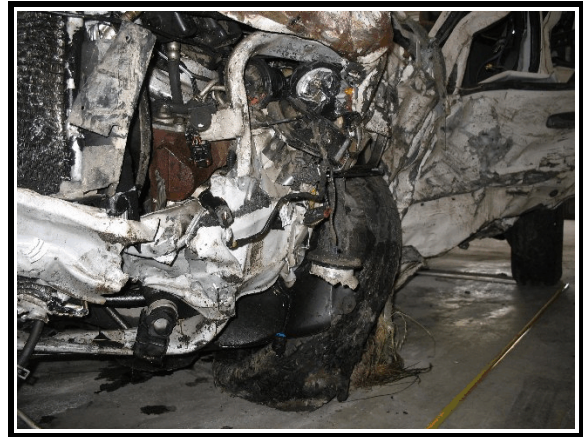
The 2001 Jeep Grand Cherokee sustained severe front end and left side damage as a result of the impact with the Chevrolet Silverado (**Figures 5-6**). The direct damage began at the left front bumper corner and extended laterally 73 cm (28.7 in) along the front end. Six crush measurements were documented at the bumper level as follows: C1 = 95 cm (37.4 in), C2 = 55 cm (21.6 in), C3 = 49 cm (19.3 in), C4 = 28 cm (11.0 in), C5 = 15 cm (5.9 in), C6 = 15 cm (5.9 in). The Collision Deformation Classification (CDC) for the impact with the Silverado was 11FYEW4.

Figure 5. Front left damage to Jeep Cherokee

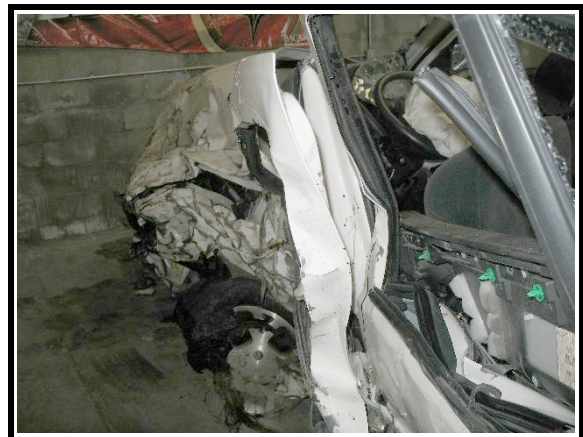
The direct damage extended from the left bumper corner 224 cm (88.1 in) rearward down the left side plane. The direct damage on the left side began 15 cm (5.9 in) forward of the rear axle. Both left side doors were jammed shut. The left wheelbase was shortened by 87 cm (34.2 in). The left front tire was torn and the rim was fractured (**Figure 7**). The roof was cut off by rescue personnel.

The CDC for the left side rollover was 00LDAO2. The lateral and vertical crush from the rollover was overlapping. The CDC for the fence impact was unknown.

Figure 6. Left side damage to Cherokee

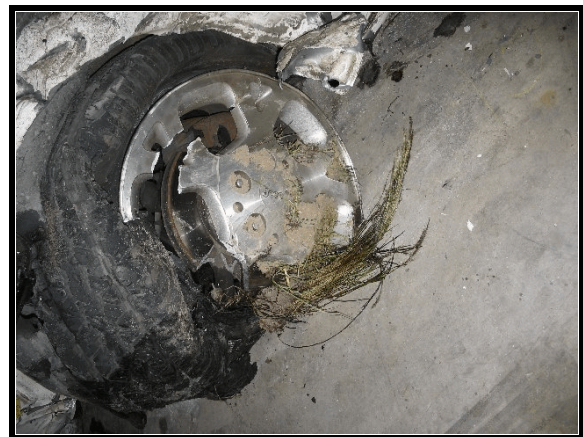
Figure 7. Left front tire/rim damage to Cherokee

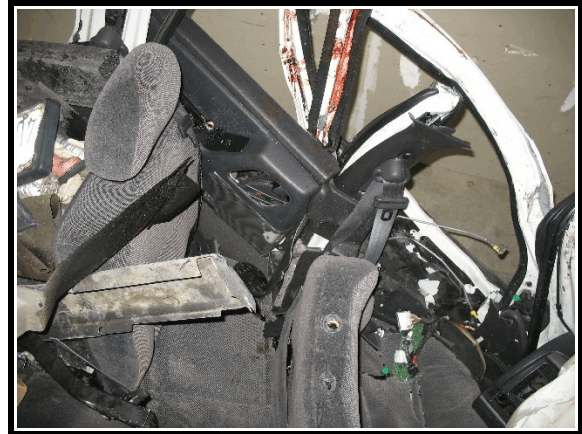
The 2001 Jeep Grand Cherokee sustained moderate interior damage as a result of passenger compartment intrusion. There was longitudinal intrusion into the driver's area from the steering wheel, left instrument panel, left kick panel, and the left toe pan. There was lateral intrusion of the left door panel. There was longitudinal intrusion into the second row left seat position from the driver and passenger seat backs. There was left side lateral door panel intrusion into the second row. The distance between the back of the driver's seat and the front of the second row left seat back was 33 cm (12.9 in) (**Figure 8**). There was blood found along the entire left B-pillar. The specific passenger compartment intrusions were documented as follows:

Figure 8. Overhead view of driver's seat back and second row seating

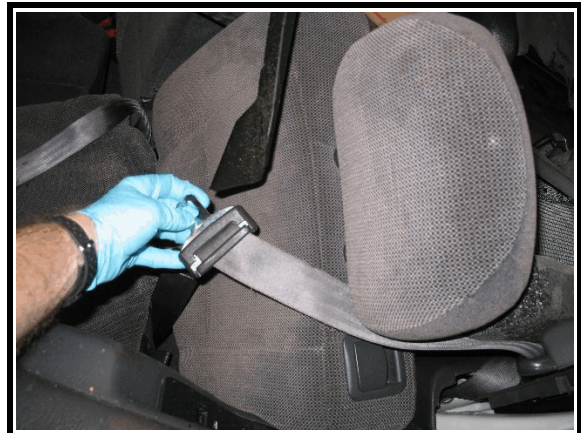
Figure 9. Second row left safety belt latch

The second row left seat safety belt was configured with a light weight locking/cinching latch plate and an ELR (**Figure 9**). The safety belt was being used to secure a forward facing CSS. There was a 25 cm (9.8 in) area of scuffing found on the seat belt webbing that began at the latchplate and extended toward the D-ring as a result of belt loading (**Figure 10**).

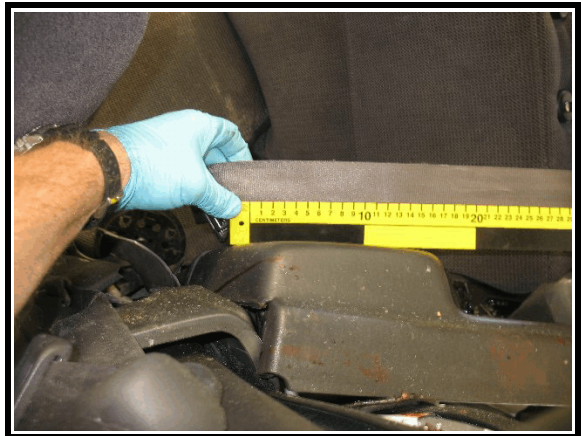
Figure 10. Second row left safety belt loading to belt webbing

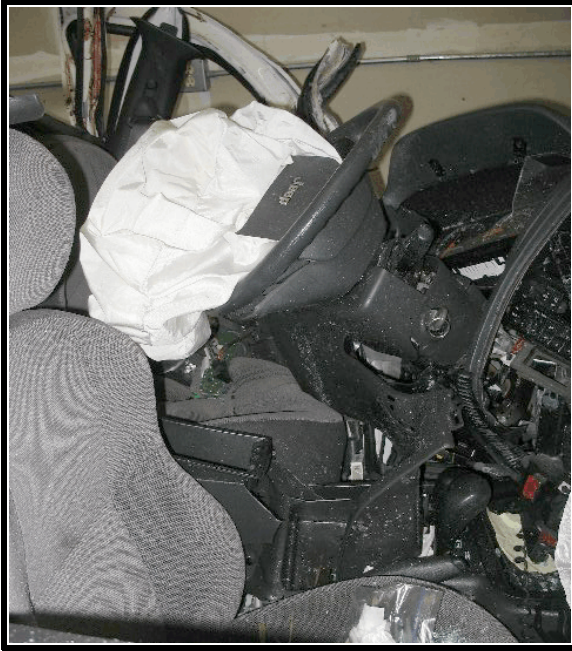
The driver's air bag deployed from the center of the steering wheel hub through H-configuration module cover flaps (**Figure 11**). The top flap measured 11 cm (4.3 in) in height and 17 cm (6.7 in) in width; the bottom flap measured 7 cm (2.8 in) in height and 17 cm (6.7 in) in width. The deployed driver's air bag measured 56 cm (22.0 in) in diameter in its deflated state. The air bag was tethered by a single internal strap. There were no vent ports. There were make-up transfers documented on the upper right quadrant of the air bag face.

Figure 11. Deployed driver's air bag

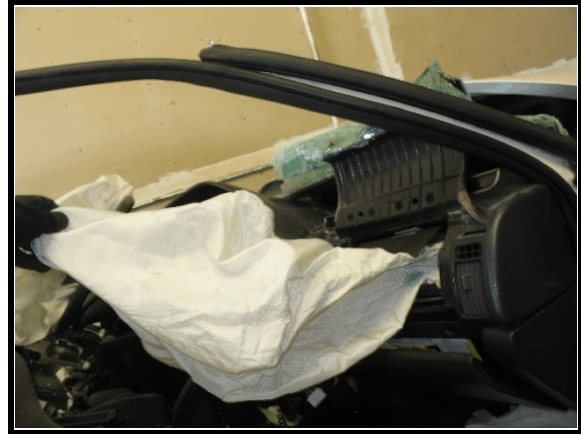
The front right passenger's air bag deployed from a mid mount module with a rectangular cover that was hinged at the top aspect (**Figure 12**). The module cover flap measured 40 cm (15.7 in) in width and 18 cm (7.0 in) in height. The deployed front right passenger's air bag measured 64 cm (25.1 in) in width and 40 cm (15.7 in) in height. There was no damage to the air bag or module cover.

Figure 12. Deployed front right passenger's air bag

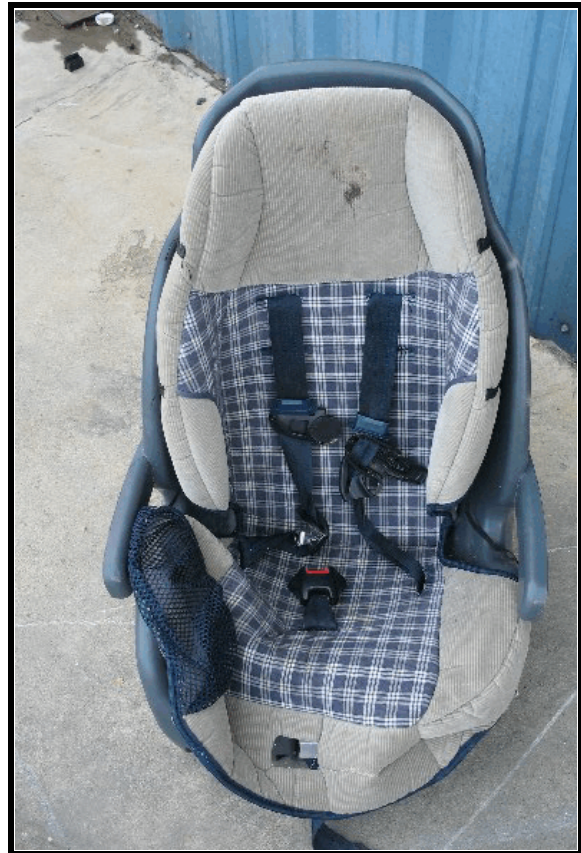
A forward facing Cosco Eddie Bauer High Back Booster CSS was positioned in the left rear of the Jeep (**Figures 13-14**). The model number was 22-859 HML and the date of manufacture was July 30, 2003. The child seat was configured with a five-point harness system and a harness retainer clip. At the time of the CSS inspection, the harness straps were routed through the top set of harness slots. A label on the child seat outlined the recommended use of the seat as follows:

Figure 13. Cosco booster seat

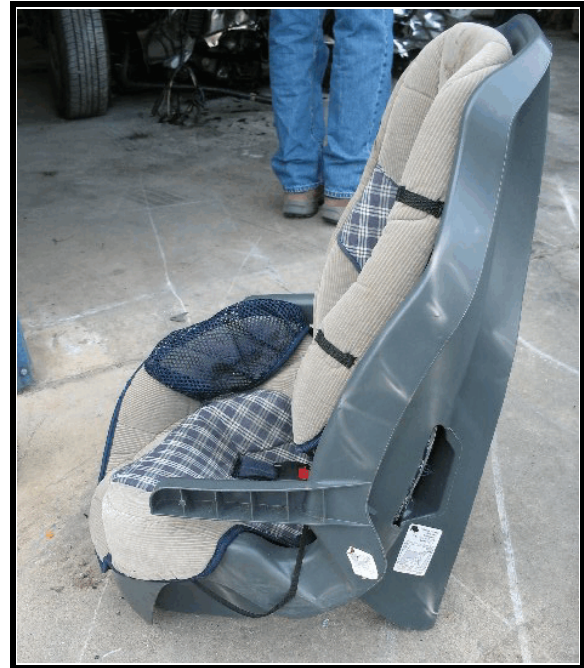
There was crazing found along the left seat back and along the base that was a result of contact with the intruding left rear door. The seat was initially pinned in place between the driver's seat back and the front of the left rear seat. During the vehicle inspection, an effort to place the CSS back into the original position was not possible due to the reduced space between the two seat backs.

Figure 14. Left side damage to Cosco booster seat

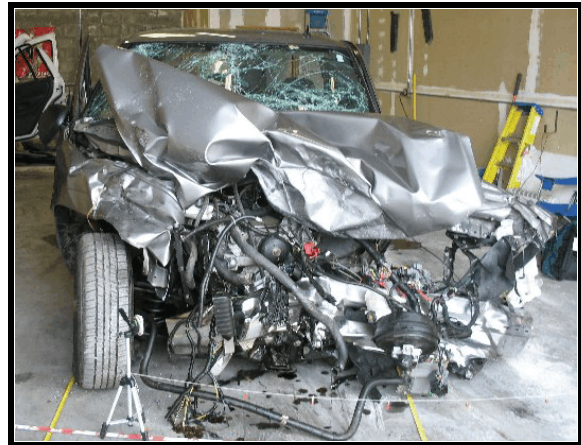
The Chevrolet Silverado sustained severe front end damage as a result of the impact with the Jeep Grand Cherokee (**Figures 15-16**). The direct damage began at the right front bumper corner and extended laterally 74 cm (29.1 in) across the front end. The entire end structure was shifted to the left 91 cm (35.8 in). There was contact damage to the left fender, hood and grille. The left front tire was holed and restricted. Both front doors were jammed shut. The right front door was bowed outward due to occupant loading from the ejected driver (**Figure 17**). The door/window frame was bowed outward 35 cm (13.8 in) near the B-pillar and 22 cm (8.7 in) near the A-pillar. The windshield was cracked due to impact damage. The front right side window was disintegrated. Six crush measurements were documented at the bumper level as follows: C1 = 100 cm (39.4 in), C2 = 89 cm (35.0 in), C3 = 81 cm (31.9 in), C4 = 64 cm (25.2 in), C5 = 49 cm (19.3 in), C6 = 29 cm (11.4 in). The CDC for the impact with the Jeep Cherokee was 82FZEW3 due to end shift to the left.

Figure 15. Front end damage, Chevrolet Silverado

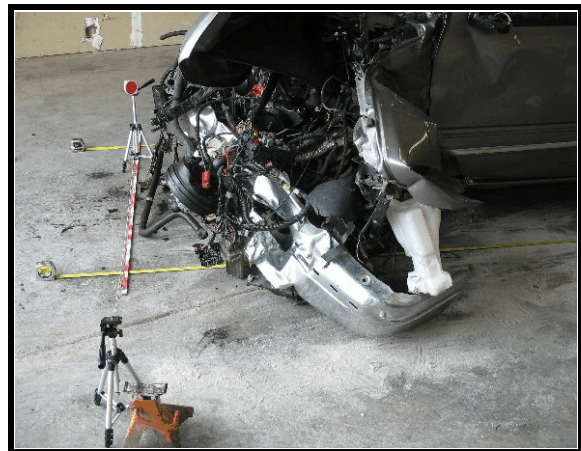
Figure 16. Side view of front end damage

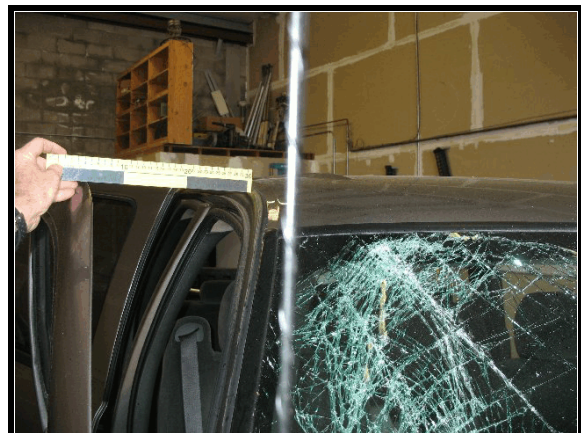
Figure 17. Front right door outward bowing

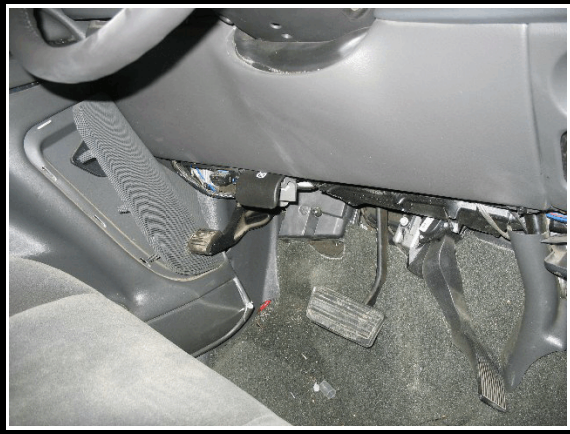
The Chevrolet Silverado sustained moderate interior damage as a result of passenger compartment intrusion and occupant contacts. There was longitudinal intrusion to the left instrument panel and the toe pan (**Figure 18**). There was lateral intrusion to the left kick panel and the left lower door. The folded down center seat back was contacted by the driver and pushed laterally to the right 13 cm (5.1 in) (**Figure 19-20**). As the driver was projected to the right, the driver struck the right interior door and deformed it outward. The driver fractured the right side window glass and was fully ejected from the vehicle.

Figure 18. Left kick panel/toe pan intrusion

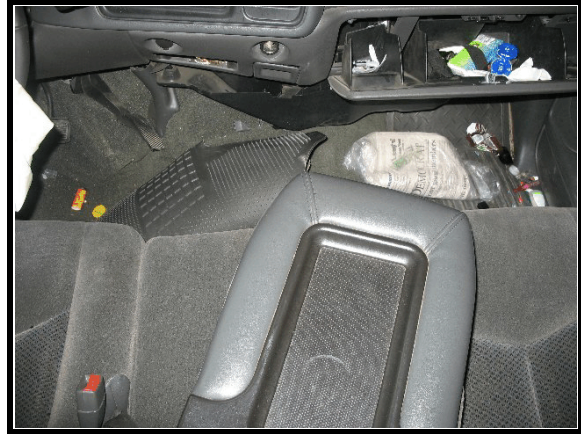
Figure 19. Movement of center fold down seat to right

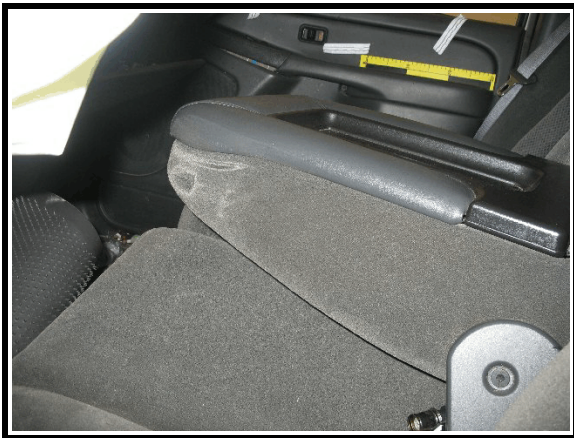
Figure 20. Contact to center fold down seat and right door

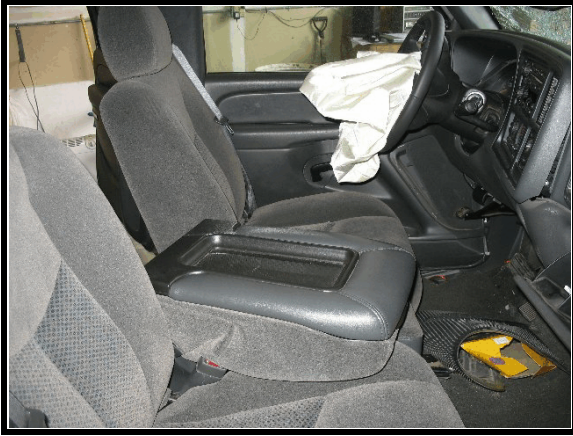
Figure 21. Side view of deployed driver's air bag

The driver's air bag deployed during the impact with the Jeep Grand Cherokee (**Figures 21-22**). The front right passenger's air bag was suppressed. The driver's air bag deployed from the center of the steering wheel hub through symmetrical I-configuration module cover flaps. Each flap measured 12 cm (4.7 in) in height and 7 cm (2.8 in) in width. The deployed air bag measured 50 cm (19.7 in) in its deflated state. The air bag was tethered by a single internal strap. There were two circular vent ports on the rear of the air bag. There was no damage to the air bag or the module covers.

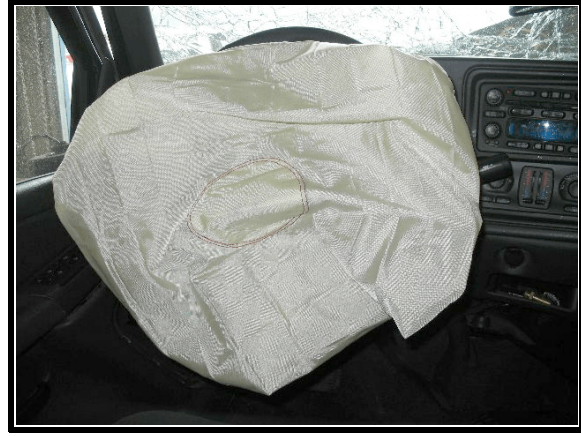
Figure 22. Front view of deployed driver's air bag
