**CALSPAN ON-SITE SIDE IMPACT INFLATABLE OCCUPANT PROTECTION
CRASH INVESTIGATION**

SCI CASE NO. – CA08012

VEHICLE – 2007 HYUNDAI SONATA

CRASH DATE – FEBRUARY 2008

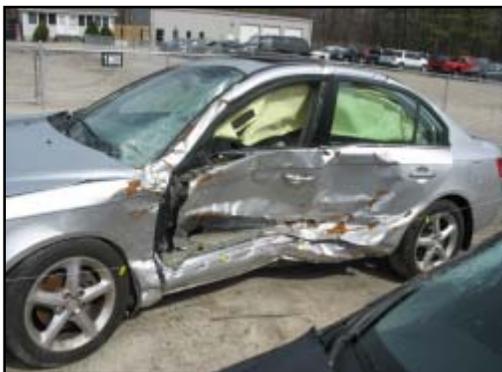
The exterior of the Hyundai Sonata sustained moderate severity damage as a result of the intersection crash (**Figures 4 and 5**). The Hyundai was subsequently deemed a total loss by the insurance carrier and was transferred to a salvage facility where it was inspected. The residual damage was measured along the lower door elevation. The maximum crush measured 50 cm (19.7”) and was located on the aft aspect of the front left door, 163 cm (64.2”) forward of the left rear axle. The direct contact damage measured 179 cm (70.5”) and began 59 cm (23.2”) forward of the left rear axle. The height of the maximum crush measured 53 cm (20.9”). A crush profile was documented at the lower door level and was as follows: C1 = 4 cm (1.6”), C2 = 32 cm (12.6”), C3 = 41 cm (16.1”), C4 = 39 cm (15.4”), C5 = 16 cm (6.3”), C6 = 1 cm (0.4”). In addition to the crush profile, a single measurement documenting the distance between the sill and the door was obtained. This measurement is identified as the Door Sill Differential (DSD) and was 29 cm (11.4”). The Collision Deformation Classification (CDC) assigned for this damage was 10-LYEW-3.

Figure 4. Residual damage to the left side of the Hyundai Sonata.

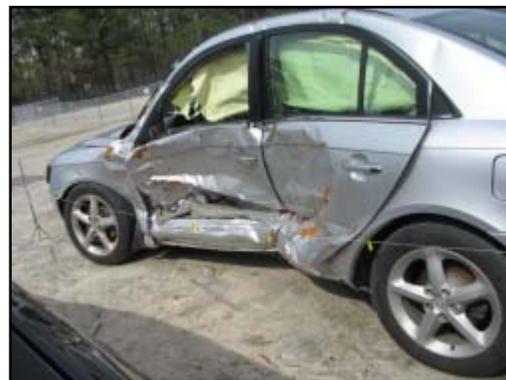
Figure 5. Oblique view of the left side crush.

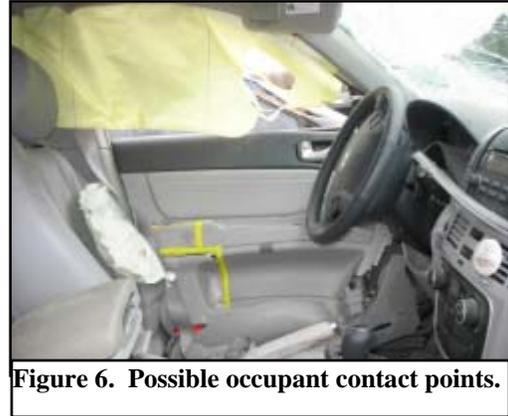
The 2007 Hyundai Sonata sustained moderate severity interior damage that was attributed to occupant contact points and passenger compartment intrusion. Two possible occupant contact points were noted to the interior (**Figure 6**). These contacts were located on the Rear Upper Quadrant (RUQ) and Rear Lower Quadrant (RLQ) of the left front door. The occupant contact to the RUQ consisted of a black scuff mark while the contact to the RLQ was evidenced by a fracture of the plastic door panel. These occupant contact points were considered as possible due to the proximity of the seat back air bag. In the deployed state, the seat back air bag membrane was positioned over the location of the contacts. Therefore, the fracture possibly occurred as the door panel intruded and deformed around the driver's left hip. The resultant intrusions are listed within the table below with **Figures 7 and 8** depicting the passenger compartment intrusions:

Figure 6. Possible occupant contact points.

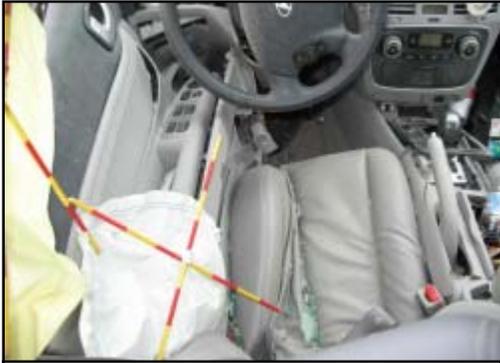
Location	Component	Magnitude	Direction
Left Front	Door panel	37 cm (14.6")	Lateral
Left Front	Roof side rail	1 cm (0.4")	Lateral
Left Front	Instrument panel	4 cm (1.6")	Lateral
Left Front	Seat back	25 cm (9.8")	Lateral
Left Front	Seat cushion	34 cm (13.4")	Lateral
Left Front	Sill	3 cm (1.2")	Lateral
Left Front	Knee bolster	Approx. 8 cm (3.0")	Vertical
Left Front	Side panel forward of A-pillar	1 cm (0.4")	Lateral
Left Front	B-pillar	32 cm (12.6")	Lateral
Left Front	Center console	5 cm (2.0")	Lateral
Left Rear	Roof side rail	1 cm (0.4")	Lateral
Left Rear	Door panel	29 cm (11.4")	Lateral
Left Rear	Sill	16 cm (6.3")	Lateral
Left Rear	Seat back	Approx. 2 cm (0.8")	Lateral
Left Rear	Seat cushion	Approx. 2 cm (0.8")	Lateral

Figure 7. Lateral intrusion into the driver's position.

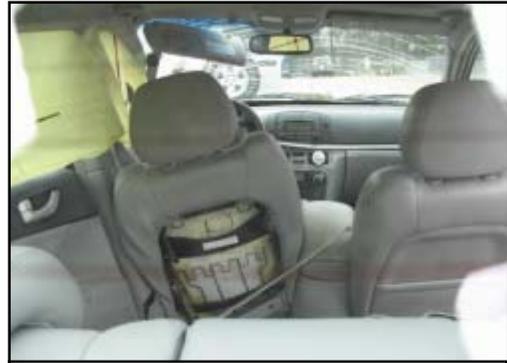
Figure 8. View of intrusions from the second row.

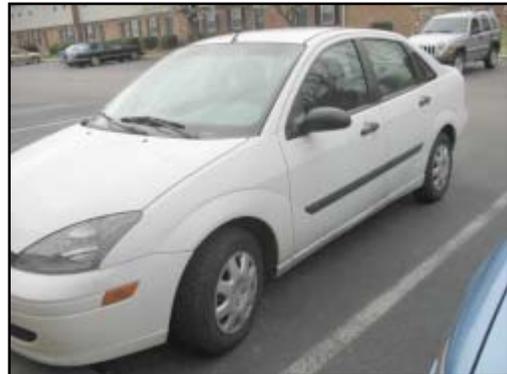
The 2004 Ford Focus sustained minor damage as result of the impact with the Ford Explorer. The damage was confined to the left side mirror which was replaced. Thus, damage data was not obtained for this vehicle. A partial CDC assigned to this vehicle of 12-LPGS-1. **Figure 9** is of the repaired Ford Focus.

Figure 9. Repaired Ford Focus.

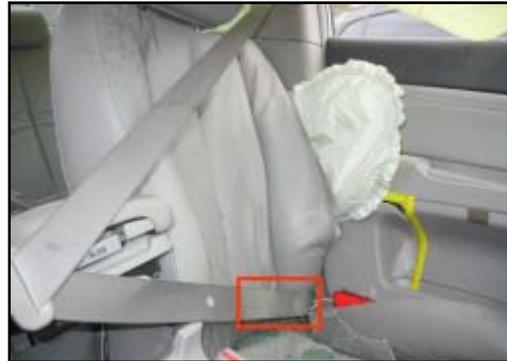
Figure 10. Driver's safety belt

The Hyundai was equipped with manual 3-point lap and shoulder belts for the five designated seat positions. All belt systems utilized continuous loop webbings with sliding latch plates. The driver's belt retracted onto an Emergency Locking Retractor (ELR) and was equipped with a retractor pretensioner. The upper D-ring was adjustable and was set to the full-up position. The driver used the safety belt at the time of the crash, which was supported by the actuated retractor pretensioner that locked the safety belt in its extended position. The safety belt webbing contained a light colored transfer on the outboard aspect below the stop button. The source of this transfer could not be identified. **Figure 10** shows the driver's safety belt and the transfer.

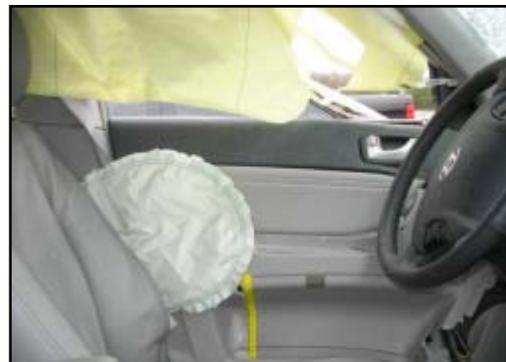
The left seat back mounted air bag was concealed within the outboard aspect of the seat back. The air bag deployed through a tear seam at the forward aspect of the seat back (**Figure 11**). The D-shaped air bag membrane measured 30 cm (11.8") in height and 30 cm (11.8") in width and consisted of two panels sewn together at the forward edge. A single vent port was present on the top outboard aspect and measured 5 cm (2.0") height and 3 cm (1.2") in width. The inboard aspect of the membrane was unremarkable. A black scuff mark was present on the outboard panel that measured approximately 5 cm (2.0") in height and 5 cm (2.0") in width. It's unknown what produced this scuff mark; however, it appeared to line-up with the scuff mark on the door panel.

Figure 11. Deployed left seatback mounted side impact air bag.

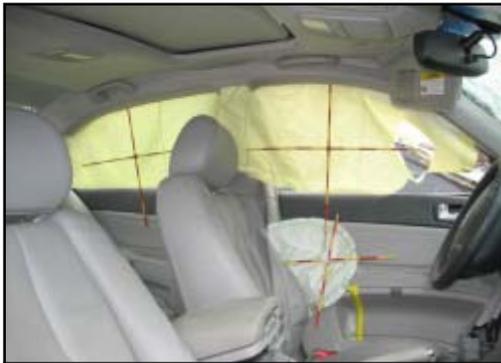
The left curtain air bag deployed from the roof side rail (**Figure 12**). The air bag membrane measured 167 cm (65.7") in length. At the front left seating position, the membrane measured 35 cm (13.8") in height extending 1 cm (0.4") below the top of the door panel. The height of the curtain air bag membrane at the left rear position was 34 cm (13.4") and extended 2 cm (0.9") below the top of the door panel. The height of the curtain air bag membrane provided head protection from the roof side rail to belt line of the vehicle.

The curtain air bag was free of damage and occupant contact points.

Figure 12. Deployed left side curtain air bag.

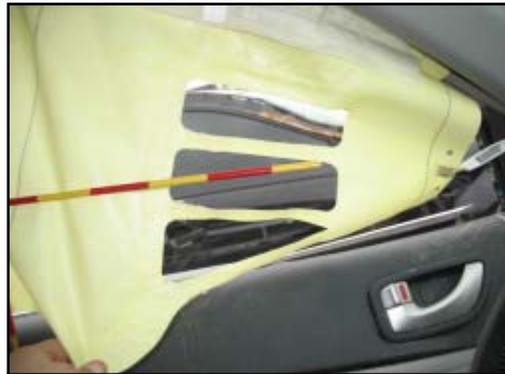
that began at the A-pillar and extended 29 cm (11.4”) rearward. Within this section were three cut outs in the membrane (**Figure 13**). These cut outs began approximately 10 cm (4.0”) below the roof rail and 12 cm (4.7”) rear of the A-pillar. The top two cuts outs were rectangular in shape measuring 5 cm (2.0”) in height and 15 cm in width (5.9”). The bottom cut out was triangularly shaped with dimensions of 5 cm (2.0”) and 15 cm (5.9”), height by width.

Figure 13. Cut outs on forward aspect of the curtain air bag.
