TRANSPORTATION RESEARCH CENTER

ON-SITE CHILD SAFETY SEAT INVESTIGATION

CASE NUMBER - IN08014
LOCATION - MINNESOTA
VEHICLE - 2004 TOYOTA CAMRY LE
CRASH DATE - March 2008

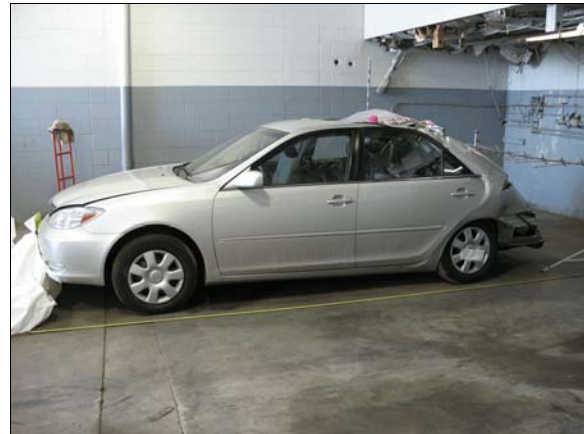
Figure 1: The damaged 2004 Toyota Camry LE

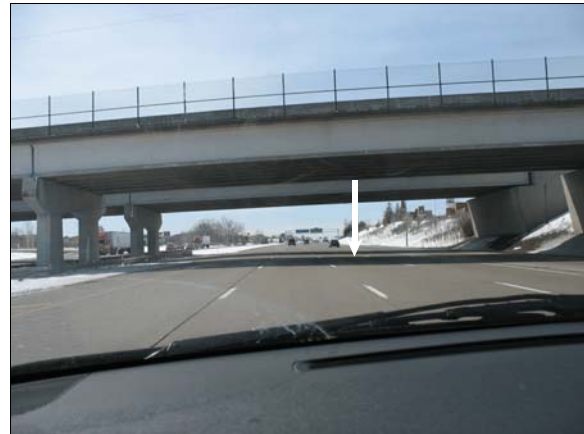
Figure 3: Overview of area of impact in westbound outside center lane (arrow)

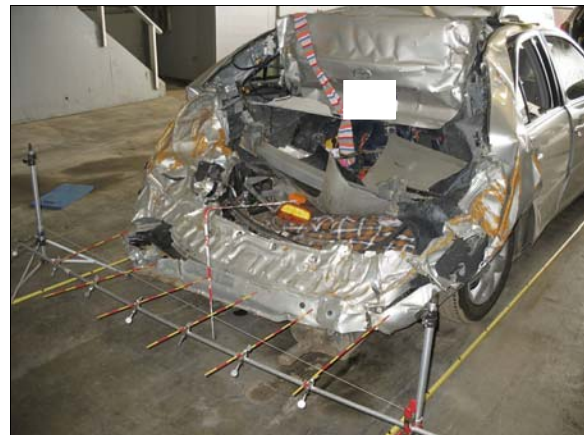
Figure 4: Damage to the back of the Toyota from the impact by the Freightliner

Exterior Damage: The Toyota's impact with the Freightliner involved the back end of the vehicle. The back bumper, both taillight assemblies, the trunk lid, both C-pillars and both quarter panels

sustained direct damage. The direct damage began at the back right bumper corner and extended 146 centimeters (57.5 inches) across the back of the vehicle. Due to the override, crush measurements were taken at the bumper level and trunk lid level. The back bumper had been torn off the vehicle during the crash, so the bumper level crush was taken to the structure behind the bumper. The residual maximum crush at the bumper level was 30 centimeters (11.8 inches) occurring at C₆. The residual maximum crush at the trunk lid level was 140 centimeters (55.1 inches) occurring at C₄. The table below shows the vehicle’s rear crush profile, which is the average of the crush at the bumper level and trunk lid level.

The left side wheelbase was reduced 7 centimeters (2.8 inches) while the right side wheelbase was reduced 6 centimeters (2.4 inches). Induced damage involved the left and right rear doors, backlight, right rear window, and the roof.

Damage Classification: The Toyota’s Collision Deformation Classification (CDC) was **06-BDAW-6 (180 degrees)** for the impact with the front of the Freightliner. Impacts with heavy trucks are out of scope for the WinSMASH program; however, the program was used to determine a Barrier Equivalent Speed (BES) based on the crush to the back of the Toyota. WinSMASH calculated the BES as 62.4 km/h. (38.5 mph)

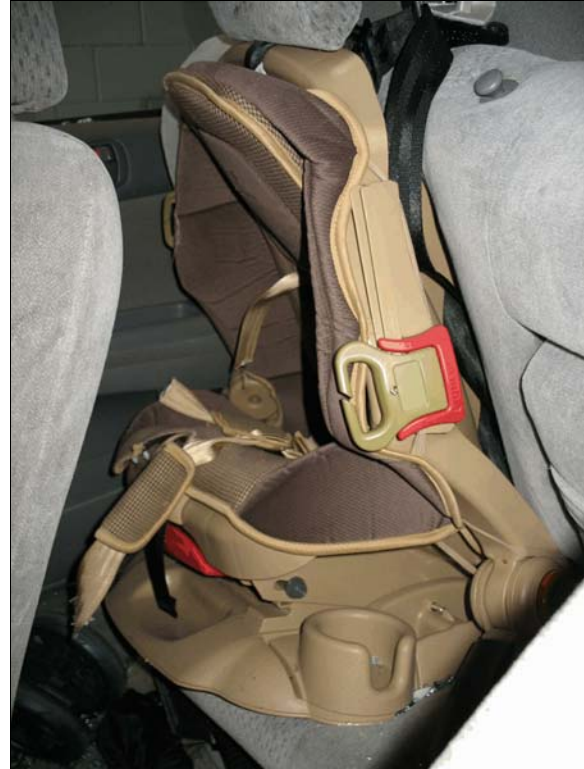
Vehicle Interior: Inspection of the Toyota's interior revealed extensive intrusion into the back seat occupant space. The CSS was found entrapped in the second row right seat position (**Figure 5**). No evidence of occupant contacts were found in the vehicle. In spite of the severe back impact, the driver's seat back was not deformed rearward and was found in the slightly reclined position. The trunk lid, second row seat back, and backlight header intruded into all of the second row seat positions. The extent of intrusion of the trunk lid, second row seat back, and backlight header were, respectively: 86 centimeters (33.9 inches) 70 centimeters (27.5 inches), and 17 centimeters (6.7 inches). There was no deformation to the steering wheel or compression of the energy absorbing steering column. All windows were closed at the time of the crash and only the backlight and right rear window glazing disintegrated due to impact forces. None of the doors opened during the crash and both rear doors were jammed shut.

Figure 5: Child safety seat as found, entrapped in the Toyota's second row right seat position

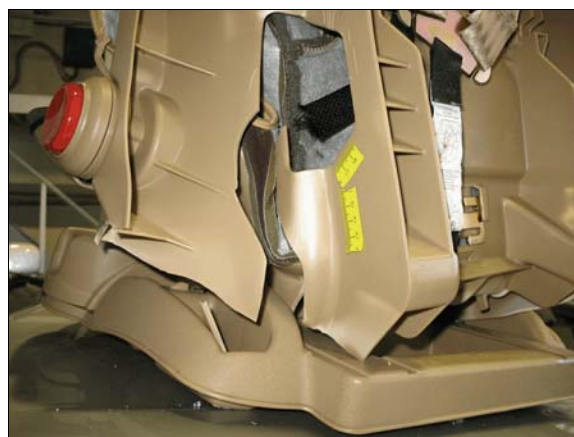
The CSS was secured in the second row right seat position by the CSS LATCH anchor straps, which were secured to the lower anchors. The tether strap was not used. Due to the intrusion of the Toyota's seat back, the CSS was held tightly in place by the LATCH anchor straps and had to be cut in order to remove the CSS for inspection. The CSS was deformed as a result of the seat back intrusion, which bent the back of the CSS forward as well as to the left 10 degrees. The right arm rest was also displaced outward, and the lower left side of the seat back sustained a crack in the shell 13 centimeters (5.1 inches) in length (**Figure 7**). The left harness strap was broken (**Figure 8**) due to loading on the harness slot as the seat back was bent forward. The harness retainer clip was also broken and the right harness strap was cut by rescue personnel.

Figure 7: Damage to the CSS's lower left side

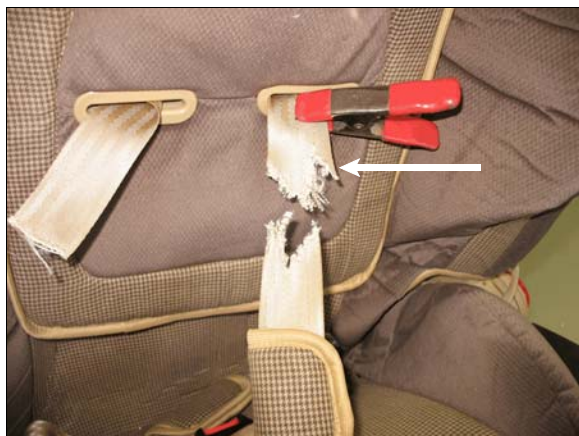
Figure 8: Arrow shows CSS's broken left harness strap; right harness strap was cut by rescue personnel to remove the child from the seat

The Freightliner's impact with the back of the Toyota displaced the second row right passenger rearward opposite the 6 o'clock direction of principal force and she loaded the back of the CSS. The intrusion of the Toyota's seat back caused the back of the CSS to bend forward and the second row right passenger moved forward with the seat back. The CSS remained secured in the vehicle during the crash and the passenger remained in the CSS. Rescue personnel cut the right harness strap in order to remove the passenger from the CSS.

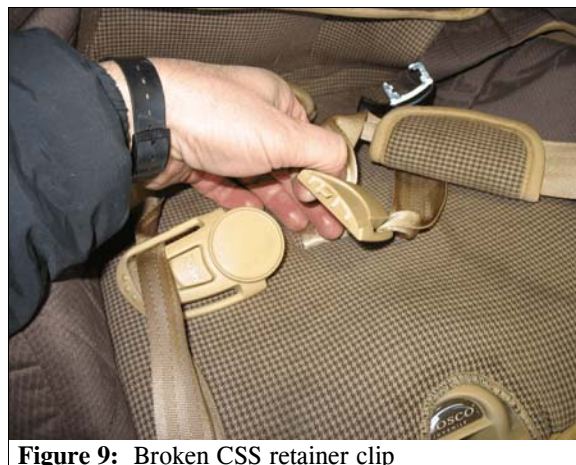
Figure 9: Broken CSS retainer clip
