CALSPAN ON-SITE BACK OVER INCIDENT INVESTIGATION

SCI CASE NO.: CA08015

VEHICLE: 2006 KIA SPECTRA

INCIDENT DATE: MARCH 2008

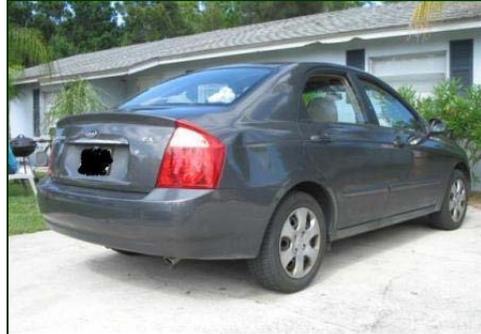
Figure 1. Rear view of the 2006 Kia Spectra.

There was no visible contact evidence from this incident present on the vehicle at the time of the SCI inspection. The Kia Spectra was not equipped with a back-up/parking aid system.

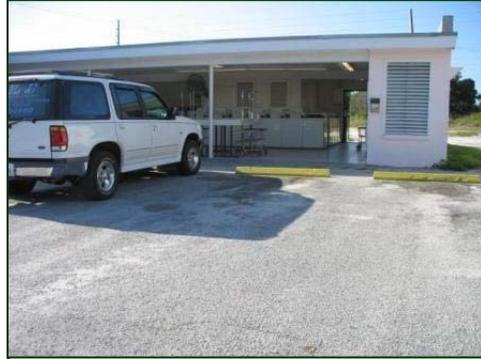
The laundry mat consisted of an L-shaped building with an open air facility adjacent to the parking lot. The parking lot was surfaced with asphalt and was not delineated into designated parking spaces. Five composite parking curbs (wheel stops) were positioned 2.2 m (7.2') outboard of the open laundry mat. A gap of 0.8 m (2.6') separated these parking curbs. At the time of this incident, two vehicles were parked in front of the facility; the vehicle operated by the mother of the non-motorist, and the involved Kia Spectra that was parked to the right of the non-contact vehicle. The mother's non-contact vehicle was parked in the center space. The parking lot was open and level. **Figure 2** is a look back view of the incident site. The schematic of the incident site is attached as **Figure 12**.

Figure 2. Look back view of the incident site.

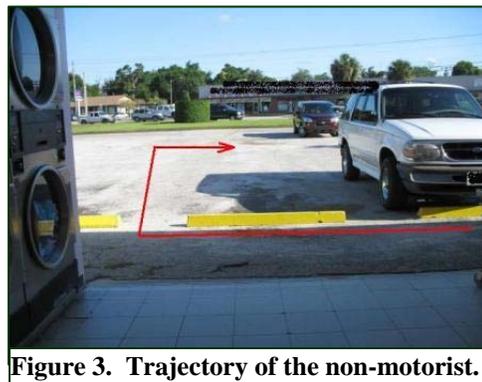
As the grandmother observed the non-motorist run along the right side of the vehicle and dart behind the Spectra, she yelled to get the attention of the driver and the non-motorist. She also noted that as she yelled, she observed the driver looking in his rear view mirror as he backed. **Figure 3** represents the trajectory of the non-motorist as viewed from the grandmother's position within the laundry mat.

Figure 3. Trajectory of the non-motorist.

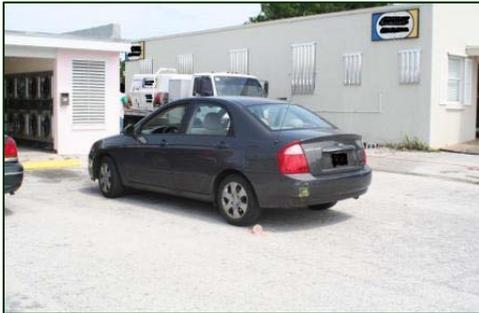
As the non-motorist turned to her right to cross behind the backing Kia Spectra, the back right area of the bumper fascia struck the child and knocked her to the pavement. The yells of the grandmother alerted the driver and he immediately stopped the vehicle. The driver estimated that he stopped within 0.6 m (2'). The on-scene police photographs indicated that the driver backed an SCI estimated distance of 1.8-2.4 m (6-8'). While backing, the driver applied a slight clockwise steering input to back on a counterclockwise arc. The non-motorist fell onto her left side and sustained abrasions of the lower left anterior leg, contusion with abrasions of the left forearm and elbow, a left shoulder abrasion, and a left pulmonary contusion.

Figure 4. Backing trajectory of the Kia and the spilled milkshake from the non-motorist.

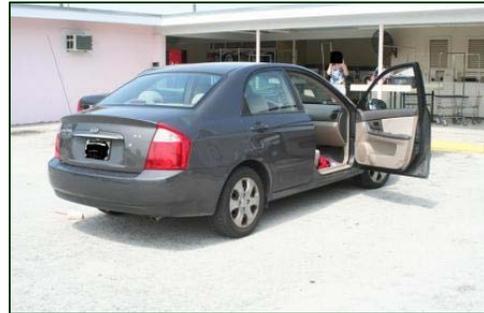
Figure 5. Final rest position of the Kia Spectra.

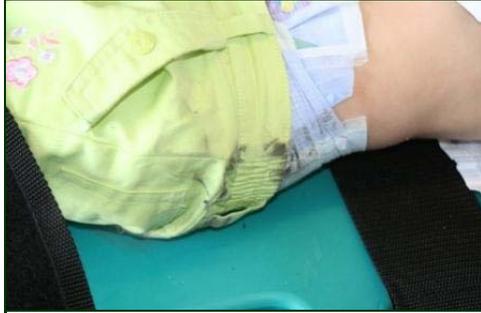
The grandmother stated during the SCI interview that a tire mark was visible on the shorts and the diaper of the child; however, the non-motorist came to rest rearward of the right rear tire. On-scene police photographs captured a black transfer over the left hip and flank area of the non-motorist (**Figure 6**). This transfer was the road film that was noted to the lower aspect of the Kia Spectra. Although the non-motorist was struck on the right side and knocked down onto her left side, the transfer probably occurred as the grandmother picked the child up from under the rear bumper and brushed the clothing against the fascia. The on-scene police images provided a view of the rear bumper fascia that revealed wipe marks (area where road film was removed) across the full length of the top surface of the fascia. These marks potentially occurred as the driver unloaded/loaded the trunk of the Kia Spectra.

Figure 6. Black transfer of the clothing over the left hip area of the non-motorist.

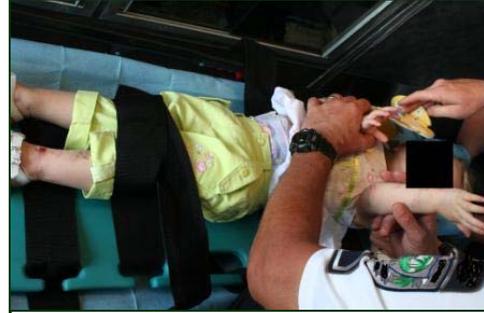
Figure 7. Soft tissue injuries to the non-motorist.

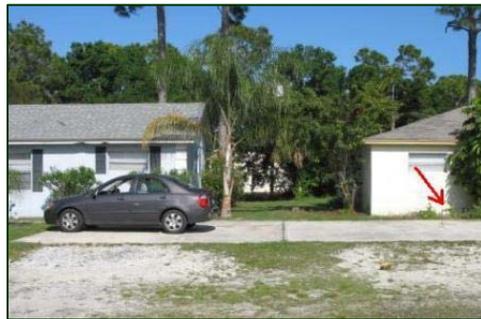
The driver was asked to look into the rear view mirror and locate the full diameter of the red reflective marker. He indicated that the reflector was fully visible to him at a point that was 5.6 m (18.4') rearward of the back bumper of the Kia. The driver was asked to locate an object in the rear view mirror that was placed on the ground on the centerline of the back plane of the vehicle. The driver noted that the object was in full view at a measured distance of 15.7 m (51.5') aft of the back bumper (**Figure 8**).

Figure 8. Rear line of sight for the driver to the reflector as viewed through the rear view mirror.

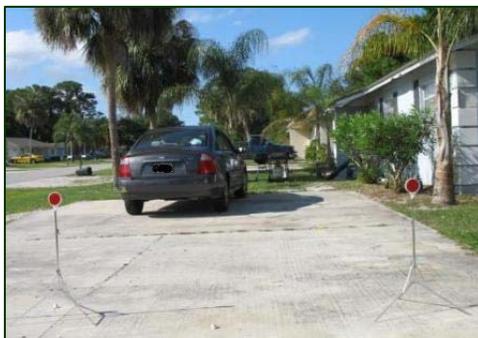
Lateral cones of visibility were established using the outside mirrors. The markers were placed at an arbitrary distance of 5.6 m (18.4') aft of the back bumper. Using the left outside mirror, the driver could detect the full diameter of the reflector 74 cm (29") left of the vehicle's centerline, or approximately 15 cm (6") inboard of the left side line of the Kia. The outboard location of the reflector was visible to the driver 216 cm (85") left of the centerline, or 127 cm (50") outboard of the extended left side plane of the vehicle. The right outside mirror yielded similar results. The driver located the inboard reflector 74 cm (29") right of the vehicle's centerline, or 15 cm (6") inboard of the extension of the right bodyline. The maximum outboard position the driver could detect the marker was 287 cm (113") right of the vehicle's centerline, or 198 cm (78") outboard of the extended right side line of the Kia.

Figure 9. Lateral cone of visibility through the right outside mirror.

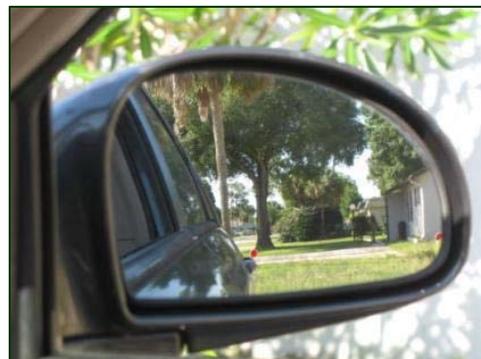
Figure 10. Visibility cone through the right mirror.

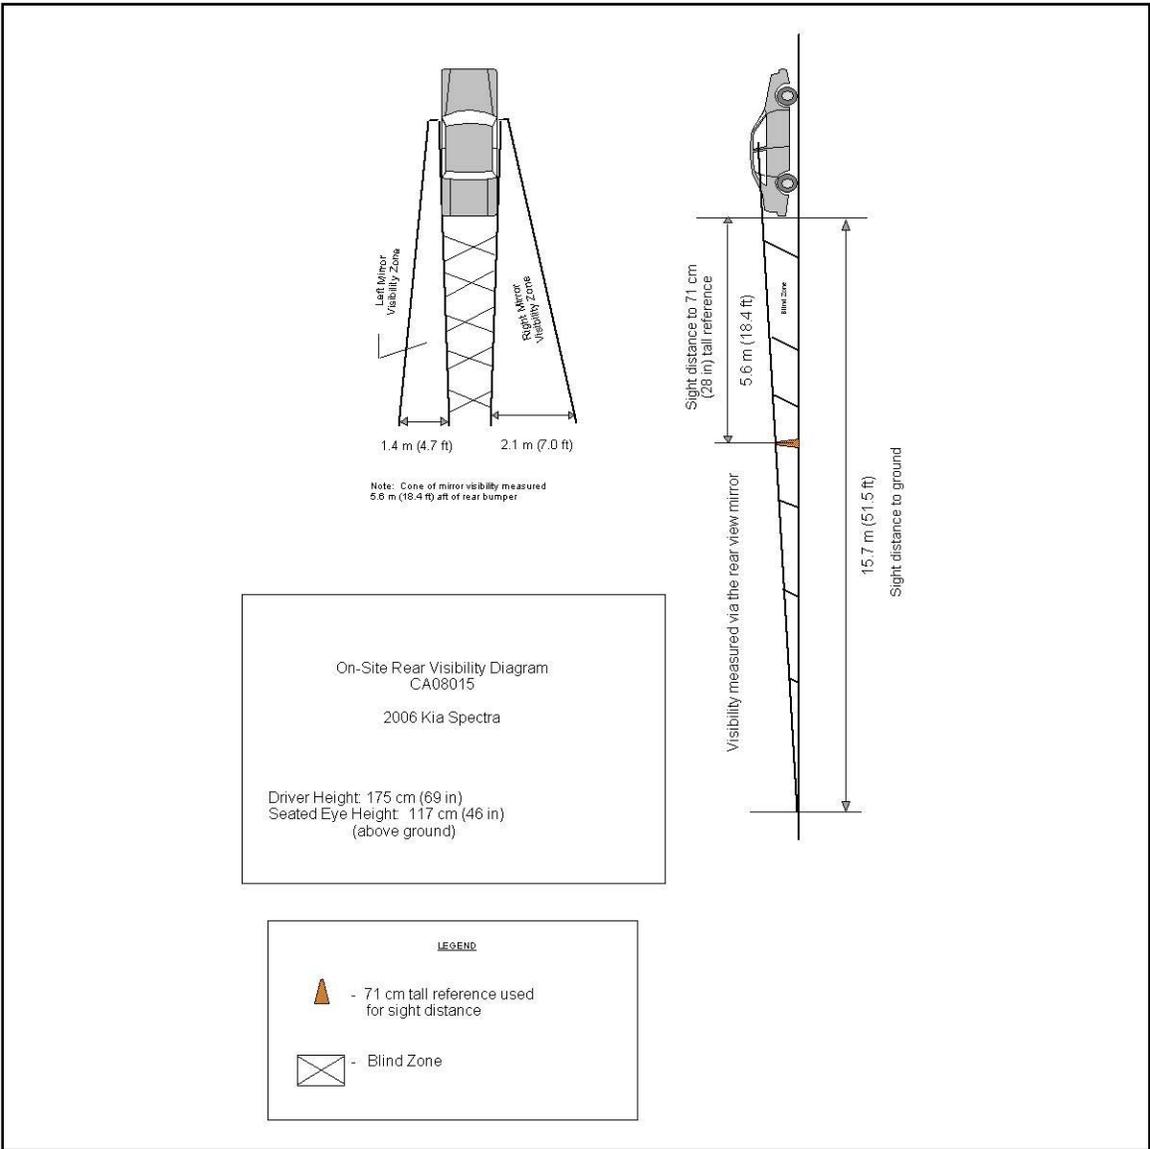
Figure 11. Rear Visibility Diagram

The established sight distances are depicted in the Rear Visibility Diagram that follows this section as **Figure 11** of this report.
