Child Safety Seat Investigation
Dynamic Science, Inc. (DSI), Case Number DS08016
2002 Ford Focus
Idaho
May 2008

1. Report No. DS08016	2. Government Accession No.		3. Recipient Catalog No.	
4. Title and Subtitle Child Safety Seat Investigation			5. Report Date May 15, 2009

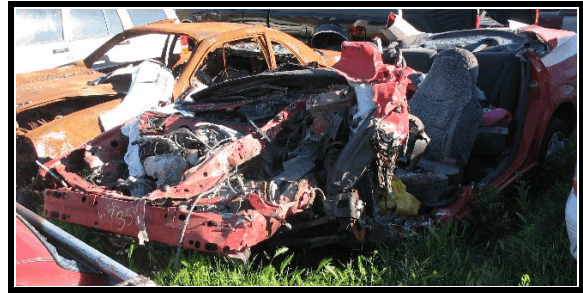
Figure 1. Subject vehicle, 2002 Ford Focus

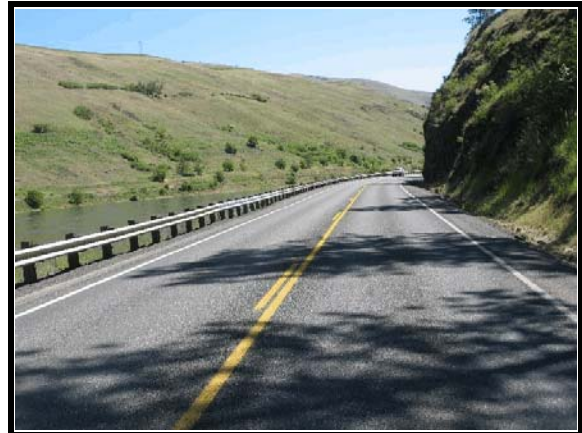
Figure 2. Approach to area of impact with Dodge (east).

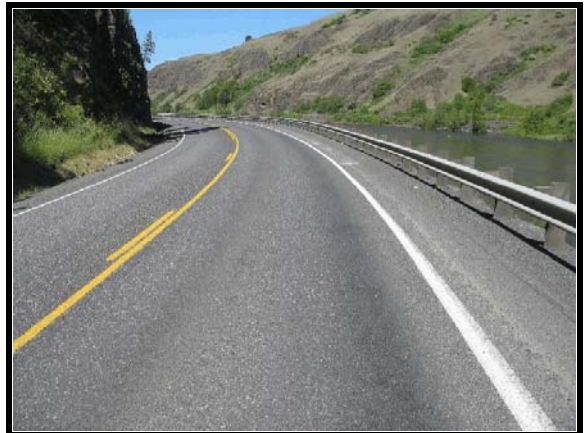
For unknown reasons, the Dodge departed the roadway on the right side, struck a guardrail, and then overcorrected into the path of the eastbound Ford. There were no marks left on the roadway prior to the Dodge striking the guardrail or prior to crossing in the path of the Ford. As the Dodge entered the eastbound travel lane it struck the left front of the Ford. The impact damage was severe and resulted in the deployment of the frontal air bag system in the Ford. The Missing Vehicle algorithm of the WinSmash program computed a total delta V of 34 km/h (21.1 mph), based on the Ford's frontal crush profile. The longitudinal and lateral components were -32 km/h (-19.8 mph) and 12 km/h (7.2 mph), respectively. Upon impact, the unrestrained driver of the Dodge was ejected. The Ford was forced rearward and to the south where it came to rest facing northeast in the embankment alongside the roadway. The Dodge rotated in a counterclockwise direction and came to rest on the south side of the roadway with its rear tires on an embankment.

Figure 3. Area of guardrail contact and approach to impact with Ford (west).

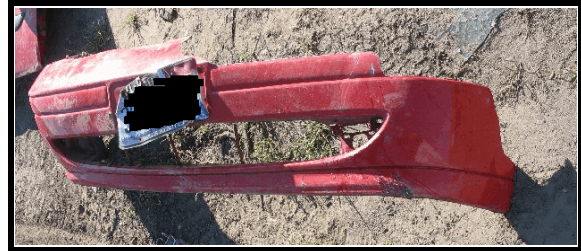
The Ford sustained moderate front end damage as a result of the impact with the Dodge pickup. The direct damage began at the left front bumper corner and extended 17 cm (6.7 in) laterally. The bumper fascia had been knocked off (**Figure 4**) and portions of the left side of the fascia were broken away. There was direct damage along the left side plane that extended to the driver's door (**Figure 5**). The damage included contact to the left A-pillar and possibly the windshield header (**Figure 6**). All the doors and the roof were removed by emergency personnel. Based on the extrication marks found on the left side of the vehicle, it was determined that the left side doors had been jammed shut. The left wheelbase was reduced by 41 cm (16.1 in). Six crush measurements were documented along the bumper backing bar as follows: C1 = 44 cm (17.3 in), C2 = 39 cm (15.3 in), C3 = 31 cm (12.2 in), C4 = 24 cm (9.4 in), C5 = 11 cm (4.3 in), C6 = 2 cm (0.8 in). The Collision Deformation Classification (CDC) for the impact with the Dodge pickup truck was 11FLAE6.

Figure 4. Bumper fascia

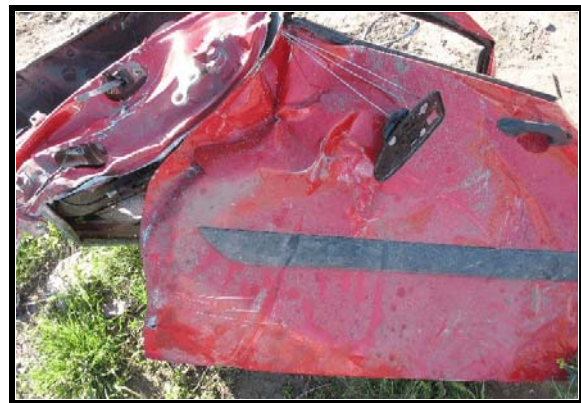
The Ford sustained severe interior damage as a result of passenger compartment intrusion and occupant contacts. The left instrument panel, left toe pan, left A-pillar, left lower A-pillar, windshield header, center instrument panel, and right instrument panel sustained longitudinal intrusion. The left front door intruded laterally to the right. The glove compartment door was found in the open position and would not close. The brake and clutch pedals were deformed to the right. The driver's knee bolster exhibited skin transfers on the right side and was cracked on the left. The steering wheel rim sustained 3 cm (1.2 in) of longitudinal deformation and left spoke was fractured and separated from the hub. The steering column appeared to have collapsed, but the shear capsule status was unknown. The center console was fractured and deformed to the right. There were scuffs across the center console and several control knobs were missing. Scuffs were located along the right instrument panel. There was substantial damage from the extrication efforts throughout the vehicle.

Figure 5. Damage to driver's door

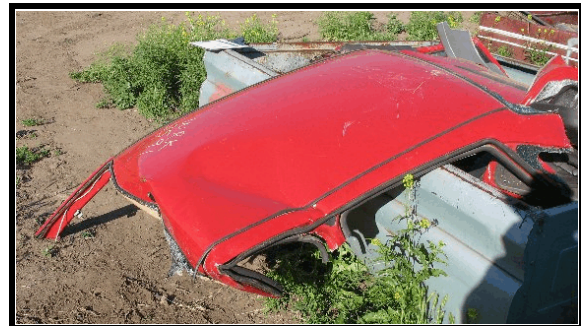
Figure 6. Windshield header/A-pillar damage

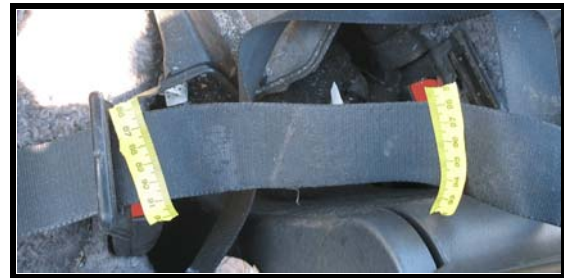
The Ford was configured with manual 3-point lap and shoulder belts for each seating position. According to the owner's manual, the front row safety belts were equipped with belt height adjustments. Their position was not known. The driver's safety belt was configured with a sliding latch plate and an Emergency Locking Retractor (ELR). Loading evidence was located on the webbing and rescue personnel had cut the webbing during extrication efforts (**Figure 7**).

Figure 7. Loading to driver's seat belt webbing.

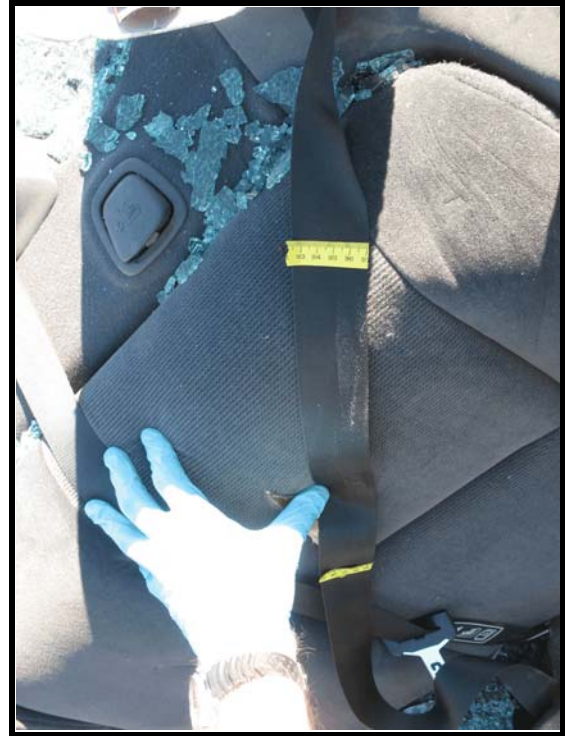
The second row left safety belt was being used by the rear seat occupant. The belt was routed through the belt positioning guides of the booster seat. At the time of the vehicle inspection, the seat belt webbing was found in the upper positioning guide of the seat and the retractor was in the ELR mode. There were loading marks on the seat belt webbing that corresponded to the upper seat belt

guide (**Figure 8**). The loading was 33 cm (12.9 in) in length and began 93 cm (36.6 in) from the stop button.

Figure 8. Loading to second row left seat belt webbing.

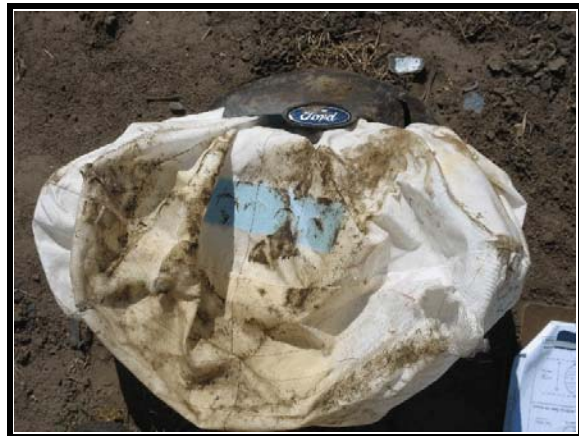
The driver's air bag module had been removed from the vehicle by emergency personnel. It was located with other vehicle components that had also been removed from the vehicle. The driver's air bag deployed from the center of the steering wheel hub through asymmetrical H-configuration module cover flaps (**Figure 9**). The top flap measured 9 cm (3.5 in) in height and 18 cm (7.0 in) in width. The bottom flap measured 9.5 cm (3.7 in) in height and 18 cm (7.0 in) in width. The deployed air bag measured 40 cm (15.7 in) in diameter in its deflated state. The air bag was tethered by a single internal strap. There were four 2.5 cm (1.0 in) semi-circular vent ports located at the 12 o'clock position on the back of the air bag. The air bag was cut and torn at the 1 and 11 o'clock positions. The damage was probably due to extrication efforts. The air bag was water-stained and covered in mud, dirt, and grease. There was a possible make-up contact to the right upper quadrant and a blood deposit was located at the bottom center and bottom left of the air bag.

Figure 9. Driver's air bag.

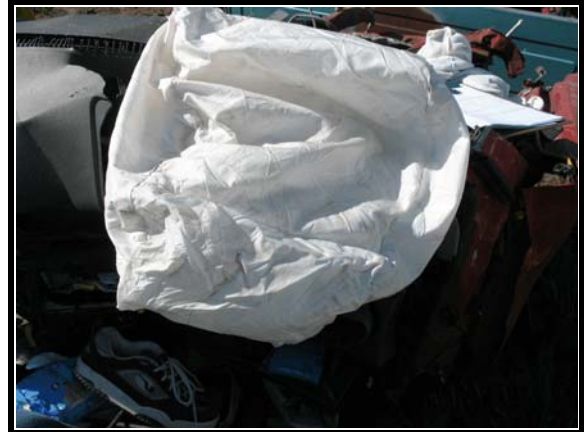
The front right passenger air bag deployed from a top mount module with a single rectangular cover flap that was hinged at the forward aspect (**Figure 10**). The module cover flap measured 44 cm (17.3 in) in width and 17 cm (6.7 in) in height. The deployed air bag measured 54 cm (21.2 in) in width seam to seam and 41 cm (16.1 in) in height. The air bag was tethered by a single internal strap. There was a single vent port located on the right side of the air bag in the 3 o'clock position.

Figure 10. Front right passenger's air bag.

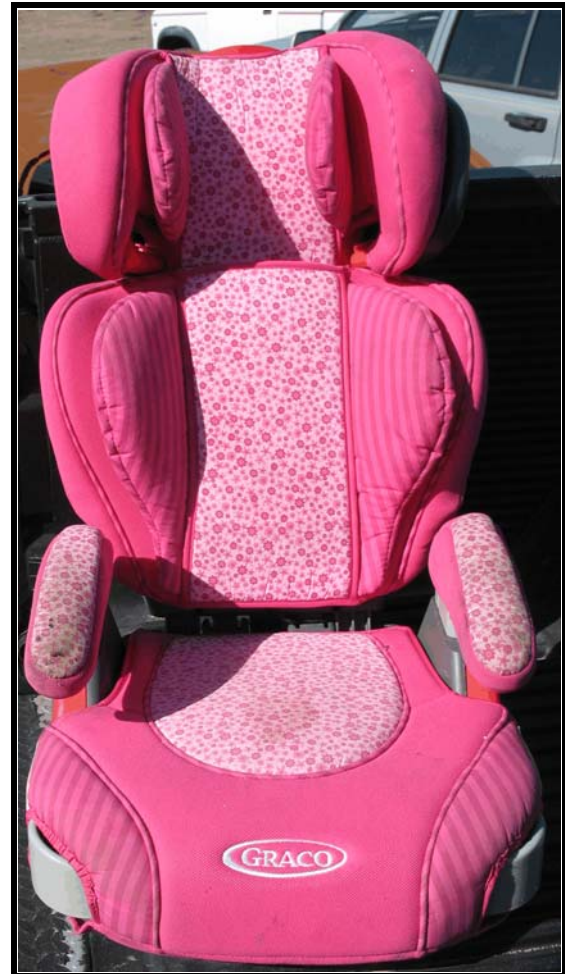
A Graco TurboBooster belt positioning booster seat was positioned in the second row left seat of the Ford Focus (**Figure 11**). The model number was 8E01CPK and the date of manufacture was June 13, 2007. The booster seat was designed to be used with or without the detachable seatback. The manufacturer recommends that the seatback be used for children 3-10 years old, whose height is between 96-145 cm (38-57 in), and whose weight is between 13-45 kg (30-100 lbs). When not using the seatback, the manufacturer recommends that the seat be used for children 4-10 years old, whose height is between 101-145 cm (45-57 in), and whose weight is between 18-45 kg (40-100 lbs). The seat was being used with the seatback in this crash. The child's height and weight are not known.

Figure 11. Graco TurboBooster belt positioning booster seat.

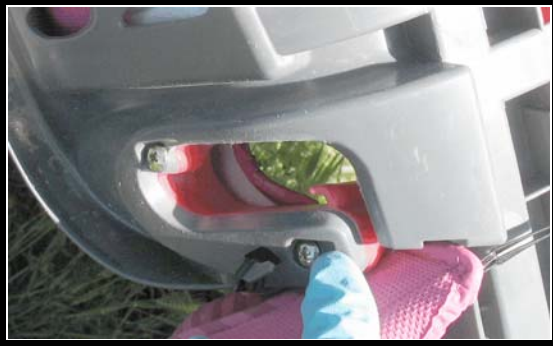
There were loading marks located at the left shoulder belt guide (**Figure 12**) and along the right lap guide (**Figure 13**). There were corresponding marks located on the vehicle seat belt webbing. There was some shifting of the plastic along the base on the right side from seat belt loading.

Figure 12. Loading marks to upper belt guide.

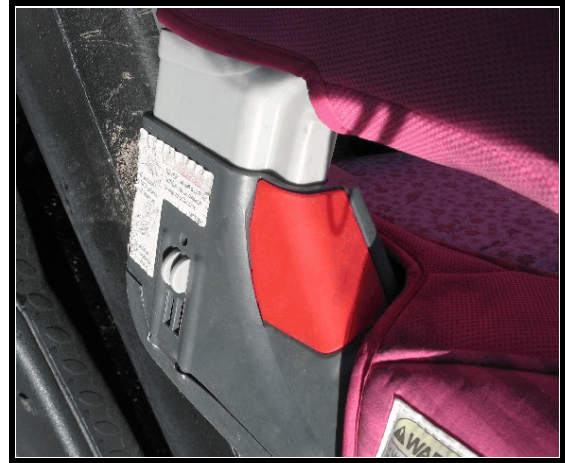
Figure 13. Loading marks to lower belt guide.

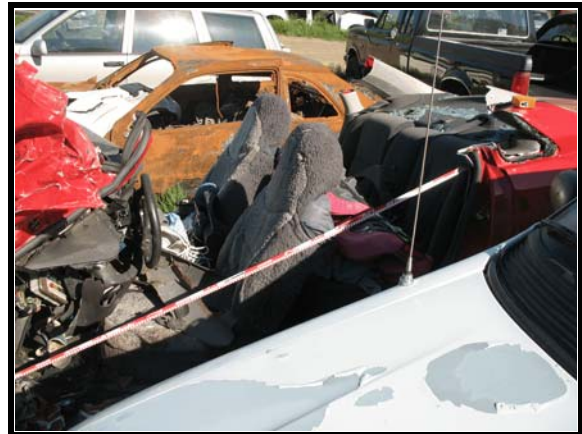
The 38-year-old female driver was seated in an unknown posture in the bucket seat and was restrained by her lap and shoulder belt (**Figure 14**). The seat was adjusted to the mid-track position. It was not known if the driver was able to execute any evasive maneuvers. At impact with the Dodge, the driver's frontal air bag deployed as the driver was displaced forward and to the left in response to the 11 o'clock direction of force. The driver's face loaded the air bag and both knees loaded the lower instrument panel/knee bolster, causing the left femur fracture and the right knee fracture. Skin transfers were located on the knee bolster. The driver's right foot and ankle contacted the toe pan area and sustained open fractures. The driver's torso loaded and fractured the steering wheel. The driver was displaced to the right and engaged the center console with her right hip. She sustained C1 or C2 neck fractures as a result of the impact force and lacerations/abrasions to both arms from an unknown source. The driver was found in her vehicle without a pulse and was pronounced dead at the scene.

Figure 14. Driver's seated position.

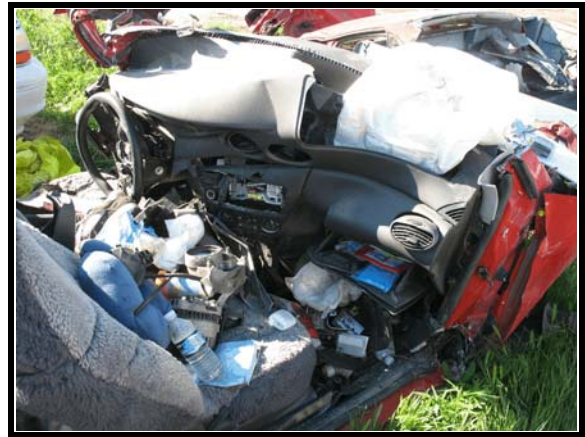
The 39-year-old male front right occupant was seated in the bucket seat in an unknown posture and was restrained by the manual lap and shoulder belt (**Figure 15**). The seat was adjusted to the mid-track position. At impact with the Dodge, the front right passenger's frontal air bag deployed as he was displaced forward and to the left in response to the 11 o'clock direction of force. He likely loaded the passenger air bag. He loaded the lap and shoulder belt, causing the flail chest, chest abrasions, and the abdominal abrasion. There were knee contacts to the center and right instrument panel. His left knee engaged the instrument panel causing an indirect left hip fracture. His right foot was on the floorboard and probably engaged the toe pan, causing the fracture. This passenger survived the crash for a short period of time. Volunteer first-responders were performing cardiopulmonary resuscitation (CPR) on this passenger when the police arrived. This effort was discontinued shortly after the arrival of the police and the front right passenger was pronounced dead at the scene.

Figure 15. Front right passenger's seated position.

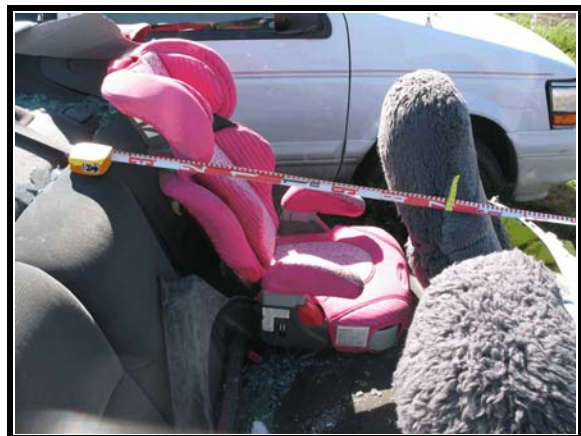
The 3-year-old female child was seated in a belt positioning booster seat that had been placed in the second row left seat position (**Figure 17**). The child was restrained by the vehicle's lap and shoulder belt. The belt had been routed through the upper left belt guide and across the lower seat guides and the retractor was in the ELR mode. At impact with the Dodge, the second row left passenger was displaced forward and to the left in response to the 11 o'clock direction of force. There was evidence of loading to the seat belt webbing and the belt guides. This passenger sustained abrasions to her upper left shoulder, chest, and abdomen. She was transported from the scene by ambulance to a local hospital.

Figure 16. Second row left passenger's seat position.
