# INDIANA UNIVERSITY

## **ON-SITE CERTIFIED ADVANCED 208-COMPLIANT VEHICLE INVESTIGATION**

CASE NUMBER - IN08017

VEHICLE - 2007 CHEVROLET TRAILBLAZER LS

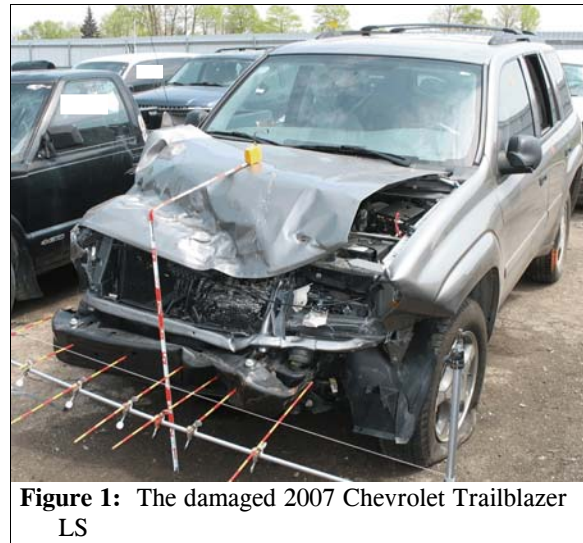
**Figure 1:** The damaged 2007 Chevrolet Trailblazer LS

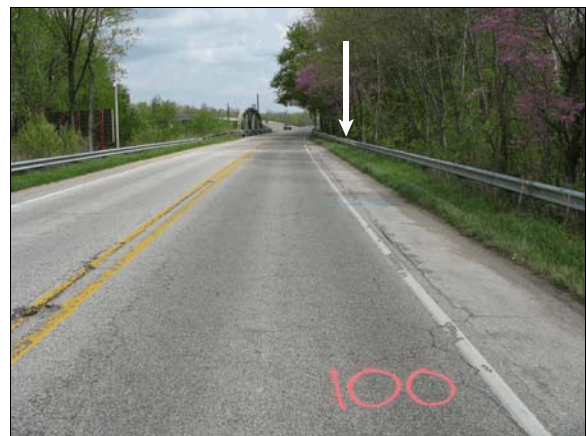
Figure 3: Northbound approach of Pontiac; arrow shows area of Pontiac's initial guardrail impact (guardrail had been replaced)

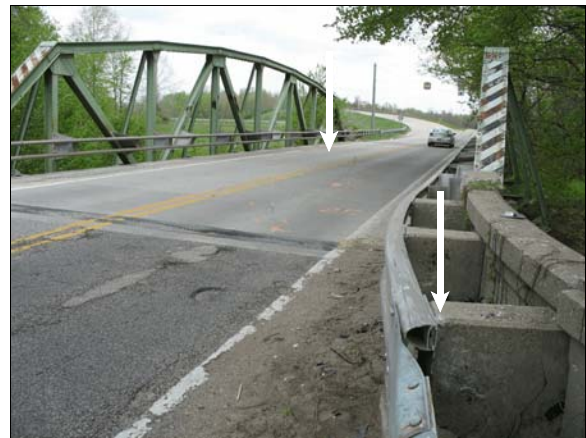
Figure 4: Arrow on right shows location of Pontiac's impact with end of east bridge rail and concrete bridge rail anchor, arrow on left shows area of impact with the Chevrolet

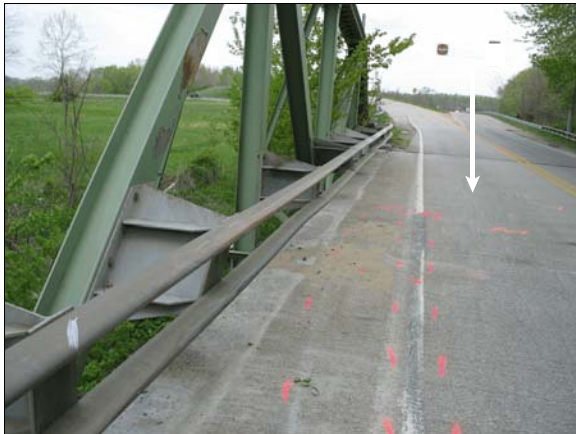
**Figure 5:** The back of Pontiac impacted the west bridge rail; arrow shows area of impact between front of the Chevrolet and left side of the Pontiac

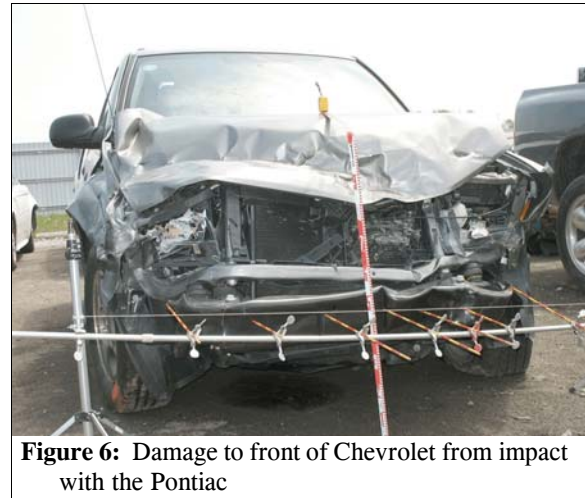
**Figure 6:** Damage to front of Chevrolet from impact with the Pontiac

**Exterior Damage:** The Chevrolet's front impact with the Pontiac involved the front of the vehicle. The bumper, bumper fascia, hood, right and left fenders, grille, and the right and left headlamp/turn light assemblies were directly damaged. The direct damage began at the front left bumper corner and extended 122 cm (48 in) across the full width of the bumper bar. The crush

measurements were taken on the bumper bar and the maximum residual crush was 18.0 cm (7.1 in) occurring 13 cm (5.1 in) right of C<sub>3</sub>. The table below shows the vehicle's crush profile for the front impact.

The vehicle's right side wheelbase was shortened 14.0 cm (5.5 in) and the left side wheelbase was shortened 4.0 cm (2.4 in). Induced damage involved both fenders, the hood and the right front door.

**Damage Classification:** The Chevrolet's Collision Deformation Classifications (CDC) were **12-FDEW-1 (0 degrees)** for the front impact and **03-RPEW-1 (90 degrees)** for the right front door impact. The Missing Vehicle algorithm of the WinSMASH program calculated the Chevrolet's total Delta V for the front impact as 23 km/h (14.3 mph). The longitudinal and lateral velocity changes were -23 km/h (-14.3 mph) and 0 km/h. The Missing Vehicle algorithm of the WinSMASH program calculated the Chevrolet's total Delta V for the right front door impact as 5 km/h (3.1 mph). The longitudinal and lateral velocity changes were 0 km/h and -5 km/h (-3.1 mph). The results for both runs were borderline because they are based only on the Chevrolet's crush profiles. The EDR recorded a maximum longitudinal velocity change for the front impact of -45.09 km/h (-28.02 mph).

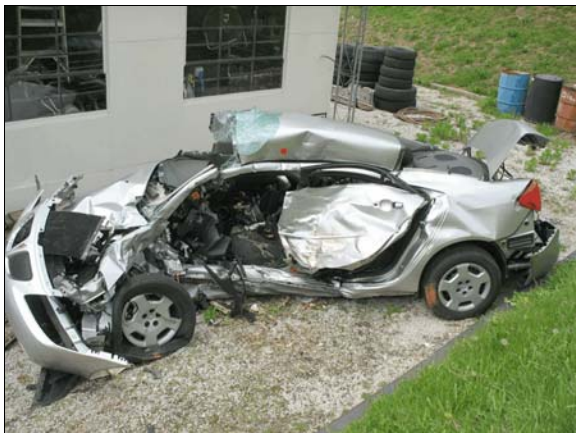
**Figure 7:** Damage to left side of Pontiac from impact with the Chevrolet

**Exterior Damage:** The Pontiac's impact with the Chevrolet involved the left side of the vehicle (Figure 7) . It sustained direct damage to the left

fender and both left side doors. Crush measurements could not be taken on the left side due to extensive alteration of the vehicle from rescue operations. Both left side doors had been cut off the vehicle, the left A and B pillars had been cut, and the B pillar displaced. The left front door was not present at the inspection. The front, entire right side and the back were extensively damaged due to the impact with the guard rail and bridge rails (**Figure 19**).

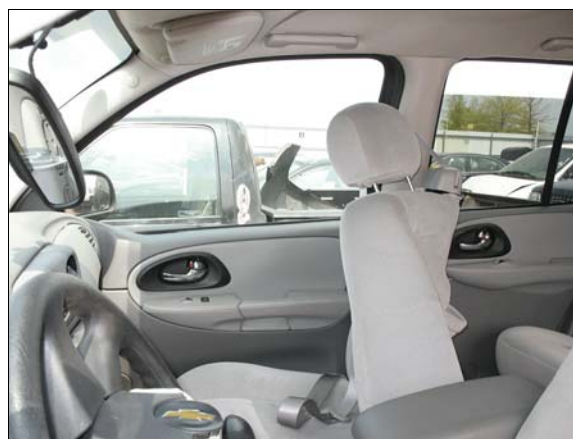
**Figure 10:** Deformation of the front right passenger seat back due to loading by the unrestrained second row right passenger

Inspection of the second row right passenger’s seat belt assembly revealed no evidence of loading. The passenger also loaded the front right seat back during the crash and bent it forward. The evidence indicated that the second row right passenger was not restrained. The remaining seat positions were unoccupied.

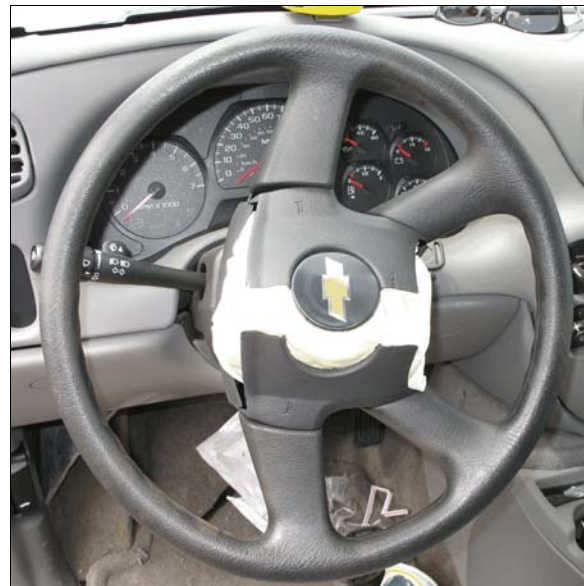
The Chevrolet's driver air bag was located in the steering wheel hub. The air bag module cover flaps (**Figure 11**) were constructed of vinyl, and the tear seams were configured horizontally across the top, bottom, and vertically down the middle. Each module flap was 7.5 cm (3 in) in width at the top, 4.3 cm (1.7 in) in width at the bottom and 13 cm (5.1 in) in height at the vertical tear seam. The cover flaps separated at the designated tear points during the deployment and there was no evidence of damage or occupant contact on the cover flaps or the air bag fabric. The deployed driver's air bag (**Figure 12**) was round with a diameter of 68 cm (26.8 in). The air bag was designed with four tethers and two vent ports.

**Figure 11:** Driver's air bag module cover flaps; steering wheel rotated counterclockwise 90 degrees

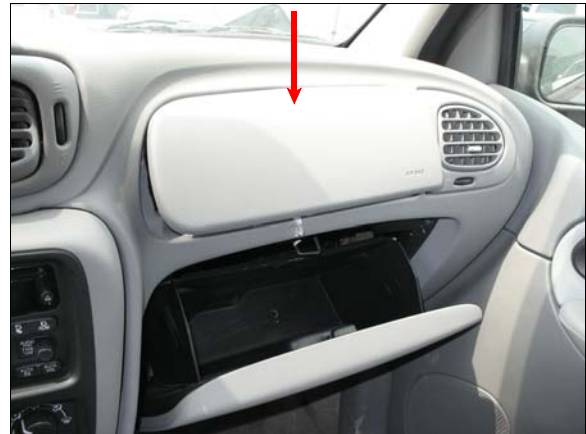
The front right passenger air bag was located in the middle of the instrument panel. The air bag module cover flap (**Figure 13**) was constructed of vinyl and hinged at the top. The cover flap was 33 cm (13 in) in width and 13 cm (5.1 in) in height. There was no evidence of damage or occupant contact on the cover flap or the air bag fabric. The deployed front right passenger air bag (**Figure 14**) was square with a length and width of 50 cm (19.7 in). The air bag was designed with one tether and two vent ports.

**Figure 13:** The front right passenger air bag module cover flap (arrow)

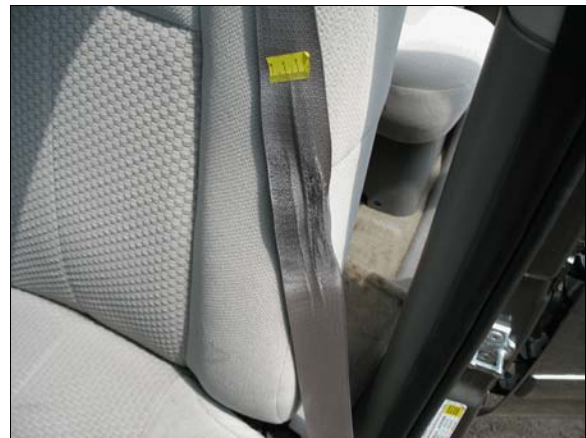
Inspection of the driver's seat belt assembly revealed load abrasions on the belt webbing (**Figure 15**), retractor housing (**Figure 16**), and the latch plate belt guide. While the EDR indicated that the pretensioner actuated, the retractor was not jammed and would retract the seat belt. The belt loading evidence indicated that the driver was restrained by the lap-and-shoulder belt.

**Figure 15:** Load mark on driver's seat belt

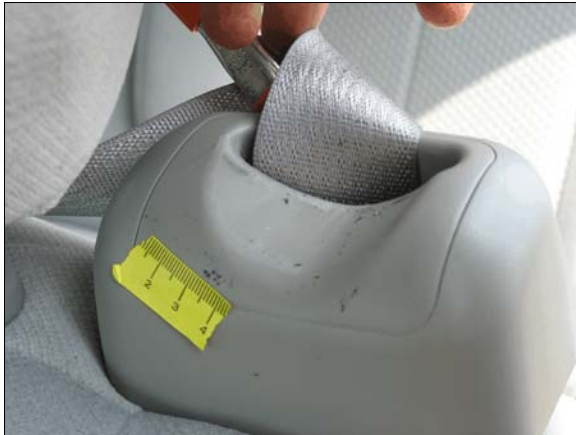
**Figure 16:** Load abrasions on driver’s seat belt housing

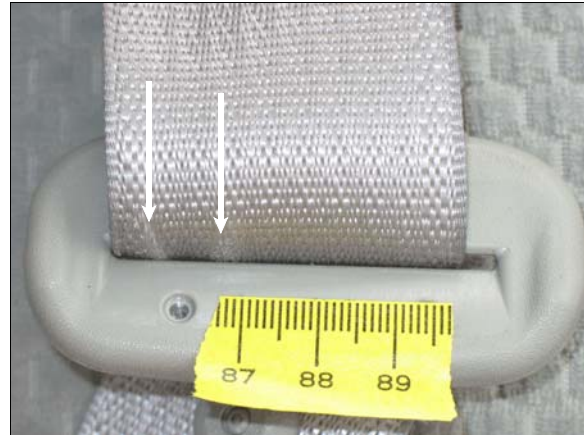
Inspection of the front right passenger's seat belt assembly revealed load abrasions on the belt webbing, latch plate belt guide (**Figure 17**), and retractor housing (**Figure 18**). The retractor was jammed indicating that the pretensioner actuated during the crash. The evidence indicated that the front right passenger was restrained by the lap-and-shoulder belt.

**Figure 17:** Load abrasions on front right seat belt webbing (arrows) and latch plate

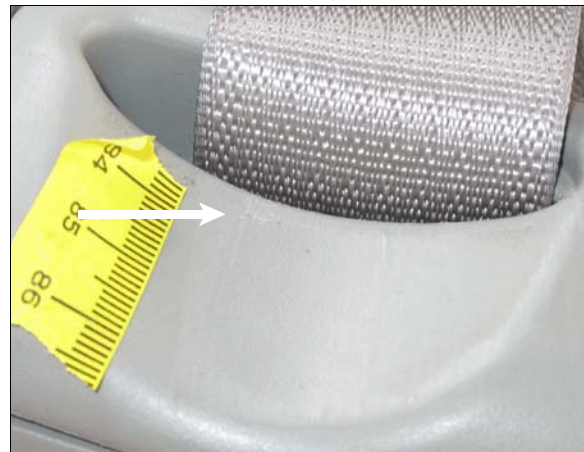
**Figure 18:** Load abrasions on the front right passenger’s seat belt housing (arrow)

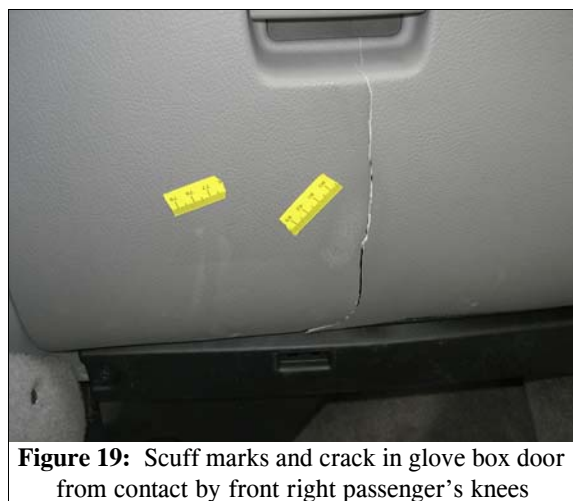
**Figure 19:** Scuff marks and crack in glove box door from contact by front right passenger's knees

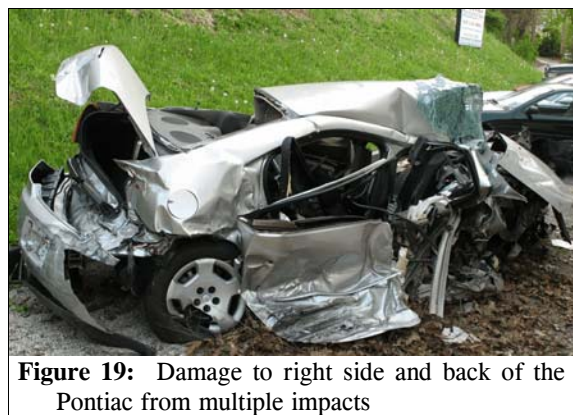
**Figure 19:** Damage to right side and back of the Pontiac from multiple impacts
