Remote Not In Traffic Surveillance Back Over Investigation
Dynamic Science, Inc. (DSI), Case Number DS08017
2000 Ford Expedition
Utah
March 2008

1. Report No. DS08017		2. Government Accession No.		3. Recipient Catalog No.	
4. Title and Subtitle Remote Not In Traffic Surveillance Back Over Investigation				5. Report Date January 20, 2009

Dynamic Science, Inc.
Crash Investigation
Case Number: DS08017

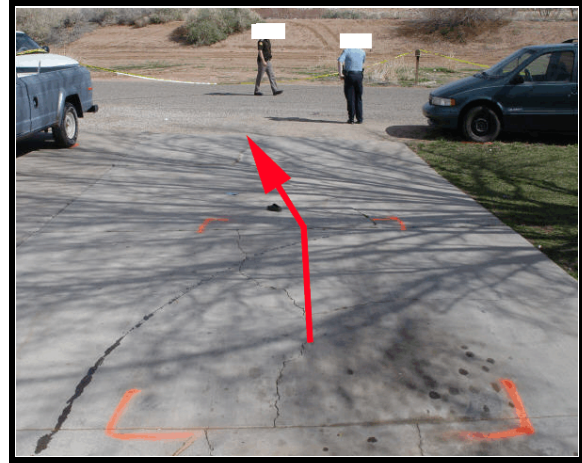
Figure 2. Backing path of Ford Expedition (north)

This incident took place at the end of a private driveway (**Figure 2**). A single family residence was located at the south end of the driveway. The driver of the 2000 Ford Expedition had pulled into the left side driveway to drop his mother off at her residence. The Expedition was facing south at that time. A second vehicle was parked in the right side of the driveway, also facing south. The concrete driveway was straight and oriented in a north/south direction. The end of the driveway intersected with a curved, gravel-covered residential roadway. The driveway had a slight downward grade. The driveway was approximately 9.1 m (30 ft) long and 6.7 m (22 ft) wide. According to the nearest reporting station, the temperature was 12 degrees C (53.6 degrees F), the humidity was

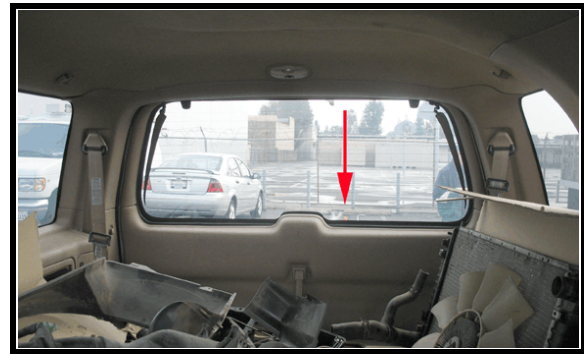
Figure 4. View through backlight from driver's seat; arrow shows target (exemplar vehicle)

The exterior of the Ford was white in color. The glazing was clear and the side/backlight glazing were tinted. There was a label affixed to the center of the backlight that partially obstructed the driver's view to the rear.

The initial set of measurements were taken with the investigator looking over his right shoulder through the backlight (**Figure 4**). The target was moved aft of the rear bumper along the vehicle's centerline until it became visible to the investigator. The point at which the target became visible to the investigator measured 4.57 m (15 ft) aft of the rear bumper. That measurement was used as the point of origin for two sets of lateral measurements which were then taken. Measurements taken laterally to the left and right resulted in a visible zone that could be viewed through the backlight. The lateral measurements were taken from the vehicle's center line to the left and right sides of the backlight until the target was out of view due to the presence of the D-pillars. The target was out of view due to the left D-pillar at a distance of 1.25 m (3.28 ft) lateral to the vehicle's longitudinal center. The target was out of view due to the right D-pillar at a distance of 2.75 m (8.86 ft) lateral to the vehicle's longitudinal center. At 4.57 m (15 ft) aft of the rear bumper, the visible zone from the left D-pillar to the right D-pillar measured 4 m (13.12 ft) in width. The roadway surface became visible to the at 9.14 m (30.0 ft) aft of the rear bumper.

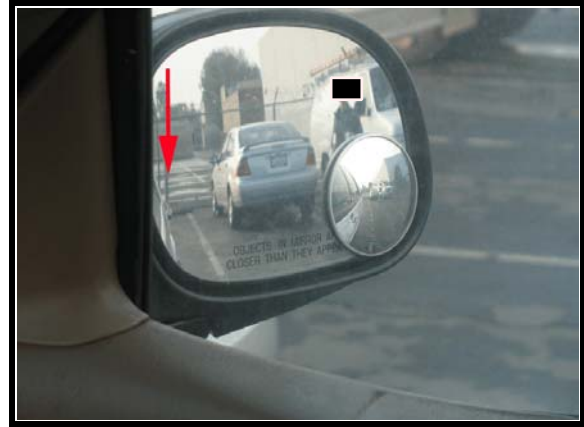
Figure 5. View through right side view mirror from driver's seat, arrow shows target where it begins to enter the mirror's lateral field of view (Note: convex mirror not present on subject vehicle)

A fourth set of measurements were then taken to calculate the left and right lateral visible zones when using the side view mirrors. From a seated posture, the side views were examined. Since the SCI investigator was using an exemplar vehicle, he adjusted the side mirrors appropriately for the driver's seated eye height. The target was placed at the left rear bumper. The target was moved further to the left until the target became visible through the left side view mirror. The target was then moved laterally to the left until the target was no longer visible. These measurements resulted in a visible zone which could be viewed through the side view mirror. This process was repeated on the right side of the vehicle (**Figure 5**). The visible zone lateral to the left bumper measured 86 cm (2.82 ft) in width. The visibility zone lateral to the right bumper measured 1.36 m (4.46 ft) in width. The area between the left and right visible zones resulted in a blind zone which measured 2.04 m (6.6 ft) in width. The vehicle's maximum width measured 2 m (6.56 ft).

The target was then placed at 4.57 m (15.0 ft) aft of the rear bumper. Lateral measurements were taken to the left and right to the points at which the investigator could view the target through the side view mirrors. The area between the left and right visible zones resulted in a blind zone. At 4.57 m (15.0 ft) aft of the rear bumper, the left and right lateral visible zones measured 1.88 m (6.17 ft) and 3.26 m (10.7 ft), respectively. The blind zone measured 1.89 m (6.2 ft) in width. The width of the nominal blind zone when using the side view mirrors diminished approximately 15 cm (5.9 in) at a distance of 4.57 m (15.0 ft) aft of the rear bumper versus at the rear bumper.

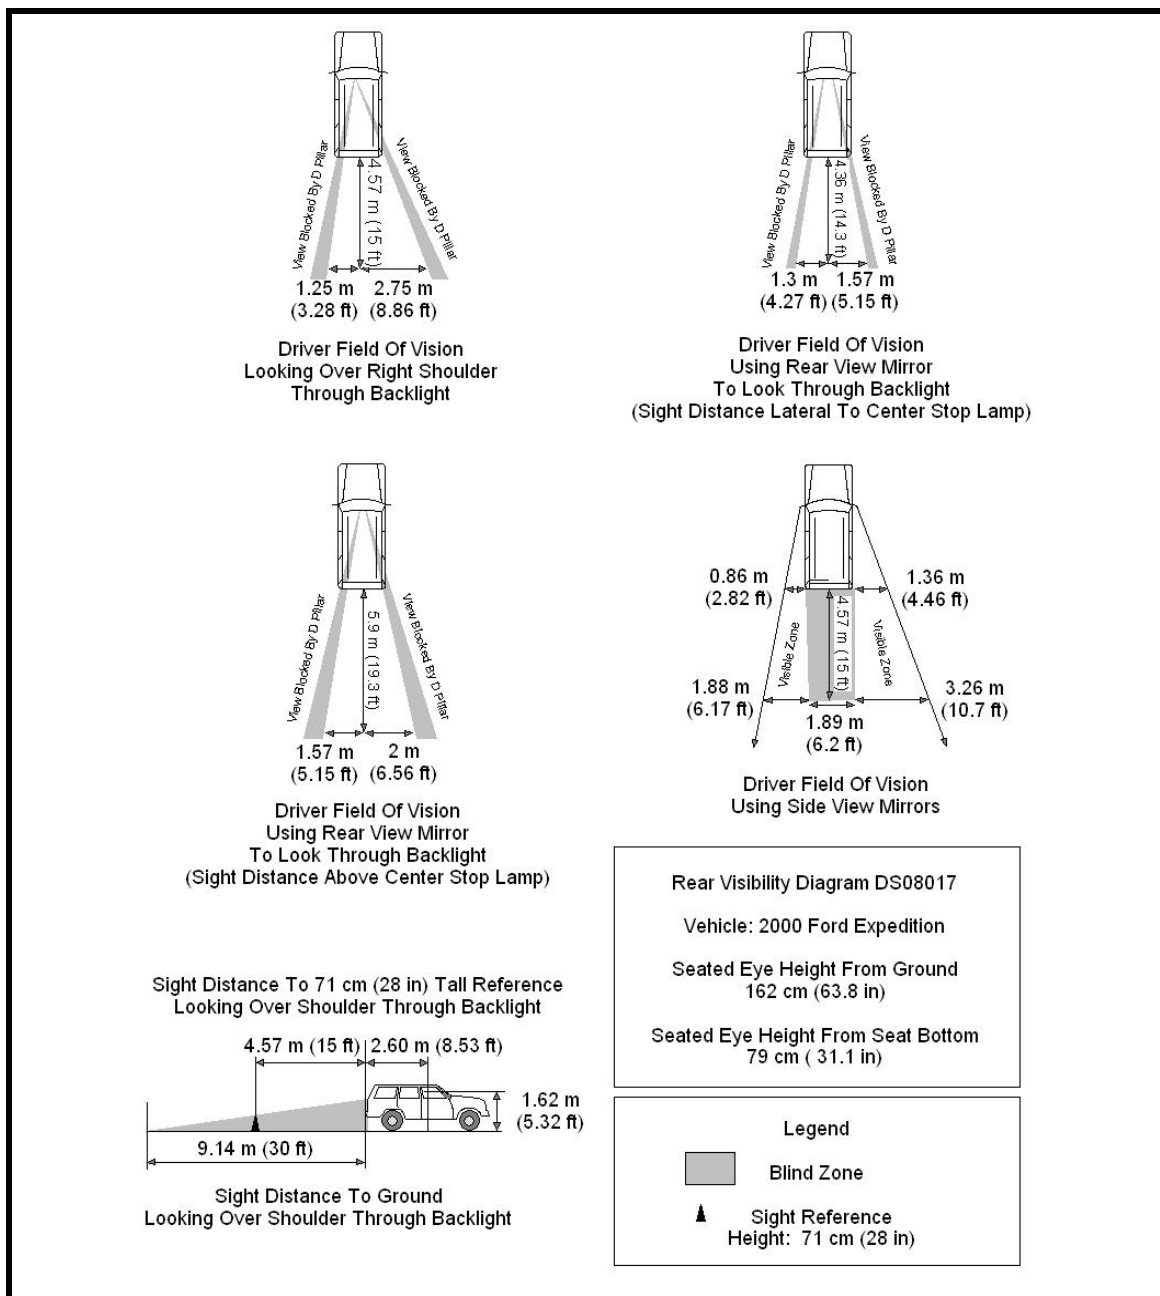
Figure 6. Nominal visibility diagram

A visibility study was conducted in order to determine the nominal blind zone behind the vehicle as well as the nominal blind zone of both side view mirrors. Measurements were taken using an exemplar 2000 Ford Expedition with the second seat folded down. The status of the second seat in the subject vehicle was not known. The standard 71 cm (28 in) high target was used to obtain the measurements. The measurements were taken on a paved level surface.

centerline until it became visible above the center stop lamp. The point at which the target became visible to the investigator measured 5.9 m (19.3 ft) aft of the rear bumper. That measurement was used as the point of origin for a set of lateral measurements which were then taken. Measurements taken laterally to the left and right would result in a visible zone that could be viewed through the backlight. The lateral measurements were taken from the vehicle's center line to the left and right sides of the backlight until the target was out of view due to the presence of the D-pillars. The target was out of view due to the left D-pillar at a distance of 1.57 m (5.15 ft) lateral to the vehicle's longitudinal center. The target was out of view due to the right D-pillar at a distance of 2 m (6.56 ft) lateral to the vehicle's longitudinal center. At 5.9 m (19.3 ft) aft of the rear bumper, the visible zone from the left D-pillar to the right D-pillar measured 3.57 m (11.71 ft) in width.

A third set of measurements were taken as the investigator used the rear view mirror to view the target through the backlight and slightly lateral to the center stop lamp. When the investigator used the rear view mirror to look through the backlight, the view down the vehicle's centerline was obscured by the vehicle's center stop lamp. The target was moved aft of the rear bumper and slightly lateral to the stop lamp until it became visible to the investigator. The point at which the target became visible to the investigator measured 4.36 m (14.3 ft) aft of the rear bumper. That measurement was used as the point of origin for a set of lateral measurements which were then taken. Measurements taken laterally to the left and right would result in a visible zone that could be viewed through the backlight. The lateral measurements were taken from the vehicle's center line to the left and right sides of the backlight until the target was out of view due to the presence of the D-pillars. The target was out of view due to the left D-pillar at a distance of 1.3 m (4.27 ft) lateral to the vehicle's longitudinal center. The target was out of view due to the right D-pillar at a distance of 1.57 m (5.15 ft) lateral to the vehicle's longitudinal center. At 4.36 m (14.3 ft) aft of the rear bumper, the visible zone from the left D-pillar to the right D-pillar measured 2.87 m (9.42 ft) in width.
