CALSPAN ON-SITE CERTIFIED ADVANCED 208-COMPLIANT VEHICLE

SCI CASE NO.: CA08018

VEHICLE: 2007 HONDA ACCORD

CRASH DATE: MARCH 2008

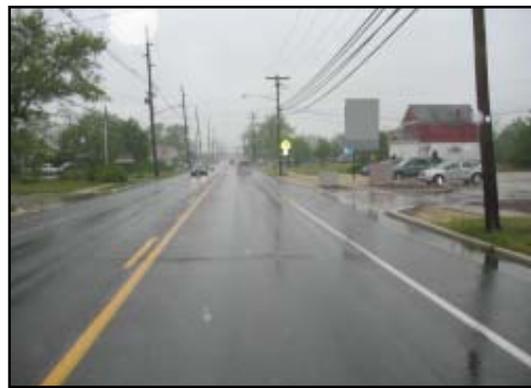
Figure 2. Honda's southbound pre-crash travel.

The 79-year old female driver of the 2007 Honda Accord was traveling in a southerly direction on the two-lane road approaching a four-leg intersection (**Figure 2**). The driver stated to the SCI investigator that as she neared the intersection, she applied the brakes for a slowing vehicle ahead. However, when she applied the brakes, she felt like the vehicle was not slowing. As she closed in on traffic ahead, she applied a right steering input and departed the right travel lane and entered the shoulder. The vehicle traversed the

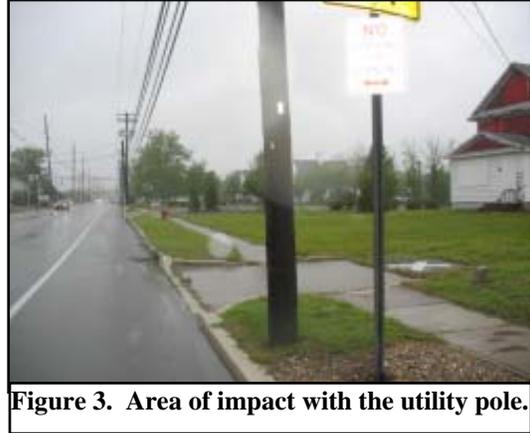
Figure 3. Area of impact with the utility pole.

The front right corner of the Honda impacted a 26 cm (10.2”) diameter wooden utility pole that was located on the gravel landscaped area (**Figure 3**) 0.5 meters (1.6”) outboard of the curb. The area of contact was outboard of the front right frame rail. The corner of the frontal structure crushed as the vehicle continued forward. The right side of the Honda engaged the pole involving the front right wheel, suspension components, and right A-pillar. The pole pocketed at the area of the A-pillar which induced a clockwise rotation. The Honda rotated approximately 140 degrees clockwise as it separated from the pole prior to coming rest on the west shoulder facing a northwesterly direction. The direction of force was 12 o’clock for this fixed object impact. The front of the vehicle yielded 3 cm (1”) of crush at the right corner of the bumper beam. No crush was present along the remainder of the bumper beam. A common velocity was not obtained between the front and right side engagements; therefore this crash was outside the scope of the WINSMASH program. Based on SCI experience, this contractor estimates that the delta-V was approximately 25 km/h (15 mph).

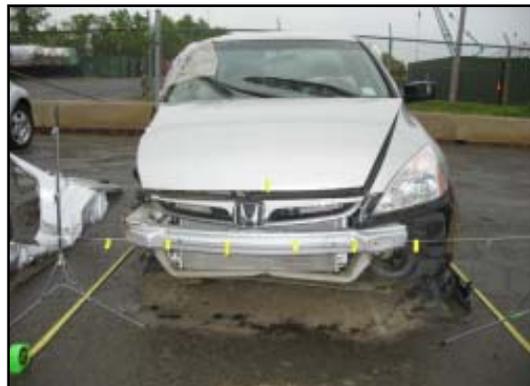
Figure 4. Resultant front damage.

The 2007 Honda Accord sustained moderate damage to the front and right side planes as a result of the impact with the utility pole (**Figure 4**). The damaged components included, but were not limited to, the bumper fascia, bumper beam, hood, right fender, right

front door, and the right front wheel and suspension components. The impact occurred outboard of the front right frame rail with the direct contact damage beginning 42 cm (16.5") right of the vehicle's centerline, extending 23 cm (9") to the right corner of the bumper fascia. Direct contact damage was also present on the bumper beam. The direct contact measured 6 cm (2.3"), beginning 55 cm (21.6") right of the centerline and extended to the right corner. The maximum crush measured 3 cm (1") and was located on the right corner of the bumper beam. A crush profile was documented along the bumper which was as follows: C1 = 0 cm, C2 = 0 cm, C3 = 0 cm, C4 = 0 cm, C5 = 0 cm, C6 = 3 cm (1").

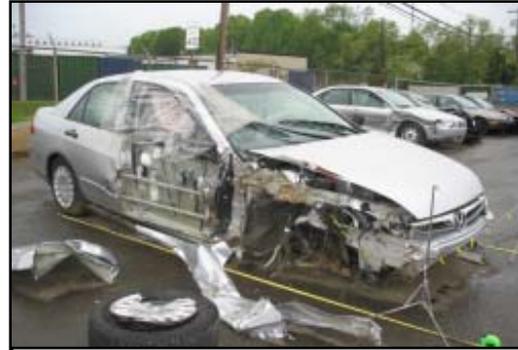
Figure 5. Damage to the right side of the Honda.

Due to the corner impact, the direct contact damage extended down the right plane of the vehicle (**Figure 5**). The direct contact damage began on the leading edge of the right fender and extended down the right side 142 cm (56") onto the right front door. Lateral deformation was present to the right fender which was approximately 13 cm (5") in depth. This deformation occurred as the vehicle continued its forward momentum while engaged with the pole. As the vehicle reached maximum engagement, the pole pocketed at the area of the A-pillar. The Collision Deformation Classification (CDC) for the pole impact was 12-FREE-6.

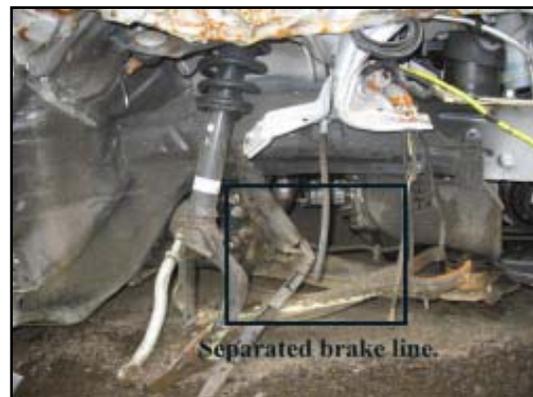
Figure 6. Separated right front brake line.

the master cylinder and brake booster, to the Anti-lock Brake System (ABS) control unit, and to the wheels. The brake lines for the left front, left rear, and the right rear brakes were unremarkable. At the right front wheel, the steel brake line transitioned to a flexible hose for connection to the brake caliper. During the right plane engagement with the pole, the right front wheel and suspension components separated, thus separating the brake hose from the caliper (**Figure 6**).

The brake fluid reservoir was inspected for adequate fluid level and was found to be in the lower third of the reservoir. The visual inspection did not reveal a malfunction of the braking system. A mechanical malfunction did not appear likely for this late model vehicle; however, it could not be ruled out.

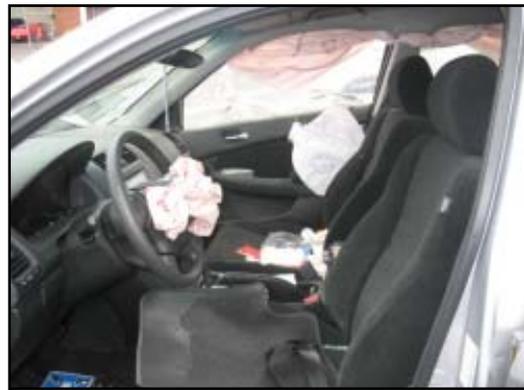
Figure 7. Overall view of the driver's area.

The driver’s contact points consisted of a red colored transfer on the face of the air bag membrane at the six o’clock position and a black colored transfer on the air bag membrane immediately right of center. A possible contact point was noted to the rear view mirror. The mirror was located facing downward which may have resulted from contact with the driver’s right hand. The restraint usage by the driver prevented her from possible further contact with interior components of the vehicle.

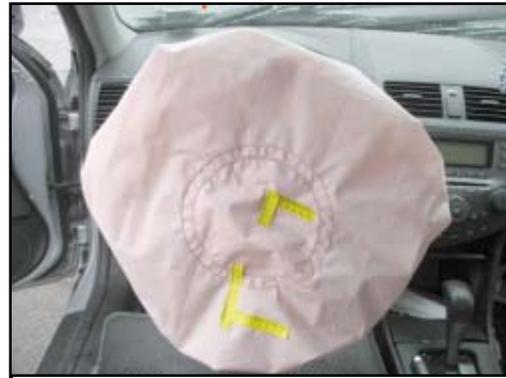
Figure 8. Deployed driver's air bag (contact points in yellow tape).

The driver's face contacted the air bag membrane as evidenced by two transfers. A reddish colored (possible make-up) transfer was located on the face of the air bag 11-14 cm (4.3-5.5") below the center and 1-6 cm (0.4-2.4") right of the centerline. A second transfer that was black in color was present on the face of the membrane. This transfer was either contact from the driver or an expansion transfer from the cover flap. The transfer was located 1-2 cm (0.4-0.8") above the center and 1-5 cm (0.4-1.9") right of the centerline. **Figure 8** is an overall view of the driver's air bag and contact points.

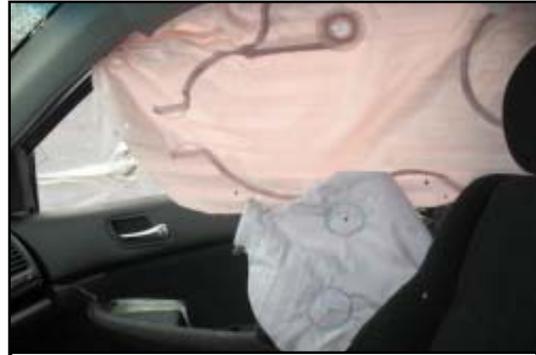
Figure 9. Seat back mounted and curtain air bag.

The right curtain air bag deployed from the roof side rail. The air bag membrane measured 167 cm (65.7") in length. At the right front seating position, the membrane measured 39 cm (15.4") in height extending 8 cm (3.1") below the top of the door panel. The height of the curtain air bag membrane at the left rear position was 37 cm (14.6") and extended 2 cm (0.9") below the top of the door panel. The height of the curtain air bag membrane provided head protection from the roof side rail to the belt line of the vehicle. The curtain air bag overlapped the seat back mounted air bag by 7 cm (2.8") in the deflated state. The curtain air bag was not tethered to the A- and C-pillars. Longitudinally, the coverage area of this curtain air bag did not completely span across the right front glazing. A triangular shaped void was present between the curtain air bag and the A-pillar. The maximum length of the void was 41 cm (16.1"). In its deflated state, the air bag membrane overlapped the C-pillar approximately 10 cm (4") providing protection beyond the rear glazing area. Occupant contact points or damage did not occur to the curtain air bag. **Figure 9** depicts the deployed seat back and curtain air bags.

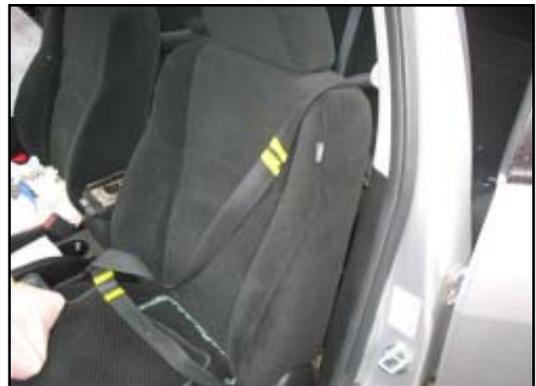
Figure 10. Driver's safety belt.

The driver utilized the safety belt during the crash which was supported by loading evidence on the lap and shoulder portions of the webbing and the latch plate. As a result of the crash, the retractor pretensioner actuated which retracted a portion of the safety belt as the driver loaded the belt system. The combination of the driver loading and the actuation of the pretensioner resulted in frictional abrasions on the webbing near the D-ring, and latch plate. The driver loading also resulted in two creases to the belt webbing near the latch plate 67-71 cm (23.4-28") above the outboard anchor and near the driver's shoulder, 140 cm (55.1") above the anchor.
