Side Curtain Air Bag Investigation
Dynamic Science, Inc. (DSI), Case Number DS08021
2006 Ford Explorer
Washington
June 2008

1. Report No. DS08021	2. Government Accession No.		3. Recipient Catalog No.	
4. Title and Subtitle Side Curtain Air Bag Investigation			5. Report Date May 19, 2009

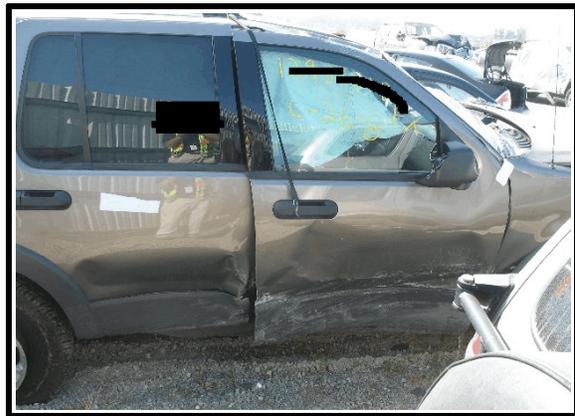
The damage to the right side was the result of the impact with the BMW (**Figure 4**). The direct damage began 16 cm (6.3 in) forward of the rear axle and extended 270 cm (106.3 in) forward along the right side plane. The damage was concentrated low along the sill area. The field L began 10 cm (3.9 in) forward of the rear axle and extended 278 cm (109.4 in) forward along the right side plane. Six crush measurements were taken at the sill level as follows: C1 = 0 cm, C2 = 6 cm (2.4 in), C3 = 10 cm (3.9 in), C4 = 16 cm (6.3 in), C5 = 5 cm (1.9 in), C6 = 0 cm. The maximum crush was located at C4. The CDC for the impact with the BMW was 02RZEW2.

Figure 4. Right side damage

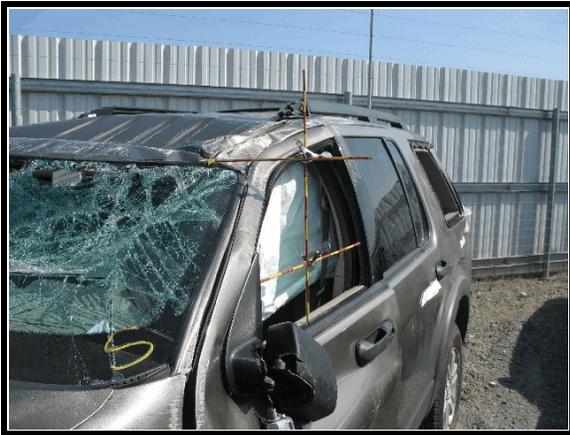
There was damage to the top and the left side planes from the rollover event (**Figures 5-6**). There was 317 cm (124.8 in) of direct contact along the left side that began 64 cm (25.1 in) forward of the front axle and extended rearward to include the left fender and left side doors. The damage extended vertically 91 cm (35.8) to the middle of the doors from the left roof side rail. There was direct damage to the hood that was 157 cm (61.8 in) wide and extended rearward 88 cm (34.6 in) rearward from the hood edge. The damage was 124 cm (48.8 in) wide across the roof and extended 104 cm (40.9 in) rearward from the windshield header edge. Both luggage rails were cracked. The maximum vertical crush to the left roof was located 29 cm (11.4 in) from the left side rail, and

measured 12 cm (4.7 in) vertically. The Collision Deformation Classification (CDC) for the rollover event was 00TDYO3.

Figure 5. Maximum vertical crush

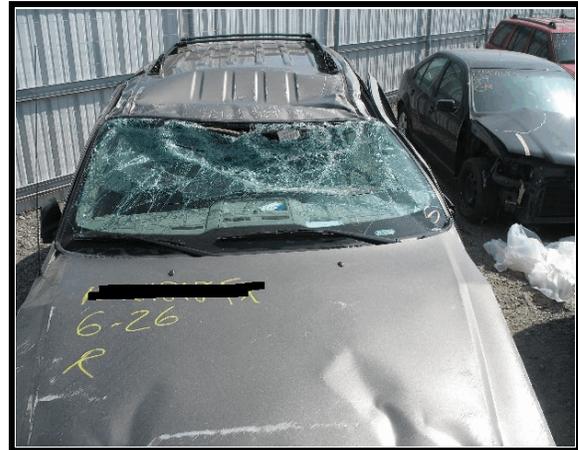
Figure 6. Rollover damage to top

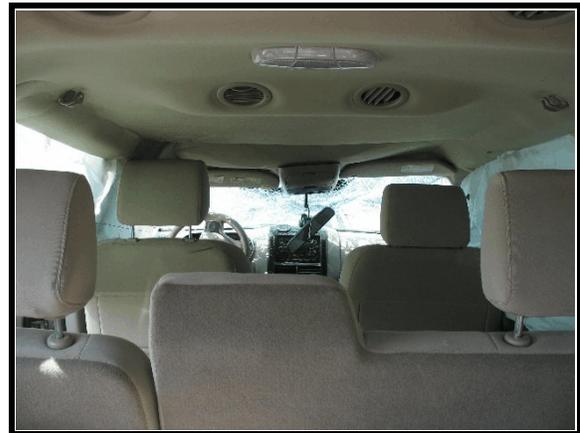
The Ford sustained moderate interior damage as a result of passenger compartment intrusion. There was vertical intrusion into the passenger compartment from both A-pillars, the roof, the windshield header, and the roof side rails (**Figure 7**).

Figure 7. Overview of intrusion

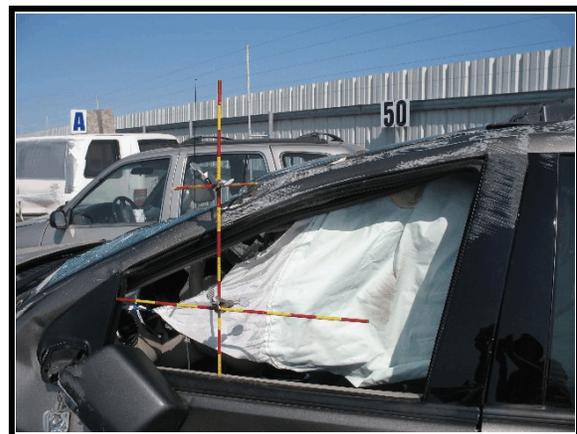
Figure 8. Damage to curtain exterior

The outboard aspect of the side curtain air bag at the driver's position sustained two areas of abrading contact with the roadway surface (**Figure 8**). The larger contact was located 22 cm (8.7 in) from the leading edge of the air bag and was 8-10 cm (3.1-3.9 in) wide by 30 cm (11.8 in) high. The smaller contact was located at 9 cm (3.5 in) from the front edge of the air bag and was approximately 2 cm (0.8 in) wide by 17 cm (6.7 in) high.

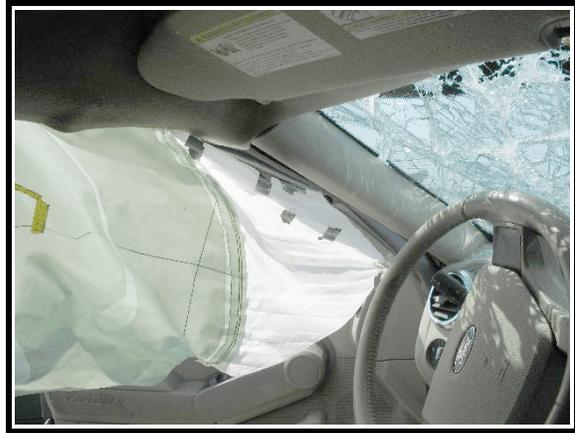
Figure 9. Contact to interior portion of curtain

There was a possible occupant contact from the driver located on the inboard aspect of the air bag at the driver's position (**Figure 9**). The contact was a dark linear transfer that measured 6 cm (2.4 in) high by 5 cm (1.9 in) wide and was located 10 cm (3.9 in) from the top of the curtain and 27 cm (10.6 in) rear of the front edge of the curtain.
