Child Safety Seat Investigation
Dynamic Science, Inc. (DSI), Case Number DS08025
1997 Honda Accord SE
California
June 2008

1. Report No. DS08025	2. Government Accession No.	3. Recipient Catalog No.	
4. Title and Subtitle Child Safety Seat Investigation		5. Report Date June 12, 2009

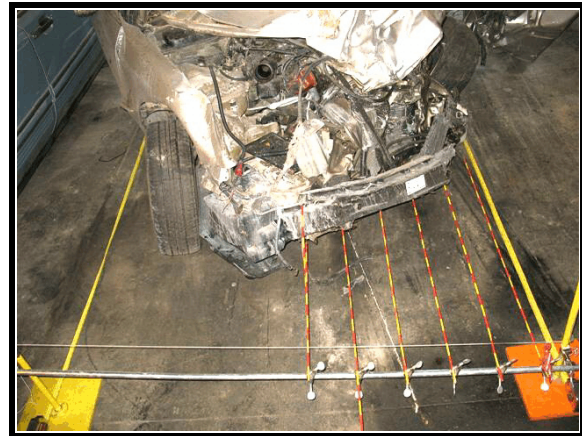
Figure 5. Crush measurements at mid bumper level, subject vehicle

Six crush measurements were taken at bumper level (**Figure 5**). The crush measurements were as follows: C1 = 108 cm (42.5 in), C2 = 94 cm (37.0 in), C3 = 88 cm (34.7 in), C4 = 63 cm (24.8 in), C5 = 37 cm (14.6 in), C6 = 29 cm (11.4 in). Maximum crush was located at C1 and measured 108 cm (42.5 in). There was also significant crush to the grille and hood. Based on National Automotive Sampling System (NASS) protocols for underride impacts, above bumper crush measurements were taken at the upper radiator support (**Figure 6**) and were as follows: C1 = 115 cm (45.3 in), C2 = 108 cm (42.5 in), C3 = 103 cm (40.6

in), C4 = 93 cm (36.6 in), C5 = 76 cm (29.9 in), C6 = 46 cm (18.1 in). Maximum crush was located at C1 and measured 115 cm (45.3 in). Per NASS protocol, the two sets of measurements were then averaged, the results of which follow: C1 = 108 cm (42.5in), C2 = 101 cm (39.8 in), C3 = 96 cm (37.8 in), C4 = 78 cm (30.7 in), C5 = 57 cm (22.4 in), C6 = 38 cm (15.0 in). The Collision Deformation Classification (CDC) for the impact was 01FDEW5.

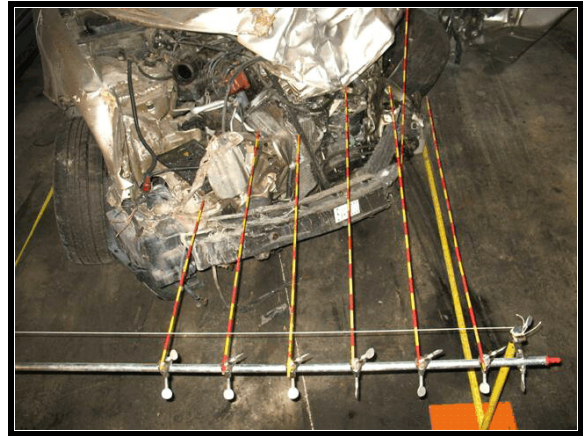
Figure 6. Crush measurements at above bumper level, subject vehicle

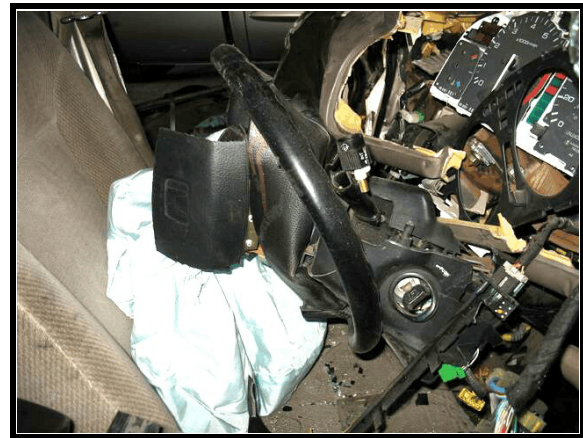
The Honda sustained severe interior damage as a result of passenger compartment intrusion and integrity loss. The vehicle sustained integrity loss of the windshield, roof, roof glass, side door, and side window. The left front door sustained damage to the hinges and structure, and came open during the crash. The left rear, right front, and right rear doors were jammed shut. The windshield was out of place and holed. The left front and rear side window glazing disintegrated. The steering column was displaced downward and the steering wheel rim was deformed an indeterminate distance in all four quarters. The upper aspect of the steering wheel rim was 25 cm (9.8 in) from the seat back (Figure 7).

Figure 7. Intrusion and deformation of steering wheel and column

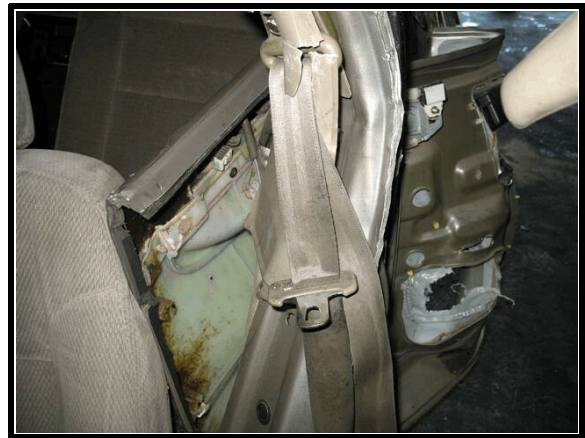
The driver's belt was used to restrain the driver and the D-ring was in the full down position. The anchorage assembly at the B-pillar was fractured during the crash (**Figure 8**). The retractor was broken and the belt was unretracted. The belt was scuffed and abraded over a 12 cm (4.7 in) long section of the belt webbing. The fractured B-pillar cover was determined to be the source of the damage to the belt. The belt was soiled and contained dried body fluids.

Figure 8. Driver's safety belt showing fracture of B-pillar cover

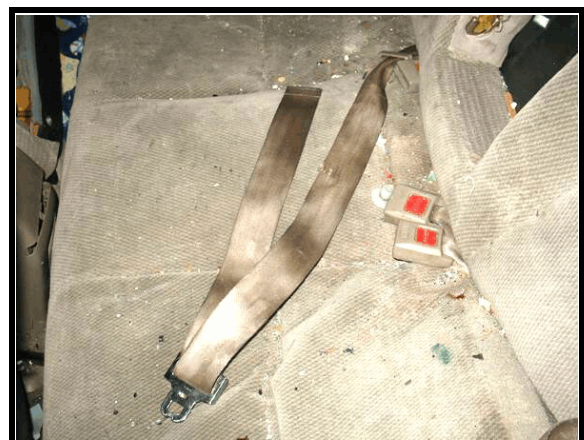
The second row middle seat was equipped with a manual lap belt and a locking latch plate (**Figure 9**). The lap belt was used to secure a rear facing CSS. The belt was routed through rear facing slots in the seat's frame. The SCI investigator found the belt routed through the CSS and buckled at the time of the vehicle inspection. There was significant slack in the belt and the CSS was leaning toward the right side of the vehicle.

Figure 9. Second row center lap belt, used to secure a Baby Trend infant safety seat

The belt had an uneven cut or tear along one edge where it was routed through the CSS belt path. The belt was creased and folded where it passed through a positioning collar at the seat bight.

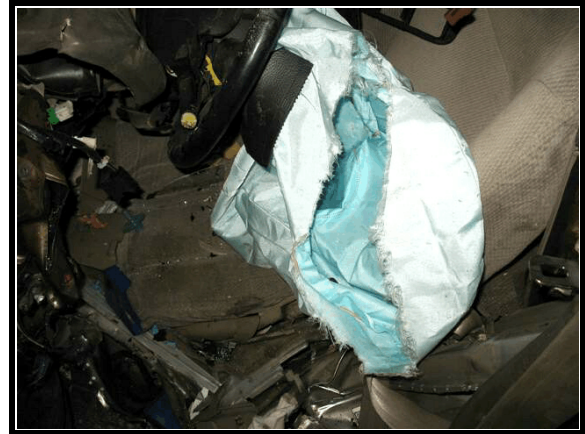
Figure 10. Driver's frontal air bag, showing tear down left side

The driver's air bag sustained a tear on the forward aspect, near the outer seam. The tear began in the upper left quadrant near the 12 o'clock position, extended 45 cm (17.7 in) downward and to the left, and ended at the bag's lower left quadrant (**Figure 10**). There was a second tear located near the outer seam on the lower left quadrant which measured 3 cm (1.2 in) in length. The source of the damage was unknown. There was dried blood on the upper right quadrant of the air bag which was a suspected occupant contact. The blood covered an area of 3 cm by 5 cm (1.2 by 2.0 in) and was located 15 cm (5.9 in) from the bag's front center. There was a dark smear, which was suspected to be a makeup transfer, that measured 3 cm (1.2 in) in length and was located 20 cm from the bag's center in the upper left quadrant.

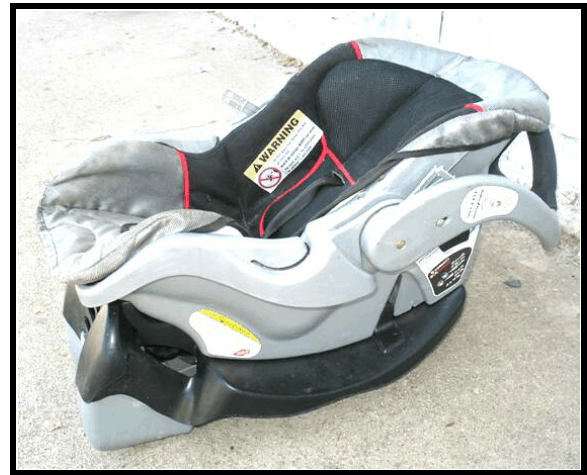
The second row middle occupant was a 4-month-old male child in a Baby Trend Flex-Loc rear facing infant CSS (**Figure 11**). The model number was 6364B and the date of manufacture was 12/04/2007. The seat was equipped with a 5-point harness, a retainer clip, and a lower buckle. The shoulder straps were routed through a single set of slots. The left strap was twisted where it passed through the slot. The seat was equipped with lower LATCH hardware but not an upper tether strap. The seat was equipped with an adjustable base and an adjustable headrest. There was an angle indicator on the side of the seat frame to assist in installation. The indicator was configured with separate markers for children weighing above or below 9 kg (20 lb). The seat had a pivoting carrier handle, which was found in the up position at the time of the inspection.

Figure 11. Baby Trend Flex-Loc infant safety seat

An investigation of the CSS revealed stress and loading evidence in several locations, specifically on the right side belt paths of the base and the CSS. During the inspection it was observed that the fixed length lap belt remained buckled and the webbing was routed through the rear facing belt paths of the child seat base. However, the CSS moved significantly to the right during the impact. It is possible that this was the result of an unlocked latch plate. Historical evidence shows that when an CSS is used in combination with a locking latch plate, the most common misuse has been that the latch plate does not lock. This can be overcome by using a locking clip, which was not used in this crash, or by twisting the latch plate one revolution to allow the bar to lock in the webbing. Based on the post-crash investigation of the CSS, neither of these steps was followed. Associative loading marks were also present within the belt path and on the belt webbing, indicative of stress being placed on these components and a partial un-spooling of the webbing through the latch plate.

Additionally, the belt paths on the child seat itself revealed considerable loading evidence and a crack at the base of the right path. Due to the belt still being engaged within the belt paths of the base during the inspection, it was determined that the CSS belt paths were not used. However, considering the marked belt loading evidence to the CSS belt paths, it is probable that the CSS was involved in a prior crash.

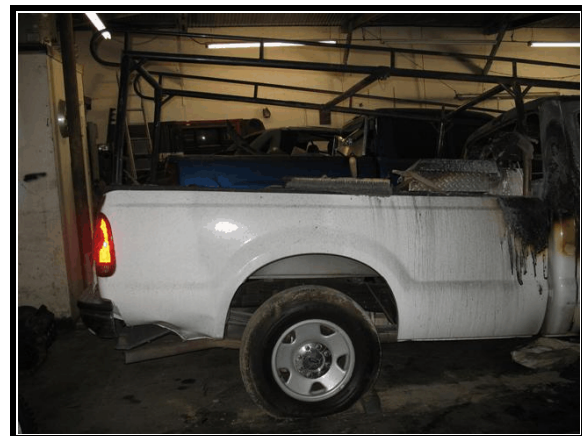
The Ford sustained minor damage to the right rear fender as a result of the impact with the guardrail (**Figure 13**). The CDC for the guardrail impact was 01RBEW1.

Figure 13. Right side damage
