Certified Advanced 208 Compliant Air Bag Investigation
Dynamic Science, Inc. (DSI), Case Number DS08027
2008 Smart Fortwo Passion
Washington
July 2008

Dynamic Science, Inc.
Crash Investigation
Case Number: DS08027

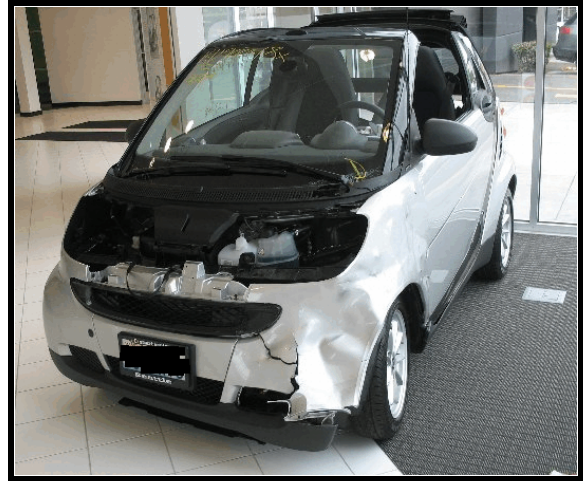
Figure 1. Subject vehicle, 2008 Smart Fortwo Passion

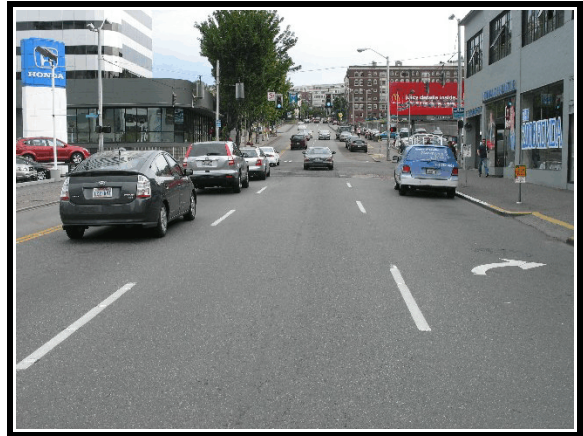
Figure 3. East approach for the 2008 Dodge Caravan

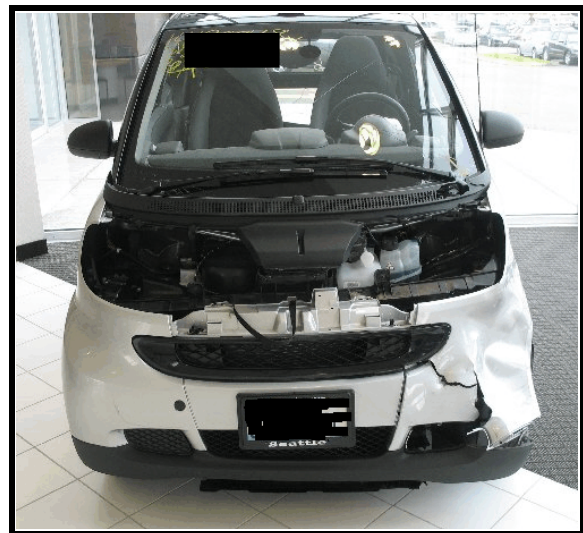
The Smart Fortwo sustained moderate front end damage as a result of the initial impact with the Dodge Caravan (**Figure 4**). The direct damage began at the front left bumper corner and extended 121 cm (47.6 in) laterally to the right. The damage on the right side of the bumper fascia was minor and consisted of tire tread marks. The fascia was fractured at its left aspect. Six crush measurements were documented at the bumper level as follows: C1 = 8 cm (3.1 in), C2 = 3 cm (1.2 in), C3 = 0 cm, C4 = 0 cm, C5 = 0 cm, C6 = 0 cm. The plastic fascia had restituted to some degree and the crush along the bumper face under-reported the crush. Two crush measurements were taken using the visible outboard portions of the bumper backing bar as follows: C1 = 12 cm (4.7 in) and C2 = 7 cm (2.8 in).

Figure 4. Frontal damage, 2008 Smart Fortwo

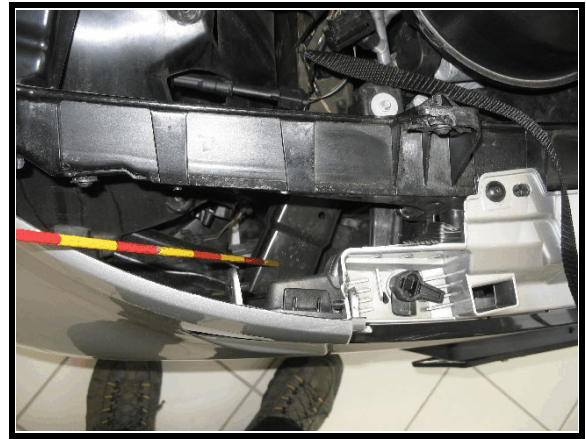
The backing bar was shifted 6 cm (2.4 in) to the right (**Figure 5**). The upper mounting bracket was shifted 3 cm (1.2 in) to the right. The Collision Deformation Classification (CDC) for the impact with the Caravan was 11FDEW2.

Figure 5. Top view of right mounting bracket and backing bar

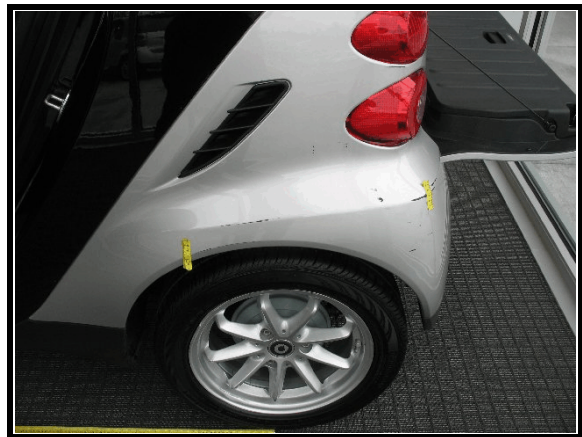
The Smart Fortwo also sustained minor left side damage as a result of a sideslap type impact with the right side of the Caravan (**Figure 6**). The direct damage began 17 cm (6.7 in) forward of the left rear axle and extended 44 cm (17.3 in) rearward along the left side plane. The CDC for this impact was 09LBEW1.

Figure 6. Left side damage

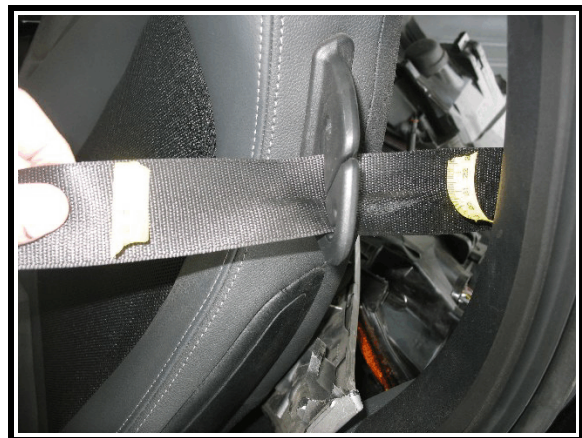
The 2008 Smart Fortwo was configured with 3-point manual lap and shoulder belts for the two seating positions. Both safety belts were equipped with retractor pretensioners. The driver's safety belt was configured with a sliding latch plate and an Emergency Locking Retractor (ELR). At the time of the vehicle inspection, the driver's retractor was restricted in the used position as a result of pretensioner actuation. The belt webbing exhibited a 19 cm (7.5 in) area of loading (**Figure 7**). The distance from the belt anchor to the beginning of the loading measured 154 cm (60.6 in). The passenger safety belt was configured with a sliding latch plate and a switchable ELR/Automatic Locking Retractor (ALR). The passenger side pretensioner did not actuate and the retractor was functional.

Figure 7. Loading to driver's seat belt webbing

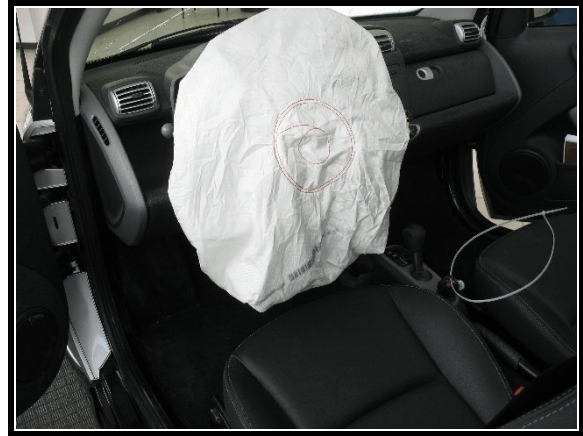
The 2008 Smart Fortwo was equipped with advanced occupant protection systems including multi-stage driver and front right passenger air bags. The driver's frontal air bag deployed as a result of the longitudinal deceleration of the Fortwo during the first impact with the Caravan (**Figure 8**). The front right passenger's air bag did not deploy. The Fortwo was also equipped with seat-mounted side air bags that did not deploy. The driver's air bag deployed from the center of the steering wheel hub through asymmetrical I-configuration module cover flaps. The left flap measured 8 cm (3.1 in) along the top and 8 cm (3.1 in) vertically to a 4 cm (1.6 in) offset. The right flap measured 3 cm (1.2 in) along the top and 8 cm (3.1 in) vertically to a 4 cm (1.6 in) offset. The air bag measured 52 cm (20.5 in) in diameter in its deflated state. The air bag was tethered by a single internal strap. There was circular stitching on the face of the air bag that measured 16 cm (6.3 in). A single 3 cm (1.2 in) circular vent port was located at the 12 o'clock aspect on the back panel. There was a printed pattern along the bottom of the face of the air bag. There were no indications of air bag damage or occupant contacts on the air bag.

Figure 8. Deployed driver's air bag
