**NOT-IN-TRAFFIC SURVEILLANCE  
CALSPAN REMOTE HYPERTHERMIA DEATH INVESTIGATION  
SCI CASE NO.: CA08027**

**VEHICLE: 2001 GMC YUKON XLT**

**LOCATION: VIRGINIA**

**DATE OF INCIDENT: JULY 2008**

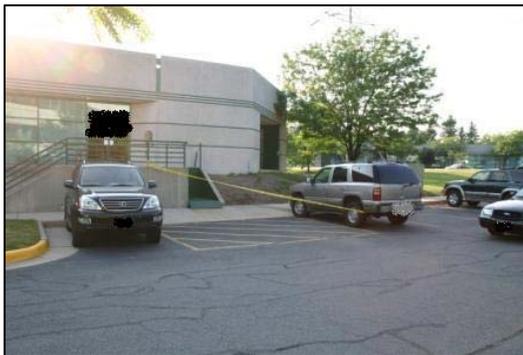
**Figure 2. Overall view of the incident site and the parked position of the GMC.**

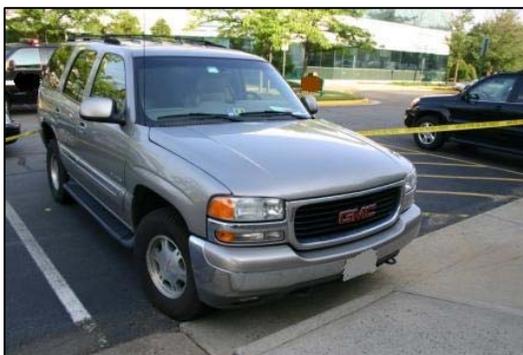
**Figure 3. Front right oblique view of the 2001 GMC Yukon.**

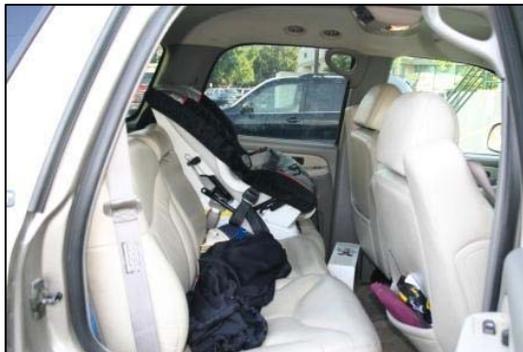
**Figure 4. Interior view of the GMC.**

The window glazing of the GMC was OEM tinted. The windshield and the front door windows were OEM solar tint. The rear door, rear quarter windows, and backlight glazing were OEM deep tint (AS3). All of the exterior glazing was clean at the time of this incident. All of the operable door windows were closed at the time of the incident. An interior image of the left rear door glazing showed numerous smears to the glazing, indicative of finger marks. The police department conducted a Tint Meter test of the GMC's glazing. The front door windows recorded a 72 percent light transmittance and the rear door and quarter windows recorded a 17 percent light transmittance.

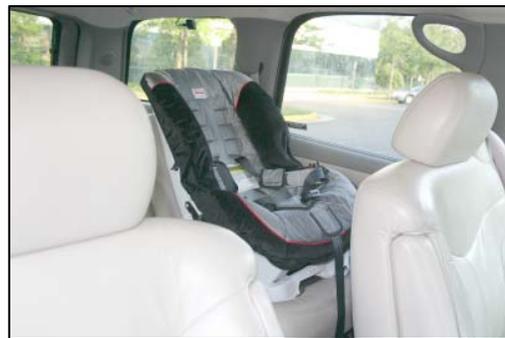
**Figure 5. Installed position of the CRS within the GMC Yukon.**

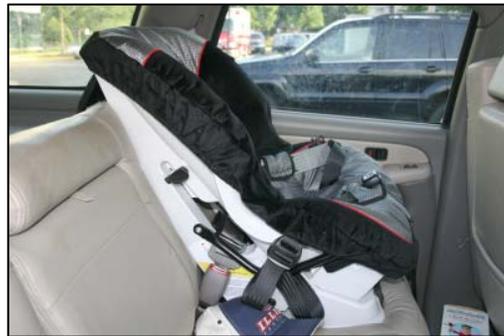
**Figure 6. Interior view of the position of the CRS within the GMC.**

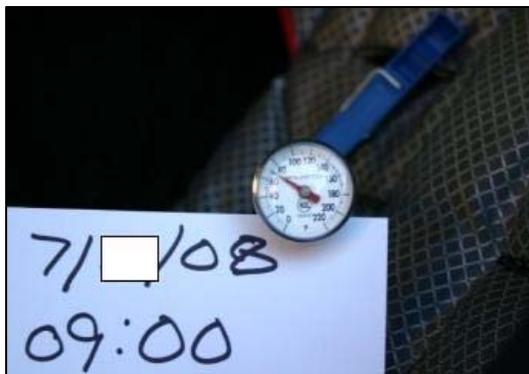
<b>Time</b>	<b>Outside Temperature</b>	<b>GMC Interior Temperature</b>
Day - 1 0900 Hours	23.3 degrees C (74 degrees F)	21.1 degrees C (70 degrees F)
Day - 1 1500 Hours	31.6 degrees C (89 degrees F)	49.4 degrees F (121 degrees F)
Day - 2 0900 Hours	26.6 degrees C (80 degrees F)	26.6 degrees C (80 degrees F)
Day - 2 1500 hours	33.3 degrees C (92 degrees F)	55.5 degrees C (132 degrees F)

**Figure 7. Lowest temperature recorded during the police reconstruction of the interior temperatures within the GMC.**

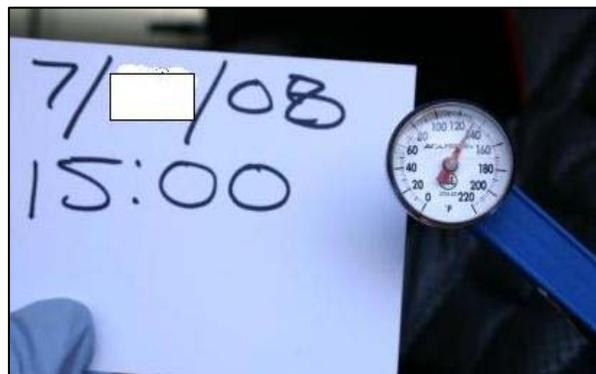
**Figure 8. Highest temperature recorded during the police reconstruction of the interior temperatures within the GMC.**

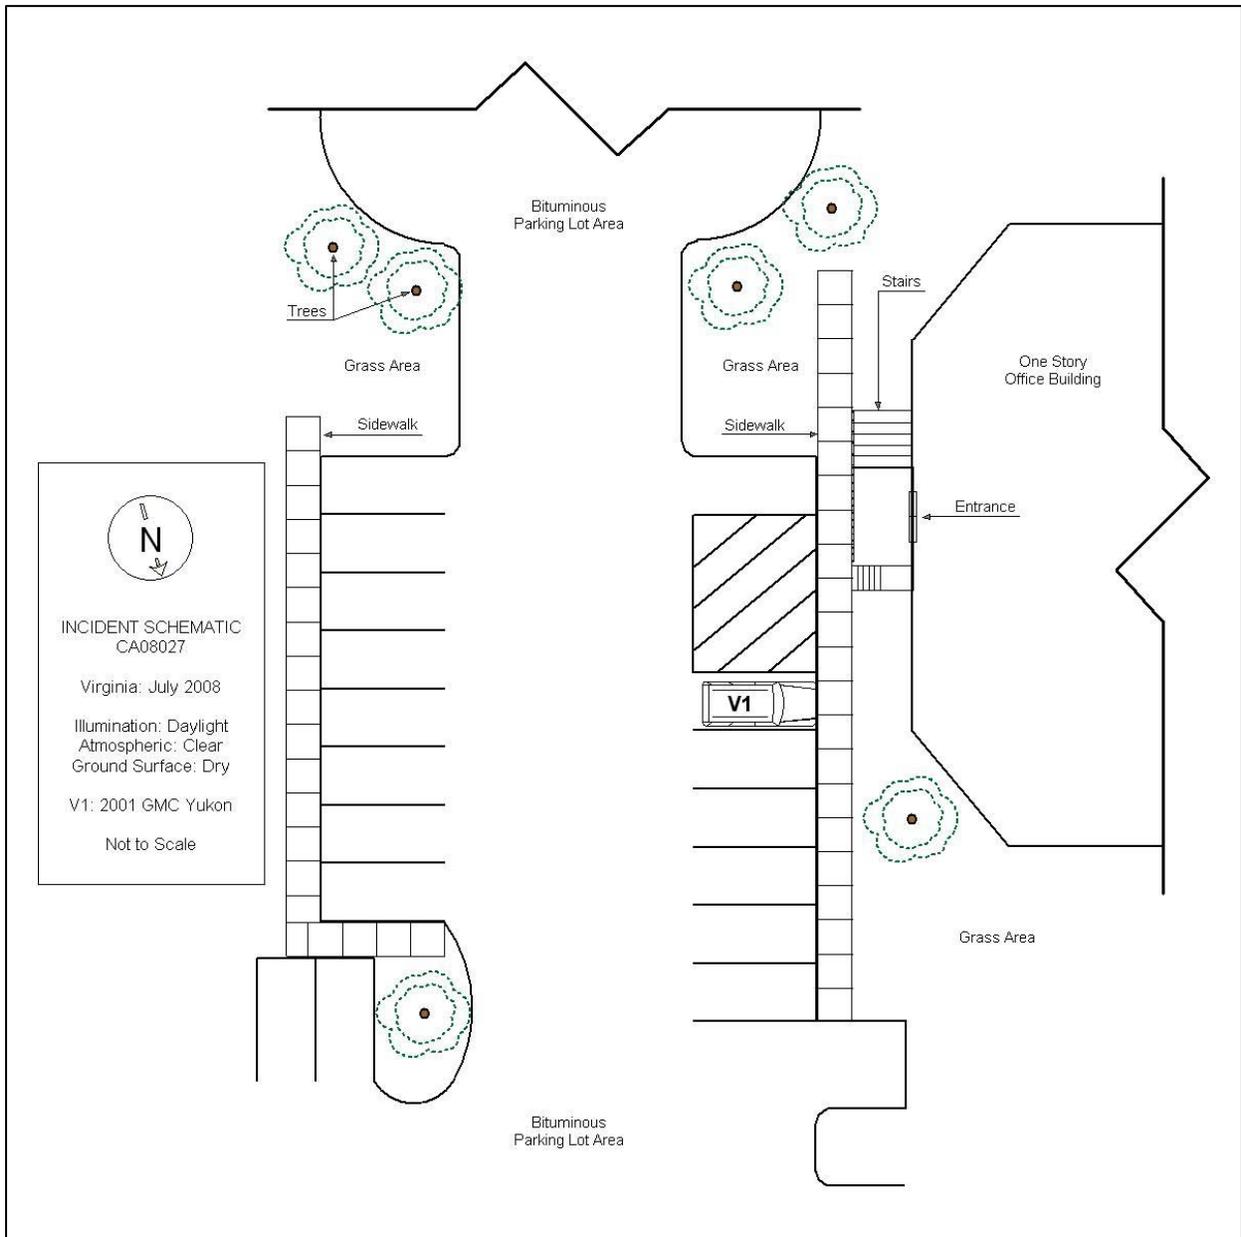
**Figure 9. Incident Schematic**

This incident occurred in a commercial parking lot during daytime hours (**Figure 2**). The parking lot consisted of a driving aisle with a single row of perpendicular parking spaces located on each side of the aisle. The parking lot was surfaced with asphalt and the parking spaces were delineated with white paint markings. Commercial office buildings were adjacent to the parking spaces with concrete sidewalks located between the buildings and the parking spaces. Landscaped areas were located at the corners of the buildings that provided minimal shade to the parked vehicles. The GMC was parked front first in a designated parking space with a “No Parking Zone” painted adjacent to the left of the vehicle. The police measured the heading angle of the parked GMC at 285 degrees. The office building located forward of the vehicle’s parked position was a single story building that was built on a berm, thus elevating the height of the building in relation to the parking lot. The driver worked in this building. A schematic of the incident site is attached as **Figure 9**.
