**CALSPAN ON-SITE CHILD SAFETY SEAT INVESTIGATION
EVENFLO CHASE DELUXE CHILD SAFETY SEAT
SCI CASE NO: CA08028**

**VEHICLE: 2008 MAZDA 6
LOCATION: ALABAMA
CRASH DATE: MAY 2008**

Contract No. DTNH22-07-C-00043

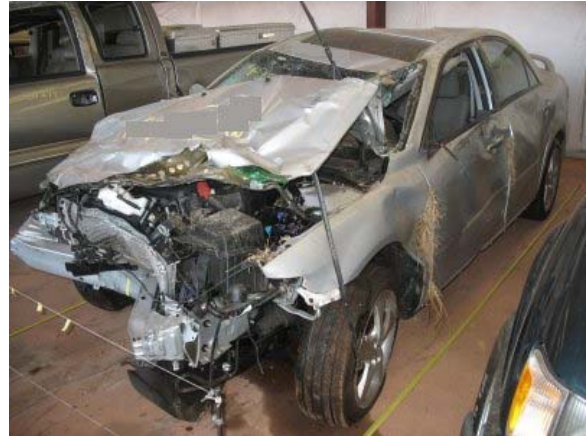
Figure 1: Left oblique view of the Mazda 6.

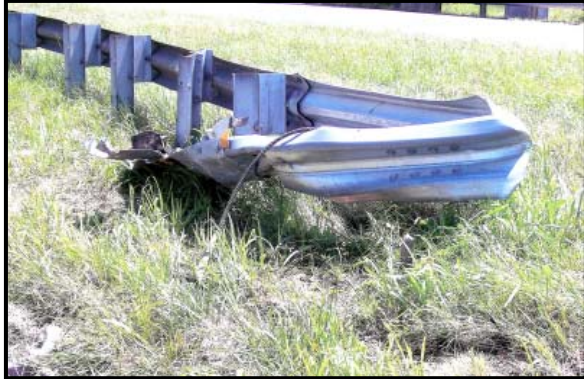
Figure 3: View of the damaged guardrail.

The front plane of the Mazda impacted the end-treatment of the guardrail. The force of the impact caused the driver air bag to deploy. The impact fractured two 15 cm (6 in) wooden posts securing the guardrail and a 3 m (10 ft) length of the W-beam deformed. The Mazda rode through the yielding object continuing its southeast trajectory through the median and began to rotate counterclockwise. The right rear bumper corner swiped against the guardrail as evidenced by a 46 cm (18 in) long horizontal abrasion to the rear fascia. The left front tire of the vehicle began to climb the back side of the median slope resulting in a weight shift to the right rear. The right rear tire furrowed into the soft earth and tripped the vehicle into a right side leading rollover. The Mazda rolled two quarter turns and impacted the ground with its roof. This impact resulted in approximately 10 cm (4 in) of vertical roof deformation at the left aspect of the windshield header. The Mazda continued to roll an additional four quarter turns and came to rest on its roof at the base of the concrete overpass column facing north east. The approximate roll distance was 20 m (65 ft).

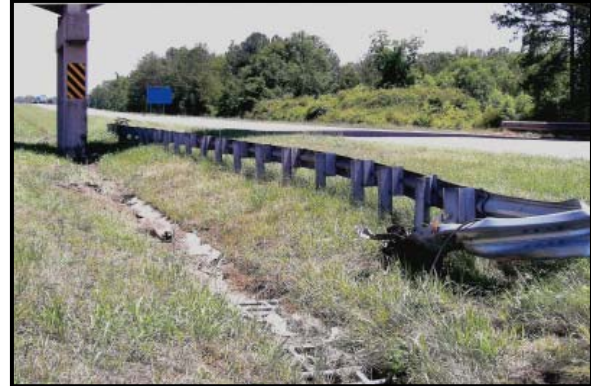
southbound lanes and was located 3.7 m (12 ft) east of the inboard shoulder. The Mazda subsequently rolled over in the median and came to rest on its roof near the base of the column in **Figure 4**. The speed limit of the interstate was 113 km/h (70 mph). A schematic of the crash site is attached to the end of this narrative report as **Figure 10**.

Figure 4: South view at the crash site depicting the guardrail impact and roll trajectory. The Mazda came to rest at the base of the pillar.

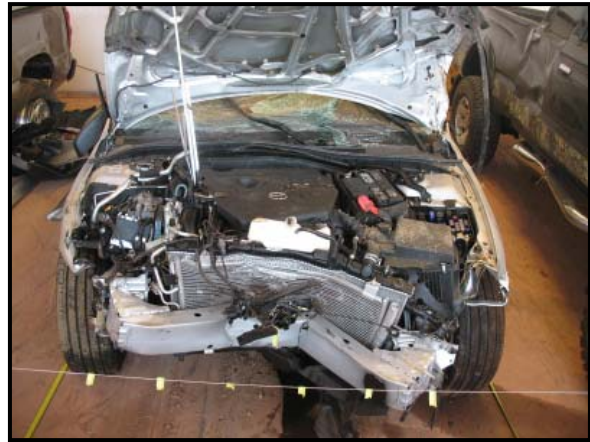
The Mazda sustained exterior damage to its front, top and side planes consistent with the dynamics of the crash. The front bumper fascia separated during the impact with the guardrail exposing the deformed bumper reinforcement bar. The reinforcement bar deformed into a U-shaped pattern. The direct contact damage was limited to the center zone of the front plane and was 20 cm (8 in) in width. The reinforcement bar deformed rearward into the radiator and engine block. The residual crush documented across the bar was as follows: C1 = 0 cm (0 in), C2 = 15 cm (5.9 in), C3 = 34 cm (13.4 in), C4 = 33 cm (13.0 in), C5 = 18 cm (7.1 in), C6 = 5 cm (2.0 in). Refer to **Figure 5**. The Collision Deformation Classification (CDC) was 12-FCEN2.

Figure 5: Front view of the Mazda.

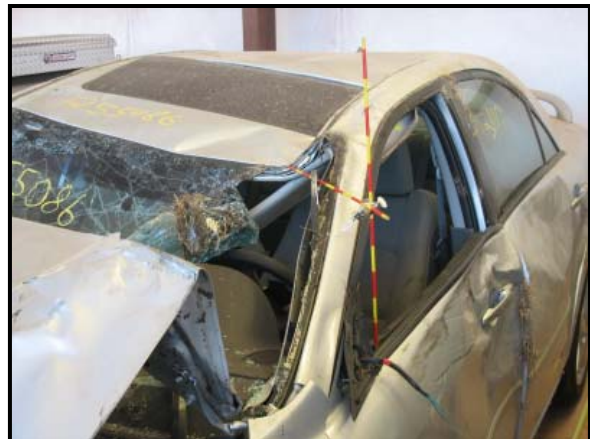
The side and top planes exhibited body panel abrasions and deformation consistent with a right side leading, six-quarter turn tripped rollover. Grass, dirt and debris were embedded in the beads of both right side tires indicative of the furrow trip. The left side of the roof deformed down in a shallow V-pattern over the driver's position. The maximum vertical deformation was located on the windshield header 15 cm (6 in) inboard of the left A-pillar, **Figure 6**. The maximum deformation measured 10 cm (4.1 in). There was no lateral deformation of the roof structure. The CDC of the rollover was 00-TDDO3.

Figure 6: Maximum vertical deformation.

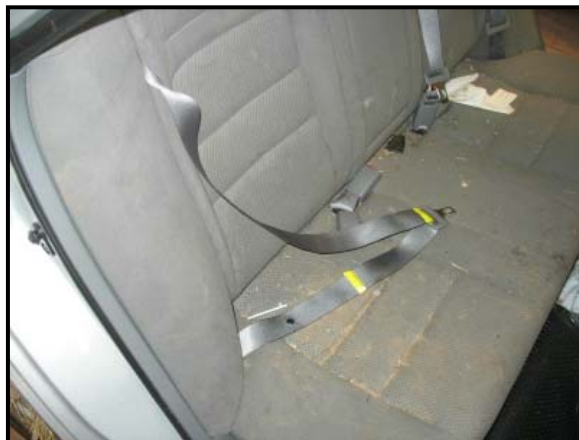
The manual restraint in the rear right position consisted of a continuous loop webbing, sliding latch plate, and a switchable Automatic Locking Retractor/Emergency Locking Retractor (ALR/ELR). The retractor had been switched to the locking mode by the driver/mother during the CSS installation. During the SCI inspection, the webbing was found in the extended and locked in the used position. The shoulder portion of the webbing was captured between the folding seat back and the outboard bolster of the seat. Refer to **Figure 7**. The length of the captured webbing measured 150 cm (59 in). The webbing was creased 28 cm (11 in) above the seat bight from its interaction with the belt path of the CSS. A second crease was noted 58 cm (23 in) above the seat bight in the area of the latch plate. Subtle abrasions were noted to the friction surface of the latch plate.

Figure 7: Rear right safety belt.

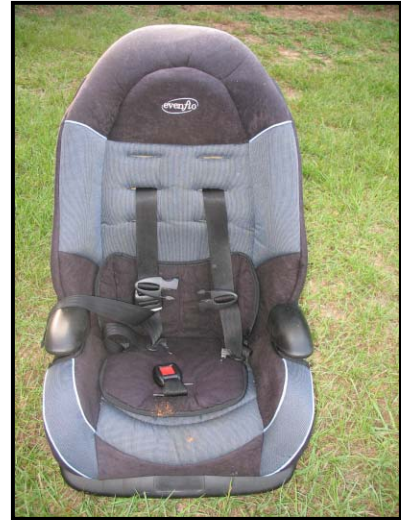
The 2 year old child was restrained in a forward facing manner in an Evenflo Chase Deluxe Child Safety Seat (CSS) that was manufactured on July 21, 2006 and was identified by the model number: 3251692L1. **Figure 8** is a view of the CSS. The seat was designed for use in a forward facing mode with the five-point harness or as a belt positioning booster seat (no harness) dependant on the weight and height of the child. The five-point harness installation was for use by a child weighting 9 to 18 kg (20 to 40 lb) with a height between 74 and 109 cm (29 and 43 in). The belt positioning booster installation was designed for children weighing 13.6 kg to 45.3 kg (40 to 100 lb) with a height less than 137 cm (54 in). At the time of the crash, the CSS was restrained by the vehicle's three-point lap and shoulder belt routed through the forward facing belt path. The mother reported that she had the switchable retractor in the automatic locking mode. The child was secured in the CSS by the five-point harness system. He had a reported height and weight of 14 kg (30 lb) and 76 cm (31 in). She stated that the harness straps were adjusted "snug" on the child. The harness retainer clip was adjusted to the arm pit level. The child was asleep at the time of the crash.

Figure 8: View of the Evenflo CSS.

Examination of the CSS was unremarkable for crash related evidence. Inspection of the forward facing belt path identified minor abrasions consistent with safety belt use. The harness straps of the seat were adjusted to the middle slots. The straps were in good condition and were not roped or twisted. There was no evidence of loading to the straps.

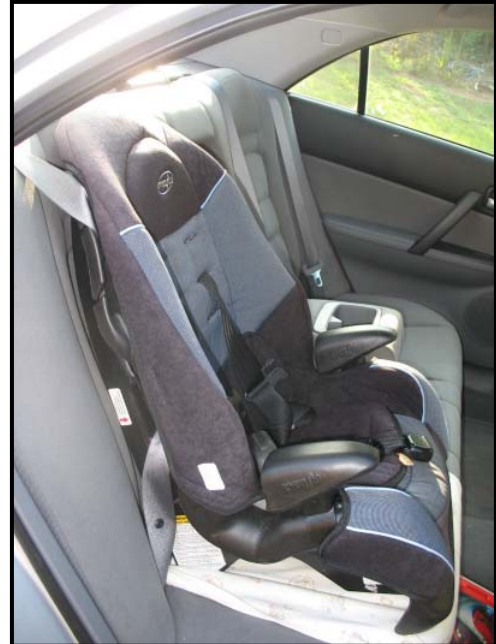
Since the time of the crash, the mother had been using the CSS in her replacement Mazda 6. At the time of the SCI inspection, it was located in the rear right position of her vehicle, **Figure 9**. Examination of the installation revealed the CSS moved side to side approximately 5 cm (2 in) at the belt path. The mother reported that the installation of this CSS was similar to the CSS installation at the time of the crash. She was not familiar with the Child Seat Checkpoints and learned how to install the seat by reading the instruction manual. She stated that she placed her knee in the seat and compressed the seat cushion, set the retractor to the locking mode and then back-fed the webbing into the retractor. Although the CSS was designed with Lower Anchors and Tethers for Children (LATCH), she was not familiar with the use of that system.

Figure 9: View of the CSS installed in the replacement Mazda 6.
