ON-SITE HYBRID VEHICLE INVESTIGATION

CASE NUMBER - IN08029

VEHICLE - 2008 FORD ESCAPE HYBRID

CRASH DATE - August 2008

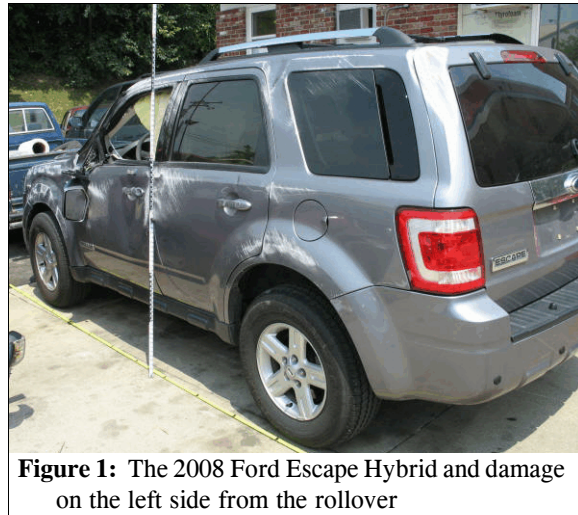
Figure 1: The 2008 Ford Escape Hybrid and damage on the left side from the rollover

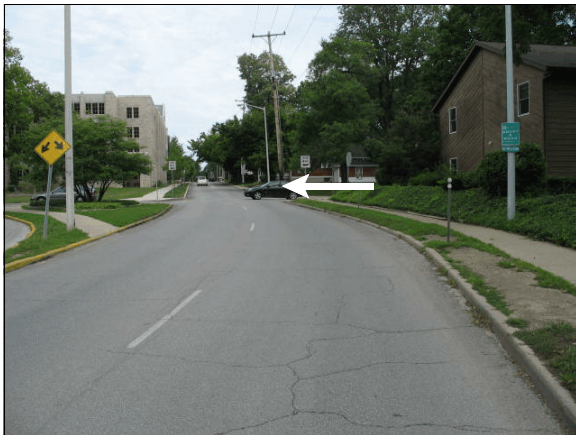
Figure 2: Approach of the Ford traveling east in the right lane; arrow shows the approach of the Oldsmobile

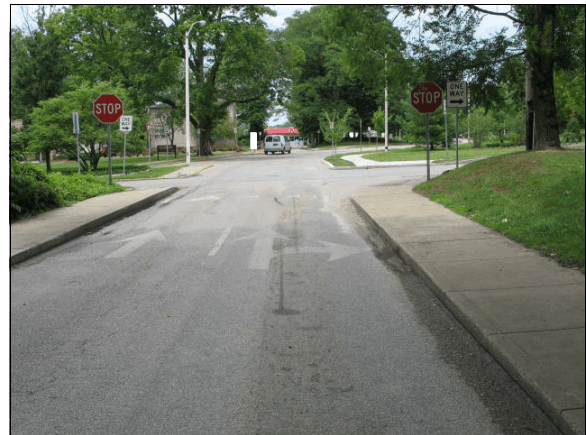
Figure 3: Approach of the Oldsmobile traveling north in the right lane

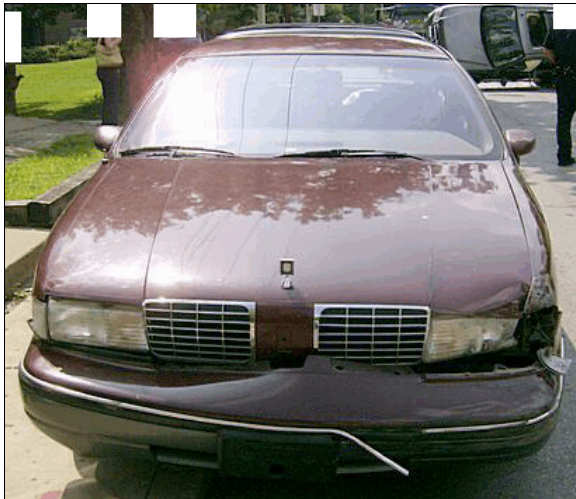
Figure 4: Damage to the front of the Oldsmobile from the impact with the Ford

Exterior Damage: The Oldsmobile's impact with the Ford involved the front plane. The front bumper, end of the left fender, hood, and left headlamp/turn signal assembly were directly damaged (**Figure 4**). The induced damage involved the left fender, hood and the grille.

Damage Classification: Based on the police photographs, the Oldsmobile's CDC was estimated to be **10-FYEW-1 (290 degrees)**. The Missing Vehicle algorithm of the WinSMASH program calculated the Oldsmobile's Delta V as 6 km/h (3.7 mph). The longitudinal and lateral components were -2 km/h (-1.2 mph) and 6 km/h (3.7 mph), respectively. The results are borderline because they are based only on the crush to the Ford.

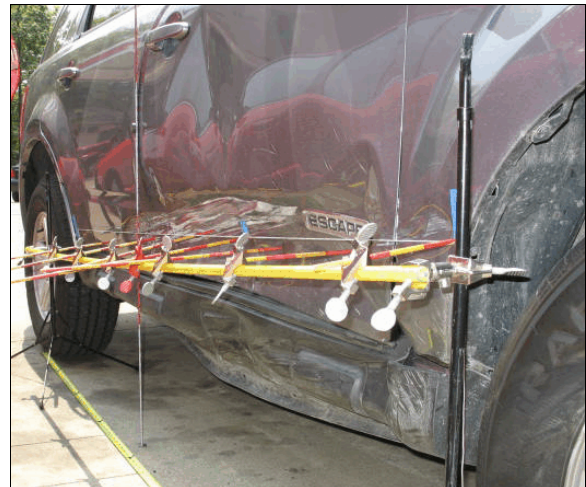
Figure 5: Damage to right side of Ford from impact by front of Oldsmobile

Exterior Damage: The Ford's impact with the Oldsmobile involved the right side plane. The right front and rear doors and the sill were directly damaged. The direct damage began 38 cm (14.9 in) rear of the right front axle and extended 142 cm (55.9 in) rearward on the side of the vehicle. The crush measurements were taken at the lower door level and the residual maximum crush was 6 cm (2.4 in) occurring 107 cm (42.1 in) rear of the right front axle. The table below shows the vehicle's right side crush profile.

Damage Classification: The Ford's Collision Deformation Classifications (CDCs) were: **01-RPEW-1 (30 degrees)** for the right side impact with the front of the Oldsmobile and **00-LDAO-2** for the rollover. The Missing Vehicle algorithm of the WinSMASH program calculated the Ford's Delta V for the right side impact as 7.0 km/h (4.3 mph). The longitudinal and lateral components were -6 km/h (-3.7 mph) and -4 km/h (2.1 mph), respectively. The results are borderline because they are based only on the crush to the Ford. The severity of the rollover event was moderate based on the damage to the Ford's left side.

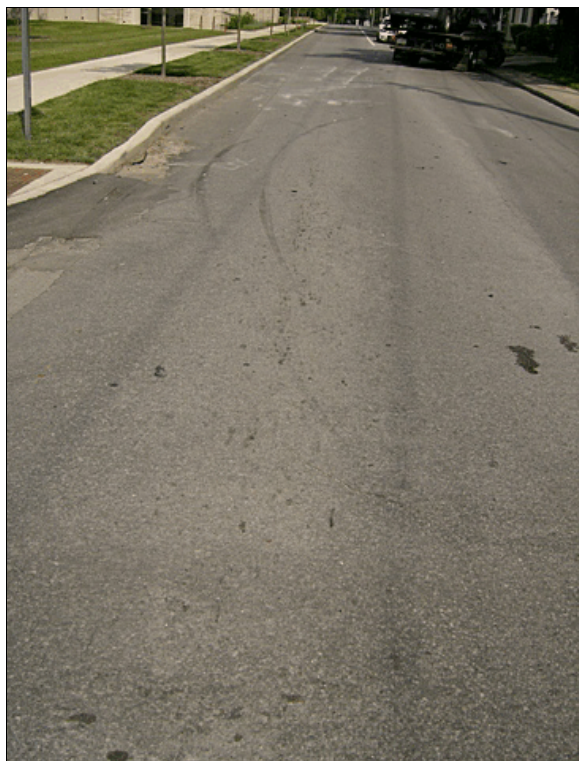
Figure 6: Police photograph showing Ford's left rear and left front yaw marks and scratches on the pavement from the rollover

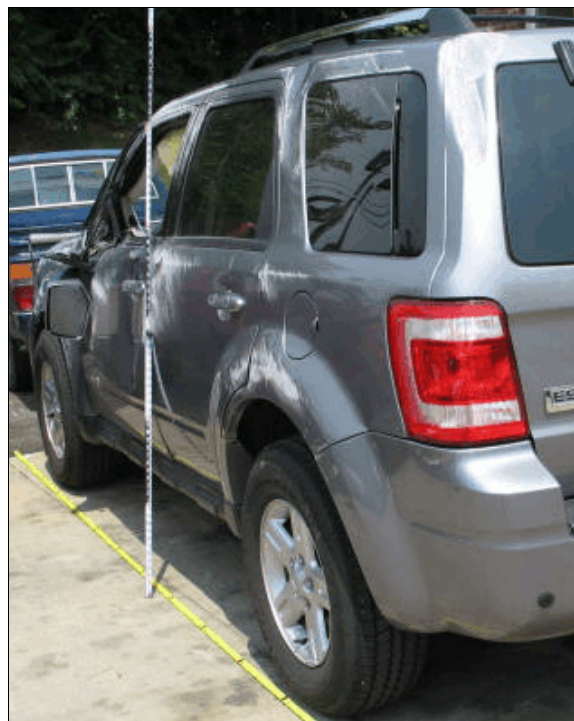
Figure 7: Damage to Ford's left side from the rollover

The damage from the rollover involved the entire left side of the vehicle. The direct damage began 53 cm (20.9 in) forward of the left front axle and extended 385 cm (151.6 in) rearward along the left side. The maximum lateral crush was 4 cm (1.6 in) and occurred at the belt line near the left A-pillar. It was the result of contact from the left side view mirror when the vehicle rolled onto its left side. There was no vertical crush to the left roof side rail. The Ford's wheelbase was unchanged and the induced damage involved the right front and rear doors.

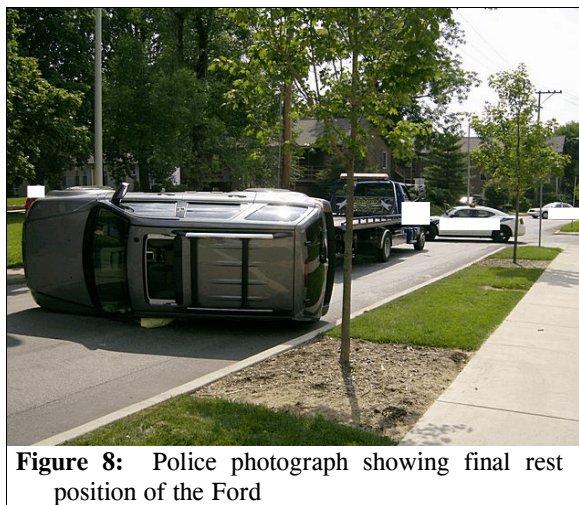
Figure 8: Police photograph showing final rest position of the Ford

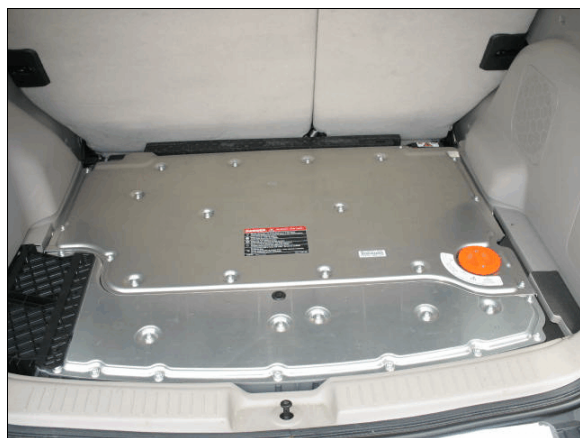
The Ford's propulsion battery was located in the cargo area under the carpet (**Figure 9**). The battery pack consisted of 50 battery modules, each comprised of five, 1.3 volt NiMH batteries sealed in a water resistant stainless steel case. The battery cells contained a base electrolyte consisting of potassium hydroxide as the dominant active ingredient, which is absorbed in a special paper. The electrolyte will not leak from the battery under most conditions; however, if the battery is crushed, it is possible for a small amount of electrolyte to leak¹. Inspection of the propulsion battery revealed no evidence of movement or damage. The battery was equipped with a high voltage service disconnect switch, which was located on the top right of the battery pack (**Figure 10**). At inspection, the switch was in the locked position. The high voltage wiring connector was located on the front right of the battery (**Figure 11**). It was undamaged and exhibited no evidence of displacement within the socket. Examination of the DC/DC converter (**Figure 12**) and the associated wiring and connectors (that were accessible) revealed no evidence of electrical arcing or melting of components. The vehicle was equipped with an inertia activated high voltage shut off switch, which was located in the jack storage compartment within the passenger side cargo area (**Figure 13**). The switch opened in the crash and disabled the high

Figure 9: The Ford's propulsion battery pack

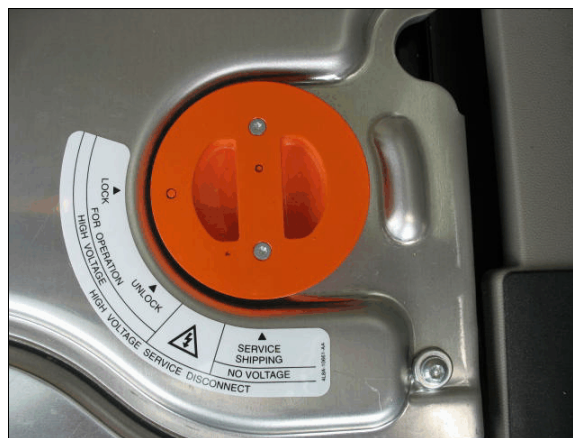
Figure 10: The high voltage service disconnect switch; switch in the locked position at the inspection

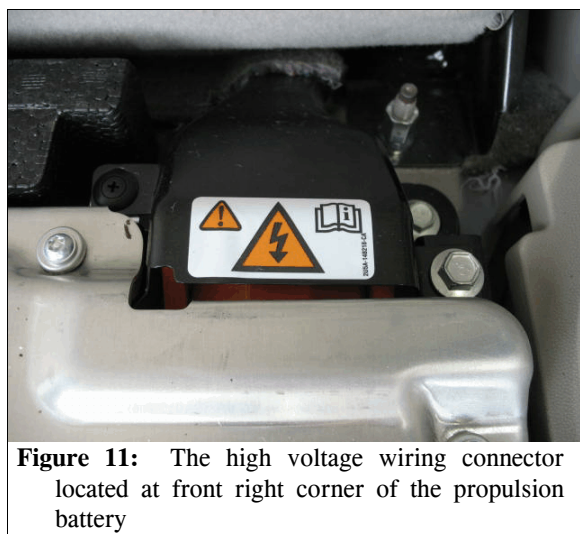
Figure 11: The high voltage wiring connector located at front right corner of the propulsion battery

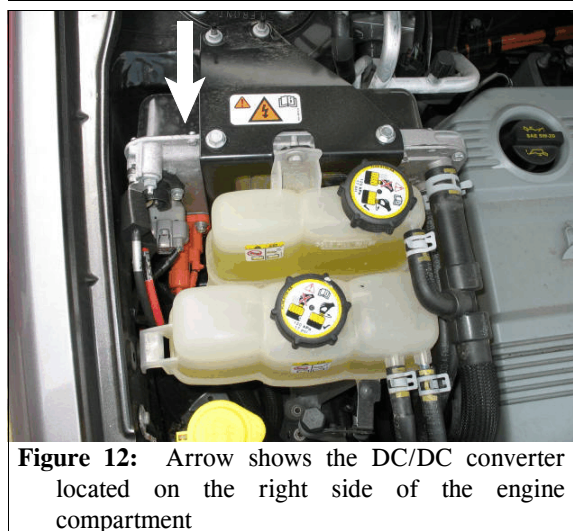
Figure 12: Arrow shows the DC/DC converter located on the right side of the engine compartment

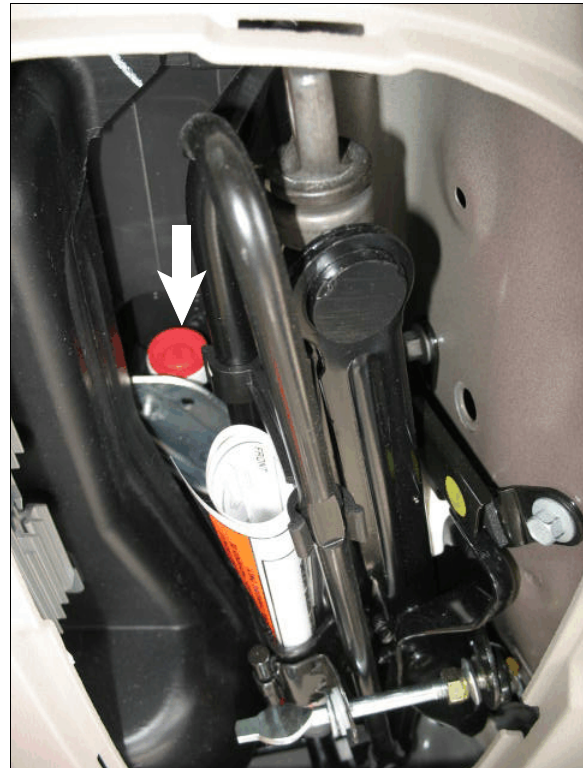
Figure 13: Arrow shows the inertia activated high voltage shut off switch located in the jack compartment

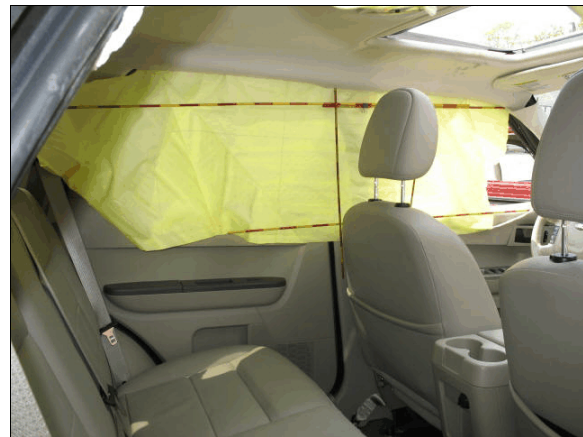
The Ford's side curtain air bags were located along the roof side rails inside the headliner, and extended along the each side of the vehicle from the A-pillar to the C-pillar (**Figure 14**). Each deployed air bag was 145 cm (57.1 in) in length and 45 cm (17.7 in) in height. Each air bag was anchored to the A-pillar by a cloth cord 37 cm (14.6 in) in length and to the C-pillar by a cloth cord 7 cm (2.8 in) in length. There was a 30 cm (11.8 in) wide gap between the leading edge of each air bag and the A-pillar (**Figure 15**). The side curtain air bags were designed with inflation chambers adjacent to each outboard seat position and did not have external vent ports. The left side curtain air bag had a few small abrasions on its outboard surface due to flying glass fragments when the left front window glazing disintegrated during the rollover. The right side curtain air bag was unremarkable.

Figure 14: The left side curtain air bag

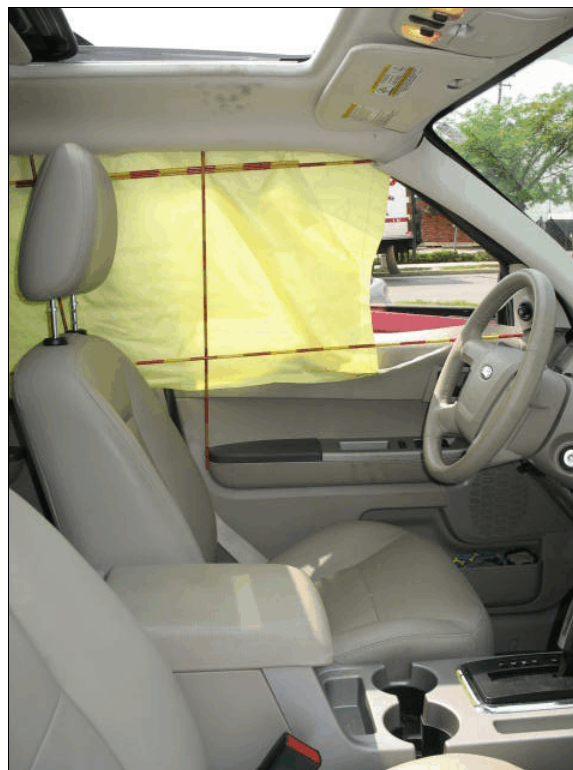
Figure 15: Gap between front of side curtain air bag and left A-pillar

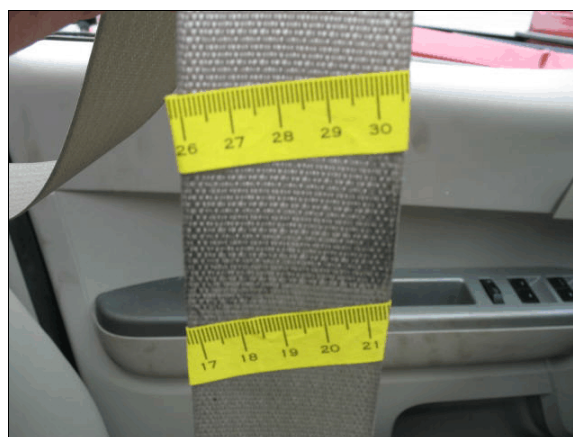
Inspection of the left front seat belt assembly revealed evidence of occupant loading, which consisted of minor abrasions on the D-ring and plastic transfer on the belt webbing (**Figure 16**). The transfer was located 54 cm (21.3 in) above the stop button, which indicated the source of the transfer was the sliding latch plate. Both pretensioner's actuated and the buckle-mounted pretensioner was reduced 3 cm (1.2 in). The evidence indicated that the driver was restrained by the lap-and-shoulder belt at the time of the crash. The remaining seat positions were unoccupied.

Figure 16: Plastic transfer from the sliding latch plate on the driver's seat belt webbing
