**CALSPAN ON-SITE ROLLOVER CRASH INVESTIGATION  
SCI CASE NO.: CA08030**

**VEHICLE: 2007 FORD F250 PICKUP TRUCK**

**LOCATION: NORTH CAROLINA**

**CRASH DATE: JUNE 2008**

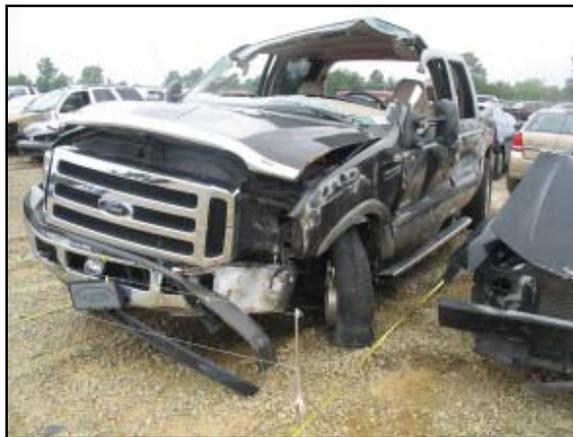
**Figure 1: Left front oblique view of the 2007 Ford F250 pick-up truck**

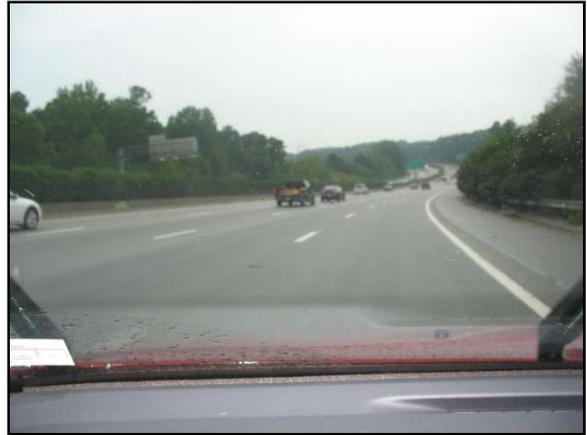
The 24-year-old male driver of the Ford was operating the vehicle westbound on an interstate roadway in the outboard lane (**Figure 2**). A non-contact vehicle was traveling ahead of the Ford in the same lane. As both vehicles traveled forward, the non-contact vehicle began to slow down and the driver of the Ford then changed lanes to the left in order to pass the non-contact vehicle. In the process of the passing maneuver, the non-contact vehicle also changed lanes to the left. The driver of the Ford observed the non-contact vehicle's encroachment and performed an evasive maneuver by initiating a left steering input. This action resulted in the Ford paralleling the non-contact vehicle's leftward trajectory as the Ford maintained its speed and relative distance from the encroaching vehicle. Both vehicles crossed the width of the roadway and each vehicle departed the south side of the travel lanes onto the paved shoulder area.

**Figure 2: Westbound pre-impact travel path of the Ford**

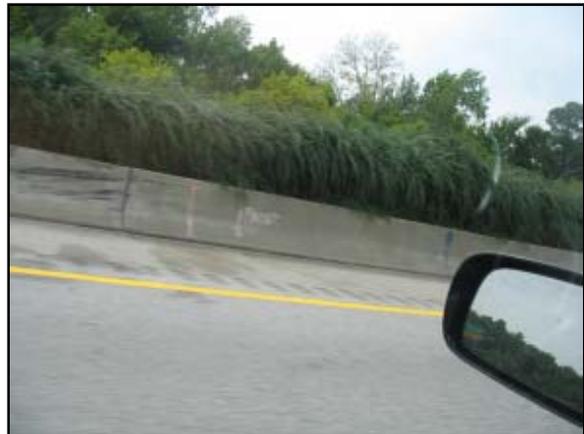
The driver of the Ford maintained his evasive trajectory until the left aspect of the vehicle's front plane impacted the center concrete barrier (Event 1), **Figure 3**. This initial event resulted in moderate frontal damage with a resultant direction of force in the 12 o'clock sector. As the Ford's front bumper deformed, it exposed the left front wheel which contacted the concrete barrier. This contact cut and deflated the left front tire and damaged the left front suspension components. Additionally, this impact resulted in the deployment of the frontal air bag system. The damage algorithm of the WinSMASH program was used to calculate the severity of the impact (delta-V). The total delta-V was 23 km/h (14.3 mph) with longitudinal and lateral components of -23 km/h (-14.3 mph) and 4 km/h (2.5 mph).

**Figure 3: Depicts the contact evidence to concrete barrier wall from the Ford's first event**

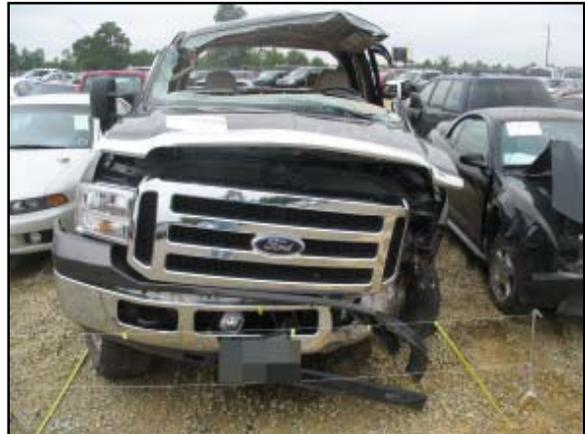
The exterior of the Ford sustained moderate damage to the front (**Figure 4**) and left side planes (**Figure 5 and 6**) as a result of the multiple event crash. The first impact (Event 1) occurred to the left aspect of the front plane. The direct damage width measured 50 cm (19.7 in) and began 41 cm (16.1 in) left of the vehicle centerline and extended to the front left bumper corner. The maximum crush measured 40 cm (15.7 in) and was located on the left corner of the front bumper. A crush profile was measured at the bumper level with the following results: C1 = 40 cm (15.7 in), C2 = 23 cm (9.1 in), C3 = 7 cm (2.8 in), C4 = 2 cm (0.8 in), C5 = 2 cm (0.8 in), C6 = 0 cm. The Ford's left wheelbase was reduced by 25 cm (9.8 in). The Collision Deformation Classification (CDC) for this event's direct damage was 12FLEW2.

**Figure 4: Overall view of the frontal damage**

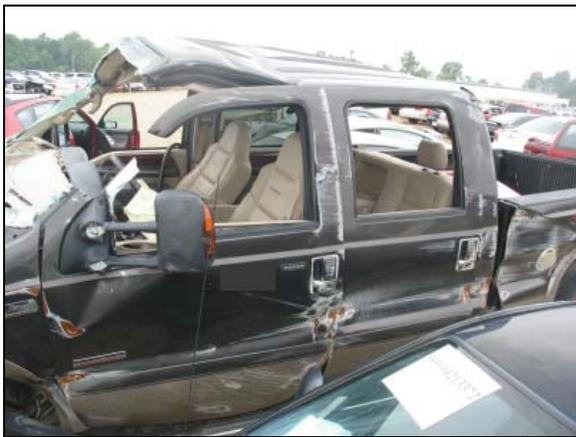
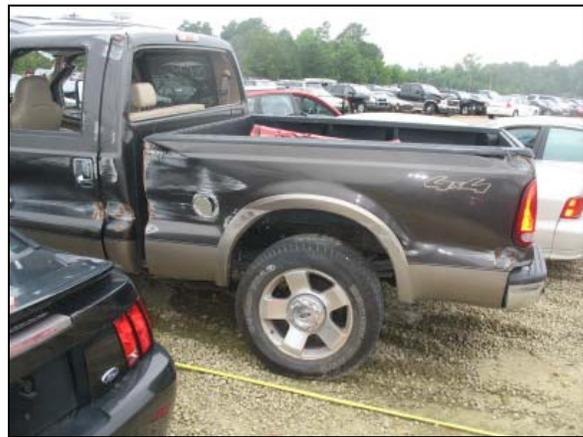
The Ford's engagement with the barrier wrapped around the left front corner as the vehicle was redirected and the barrier contact extended along the entire length of the left plane. The 86 cm (34 in) height of the abrasion pattern across the left doors was consistent with the height of the barrier. The direct damage consisted of surface abrasions with minimal lateral deformation.

Scuffing was observed on the sidewall of the left rear tire due to the barrier contact. The left doors were jammed shut.

As the forward aspect of the Ford disengaged from the barrier, the left front rim contacted the pavement and tripped the vehicle into a one-quarter turn rollover. The rollover event (Event 2) resulted in longitudinally oriented abrasions along the left side plane that extended vertically to a height of 190 cm (75 in) at the roof side rail. Heavy abrasions were noted to the forward side of the left mirror mount. Minimal lateral deformation to the body panels was noted. There did not appear to be lateral deformation of the greenhouse; the post-crash extrication damage to the A-pillars and roof hampered any meaningful measurements. The pickup truck's frame aft of the cab was deformed laterally to the right evidenced by the 15 cm (6 in) left-side gap between the cab's aft wall and the pickup bed. The gap between the cab and bed on the right was closed. The CDC for this event was 00LDAO3.

Figure 5: View of the Ford's left side damage.

Figure 6: View of the Ford's left side damage.

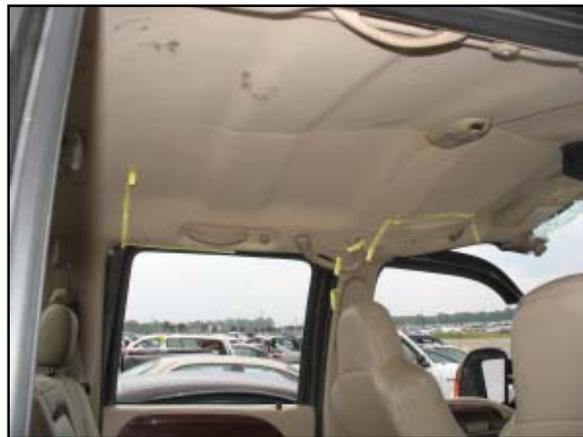
The interior of the Ford sustained moderate damage attributed to minor occupant contact, passenger compartment intrusions, frontal air bag deployment, and post-crash extrication damage. A 6 cm x 5 cm (2.5 in x 2 in) scuff mark was noted on the glove box door. It was located 6 cm (2.3 in) right of the glove box centerline and 48 cm (19 in) above the floor. The transfer case shift lever was found in a deformed condition from a possible front right passenger contact. **Figure 7** depicts the interior evidence at the Ford's left roof area. Two small scuff marks were observed at the upper aspect of the left B-pillar and grab handle. Post-crash

Figure 7: Left roof area of the Ford.

body fluid was noted on the upper left B-pillar and along the left roof side rail at the both driver and second row left positions. During the extrication efforts, rescue personnel cut the A-pillars and deflected the roof upward and rearward, which creased the headliner at the midpoint of the roof.

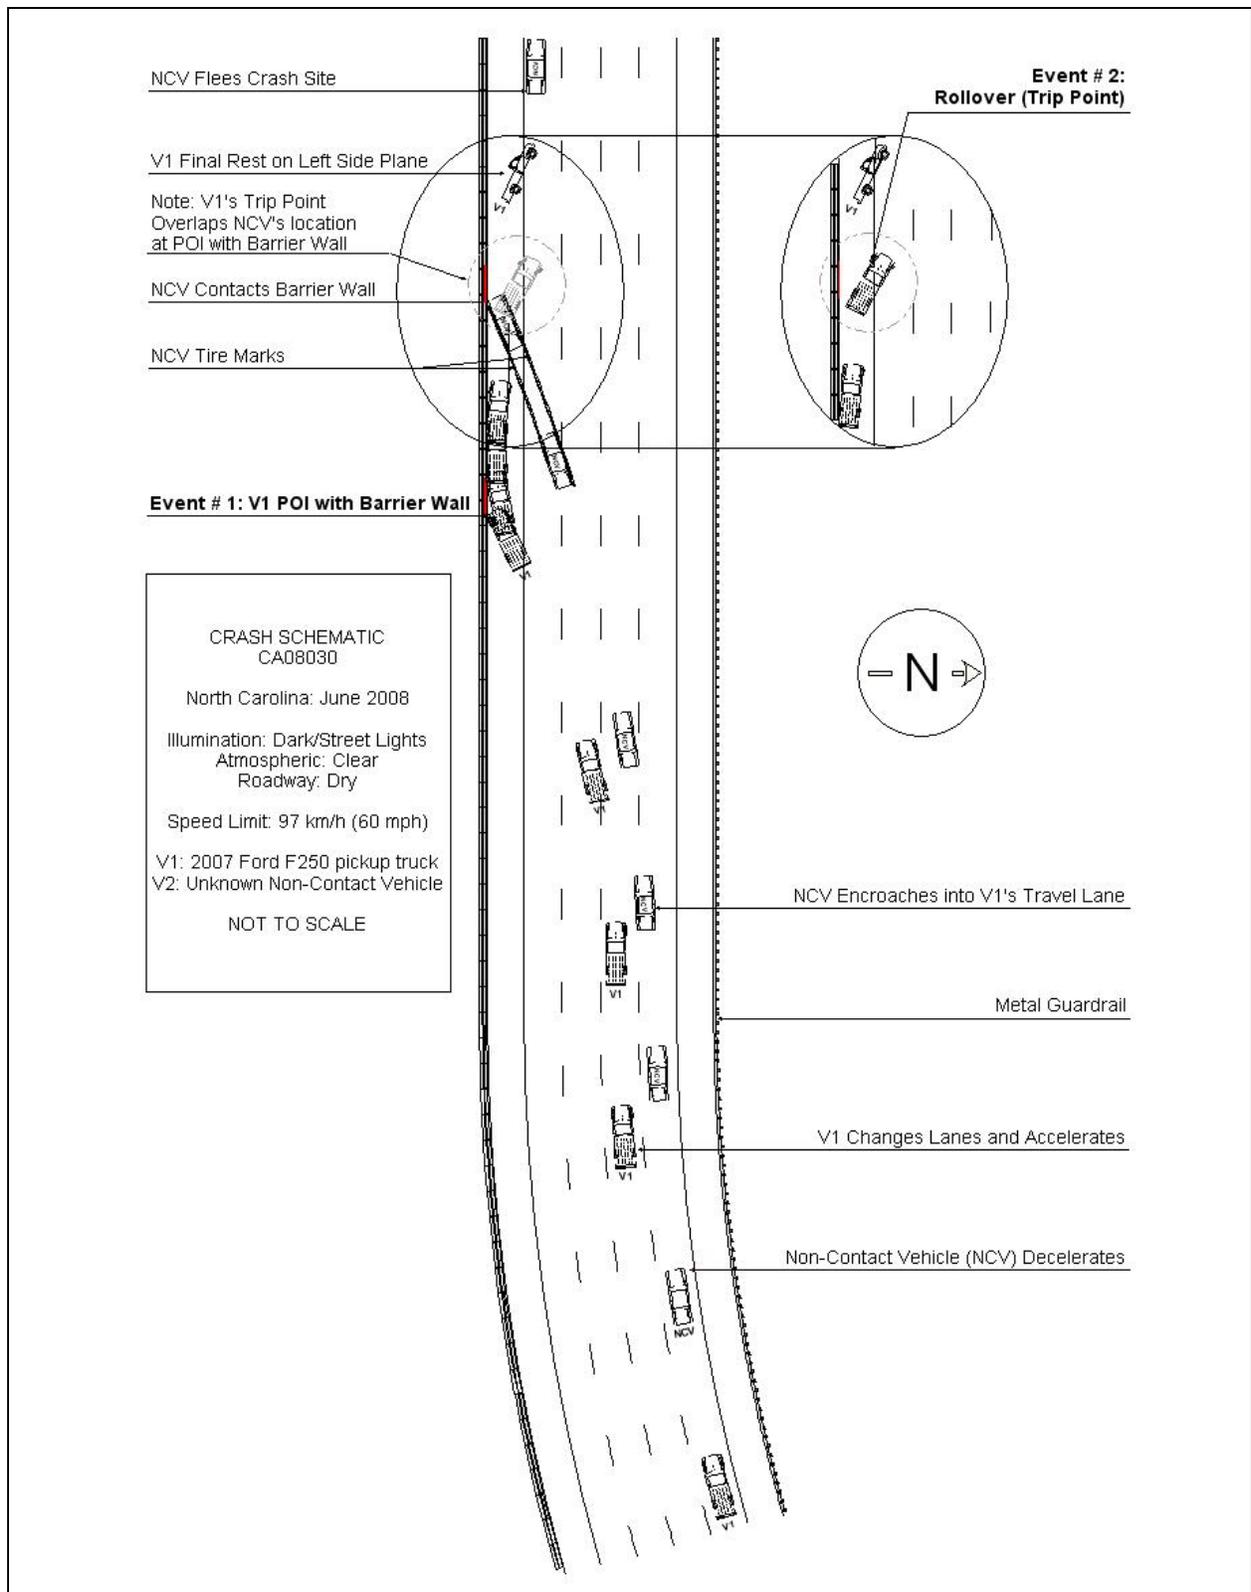
**Figure 8: Crash Schematic**
