## ON-SITE SIDE IMPACT INFLATABLE OCCUPANT PROTECTION INVESTIGATION

CASE NUMBER - IN08030  
LOCATION - TEXAS  
VEHICLE - 2007 CHEVROLET IMPALA LT  
CRASH DATE - May 2008

1. <i>Report No.</i> IN08030		2. <i>Government Accession No.</i>		3. <i>Recipient's Catalog No.</i>	
4. <i>Title and Subtitle</i> On-Site Side Impact Inflatable Occupant Protection Investigation Vehicle - 2007 Chevrolet Impala Location - Texas			5. <i>Report Date:</i> April 6, 2009

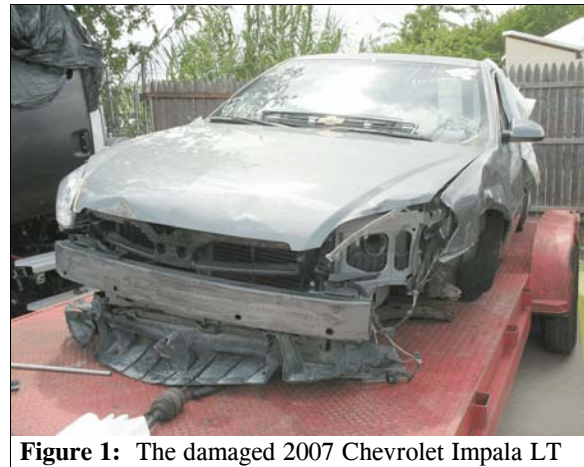
**Figure 1:** The damaged 2007 Chevrolet Impala LT

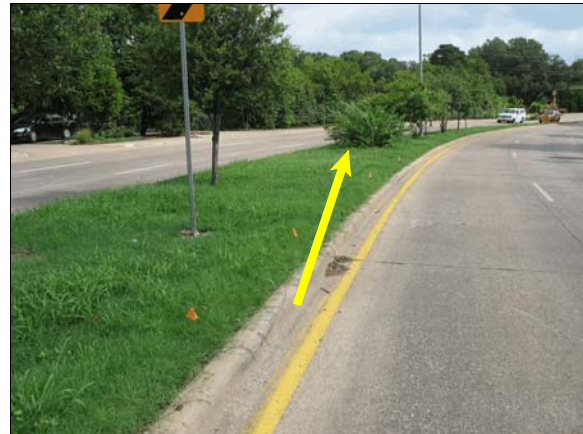
**Figure 3:** Chevrolet's median curb and shrub impacts (arrow shows path of vehicle)

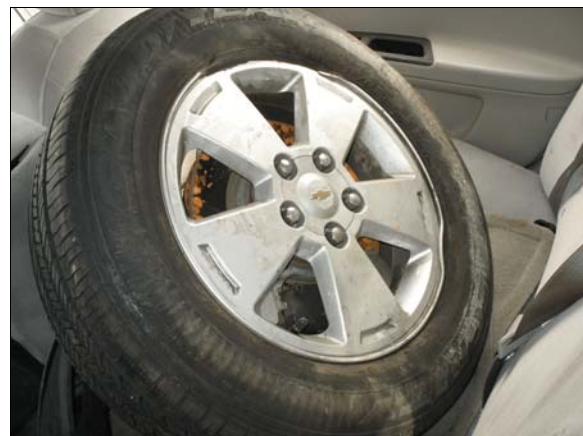
**Figure 4:** Left front wheel damage from curb impacts

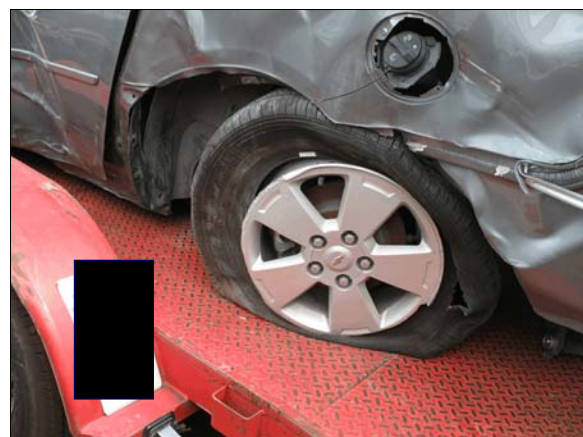
**Figure 5:** Left rear wheel damage from curb impacts

**Exterior Damage:** The Chevrolet’s curb impacts (events 1, 2, 4, and 5) involved the left front and rear wheels (**Figures 5 and 6**) and both rims were damaged in multiple areas. The impact with the foliage in the median (event 3) involved the frontal plane. The direct damage involved the bumper fascia and hood. The front of the vehicle had overlapping damage from events 6 and 7 (tree/shrub and fence), which involved the whole front end. The bumper fascia and energy absorbing material were removed, and there was no residual crush to the bumper bar (**Figure 7**). The direct damage from the vehicle’s impact with the fence (Event 7) involved the entire lower portion of the bumper fascia (**Figure 7**) and consisted of scratches. There was no induced damage observed. The Chevrolet’s next four impacts (events 8, 9, 10 and 11) to the fence, trees, and bushes involved the left and right sides. For the first of these impacts (Event 8), only the left fender was directly damaged (**Figure 8**). The direct damage began 365 cm (143.7 in) forward of the left rear axle (extrapolated from an exemplar vehicle due to the displacement of the left rear axle and the missing left front wheel on the subject vehicle) and extended rearward 109 cm (42.9 in). The induced damage involved the hood, fender, and the left front turn light/headlamp assembly. The crush measurements for this impact were taken at the mid-fender level and the residual maximum crush was 8 cm (3.1 in), occurring at C<sub>3</sub>. The Chevrolet’s second left side impact with the trees and bushes (Event 9) involved the left rear half of the vehicle (**Figure 9**). The direct damage involved the left front and rear doors, left rear wheel, left quarter panel, and a portion of the side of the back bumper fascia. The direct damage began 146 cm (57.5 in) forward of the left rear axle and extended 255 cm (100.4 in) rearward. The induced damage involved the left front door, left rear door, and quarter panel. The crush measurements were taken at the mid-door and lower quarter panel level and the residual maximum crush was 14 cm (5.5 in), occurring at C<sub>3</sub>. The Chevrolet’s third impact with the fence, trees, and bushes (Events 10 and 11) involved the right side plane. The direct damage involved the right fender, right front door, hood, and right front wheel (**Figure 10**). The direct damage began 364 cm (143.3 in) forward of the right rear axle and extended rearward 180 cm (70.9 in). The crush measurements were taken at the lower door and fender level, and the residual maximum crush was 12 cm (4.7 in) occurring at C<sub>3</sub>. The crush was primarily due to the impact with the trees (Event 11), but scratches from the fence impact (Event 10) also overlapped the damage area. The Chevrolet’s right wheelbase was shortened 4 cm (1.6 in). The left wheelbase measurement could not be determined due to the detached left front wheel. Induced damage involved the right front door. The tables below show the crush profiles for events 8, 9, and 11.

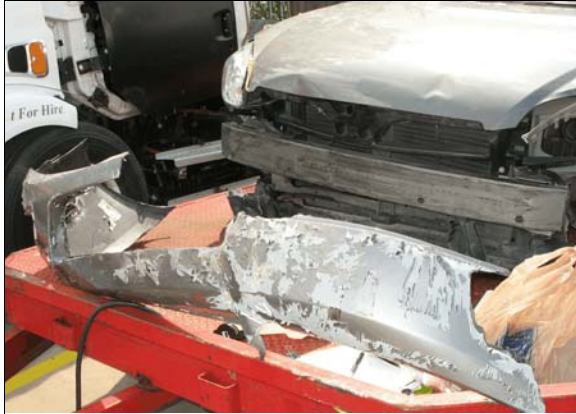
**Figure 6:** Damage to the front and front bumper fascia

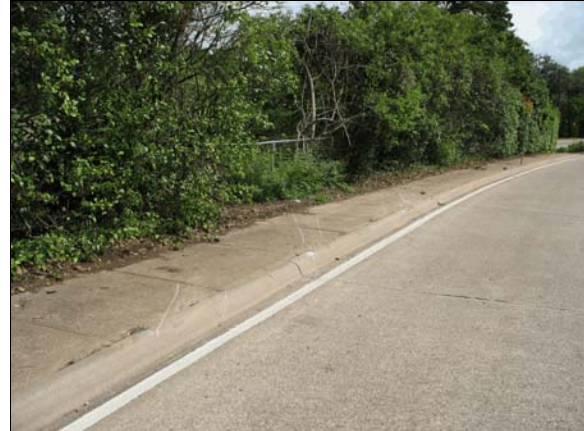
**Figure 7:** Area of multiple impacts on northwest side of south travel lanes

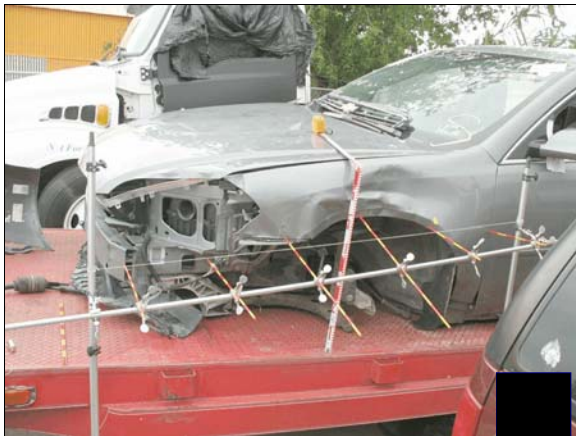
**Figure 8:** Damage to the left fender

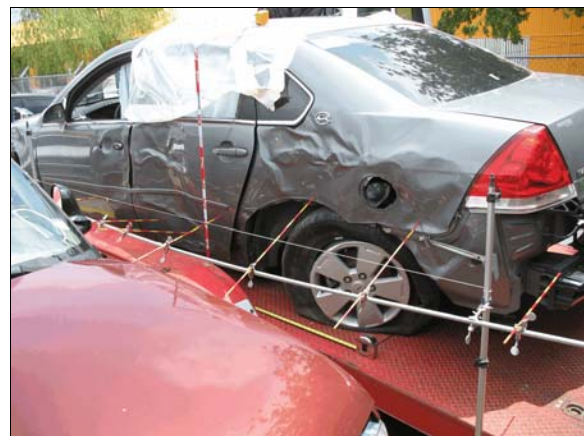
**Figure 9:** Damage to left side doors and quarter panel

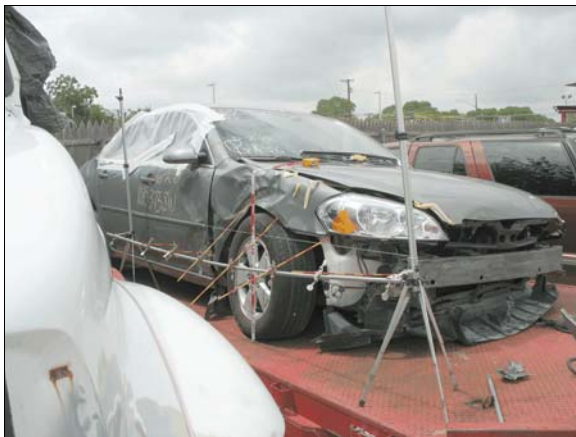
**Figure 10:** Right side damage

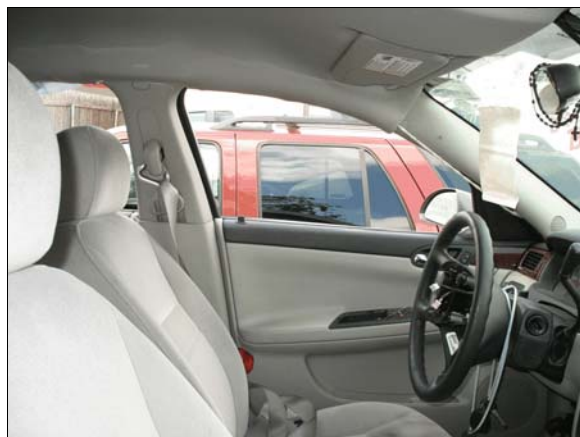
**Vehicle Interior:** The inspection of the Chevrolet's interior (**Figures 11 and 12**) revealed no discernable evidence of occupant contact. There was steering rim deformation or compression of the energy absorbing steering column. All the doors remained closed and operational. The left front and left rear window glazing was open and the remaining glazing was either fixed or closed. The windshield glazing was cracked and in place due to impact forces, and the left rear glazing was disintegrated due to impact forces. The remainder of the Chevrolet's glazing was undamaged. The vehicle sustained no passenger compartment intrusion.

**Figure 11:** Driver's seating area

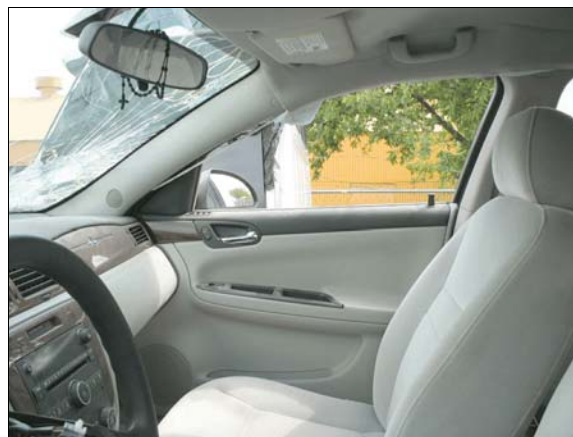
**Figure 12:** The front right passenger's seating area

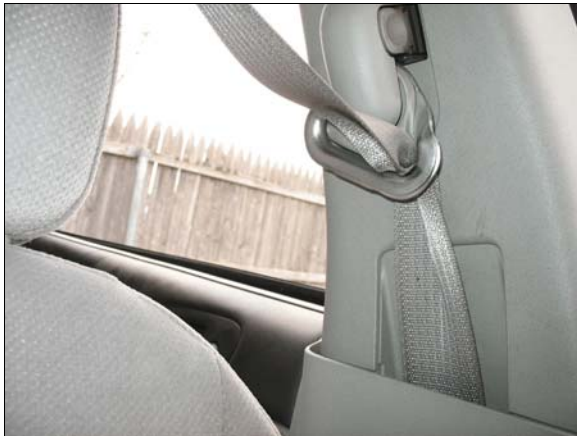
The inspection of the driver's and front right passenger's seat belt systems revealed that the pretensioners had actuated in the crash. The webbing of both belts was wedged in the forward corner of their respective D-rings (**Figures 13** and **14**). The wedge point on the driver's seat belt was 100 cm (39.4 in) from the stop button and 90 cm (35.4 in) for the front right passenger's seat belt. When unwedged from the D-ring, the front right belt webbing would not retract and the webbing for both belts had a slightly stretched appearance. The evidence indicated that the driver and front right passenger were restrained by the lap-and-shoulder belt. The EDR also recorded the driver and front right passenger seat belt switch circuit status as buckled. Inspection of the second row right passenger's seat belt system revealed no evidence that it was in use during the crash. The front center, second row left, and second row center seat positions were not occupied.

**Figure 13:** Driver's seat belt webbing wedged in D-ring

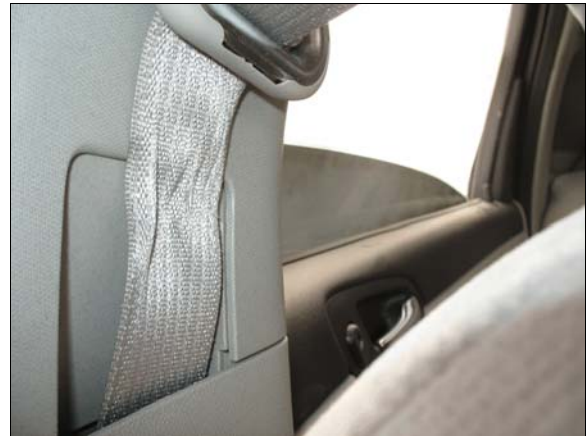
**Figure 14:** Front right seat belt and D-ring
