On-Site Certified Advanced 208-Compliant Air Bag Investigation  
Dynamic Science, Inc. (DSI), Case Number DS08034  
2008 Lexus RX350  
Washington  
August 2008

1. Report No. DS08034	2. Government Accession No.	3. Recipient Catalog No.	
4. Title and Subtitle On-Site Certified Advanced 208-Compliant Air Bag Investigation		5. Report Date September 3, 2009

**Dynamic Science, Inc.**  
**Crash Investigation**  
**Case Number: DS08034**

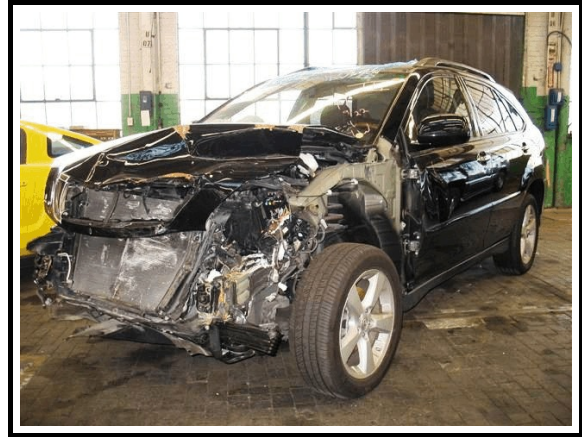
This on-site Certified Advanced 208-Compliant (CAC) Air Bag Investigation focused on the air bags in a 2008 Lexus RX350 (**Figure 1**) that was involved in a frontal crash with a 1992 Chevrolet K1500 Blazer. The Lexus was equipped with advanced dual-stage Certified Advanced 208-Compliant (CAC) driver and front right passenger frontal air bags. The air bags were certified by the manufacturer to be compliant with the advanced air bag requirements of Federal Motor Vehicle Safety Standard (FMVSS) No. 208.

**Figure 1.** Subject vehicle, 2008 Lexus RX350

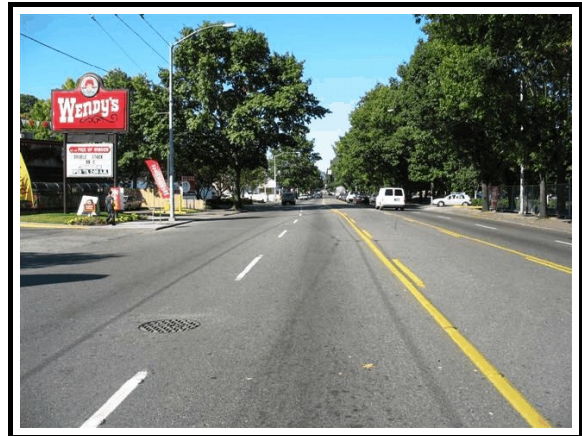
The crash site was at the intersection of a north/south roadway and a commercial driveway (**Figure 2**). The north/south roadway was configured with two lanes for each direction of travel and a center two-way left turn lane. The through lanes were separated by white dash stripes and the two-way left turn lane was separated from the through lanes by yellow dashed and solid stripes. The roadway was straight, level, and had a asphalt surface. The roadway was bordered on each side with raised curbs and sidewalks. The posted speed limit was 56 kmph (35 mph).

**Figure 2.** Crash site, looking north

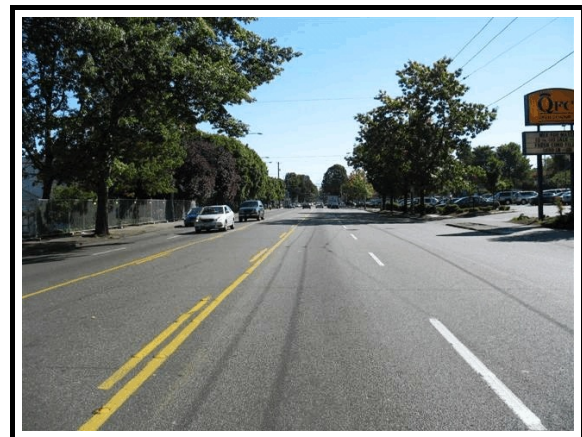
This crash occurred in August 2008 during daylight at 1903 hours. The weather was clear and the roadway was dry. The Lexus was being driven by a 49-year-old female and was traveling southbound in the inboard lane at a driver-estimated speed of 56-61 km/h (35-38 mph) (**Figure 3**). A 48-year-old female occupant was seated in the vehicle's front row right position. The driver of the Lexus had both hands on the steering wheel, her right foot on the accelerator, and her left foot on the floor. She observed the Chevrolet approaching from the opposite direction; she braked and steered to the right in an evasive response.

**Figure 3.** Southbound approach, subject vehicle

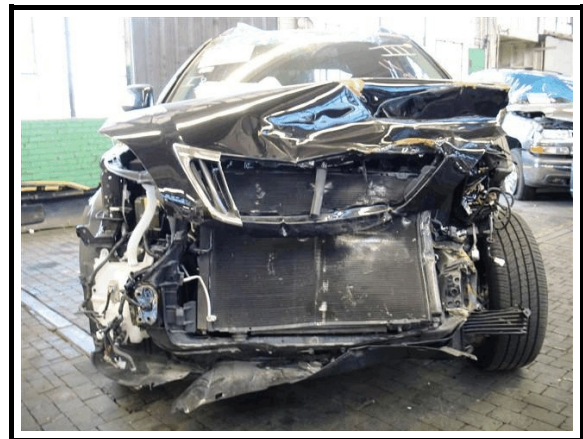
The Lexus sustained moderate front end damage as a result of the impact with the Chevrolet (**Figure 4**). The front bumper fascia and backing bar were detached from the vehicle, the hood was buckled and the left and right front fenders and headlamps were missing. The bumper backing bar was located in the vehicle's cargo area and was fractured. The radiator was displaced rearward and there was damage to components within the engine compartment.

**Figure 4.** Front end damage, subject vehicle

The front bumper fascia was found within the vehicle's rear cargo area and was used to measure the location and extent of direct damage. The direct damage to the front end began at the front left bumper corner, extended 142 cm (14.2 in) to the right, and ended at the front right bumper corner. Crush measurements were taken at the left and right front bumper mounts and the lower radiator support as follows: C1 = 27 cm (10.6 in), C2 = 25 cm (9.8 in), C3 = 23 cm (9.1 in), C4 = 19 cm (7.5 in), C5 = 15 cm (5.9 in), C6 = 11 cm (4.3 in). The maximum crush to the front end measured 27 cm (10.6 in) and was located at C1. The Collision Deformation Classification (CDC) for the first impact was 11FDEW2.

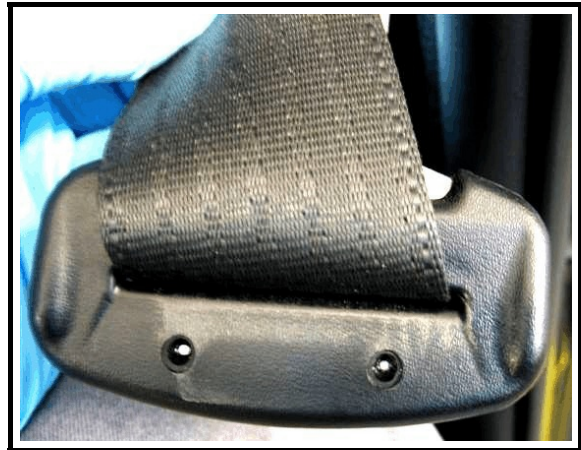
**Figure 5.** Abraded latch plate, driver's safety belt

The driver's safety belt retractor was locked with the belt webbing in the used position due to the actuated retractor pretensioner. The plastic casing on the latch plate showed evidence of occupant loading in the form of scuff marks deposited by the safety belt webbing (**Figure 5**). Based on evidence of occupant loading and the locked position of the webbing, it was determined the front row left safety belt was used to restrain the driver.

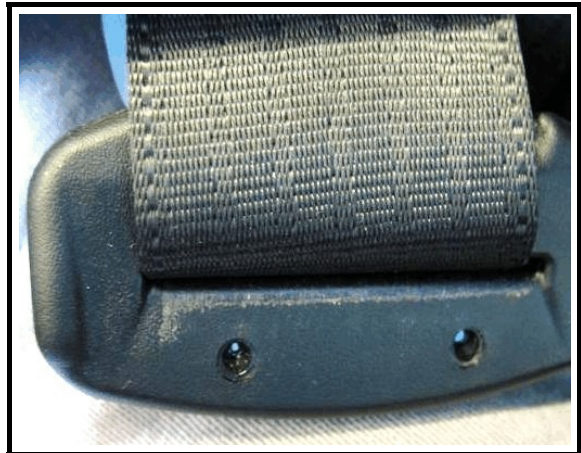
**Figure 6.** Abraded latch plate, front right occupant's safety belt

The front row right occupant's safety belt retractor was locked with the belt webbing in the used position due to the actuation of the retractor pretensioner. The plastic casing on the latch plate showed evidence of occupant loading in the form of scuff marks left by the safety belt webbing (**Figure 6**) and the webbing was abraded in two areas. The abraded areas were measured with the belt in the buckled position. The first abraded area was located at 13 cm (5.1 in) below the D-ring, and extended 9 cm (3.5 in) toward the buckle. When the occupant loaded the safety belt and the pretensioner actuated, the abraded area was contacted by the D-ring. The second abraded area was contacted by the latch plate, and measured 11 cm (4.3 in) in length. Due to evidence of occupant loading and the locked position of the belt webbing, it was determined the front right safety belt was used to restrain the right occupant.

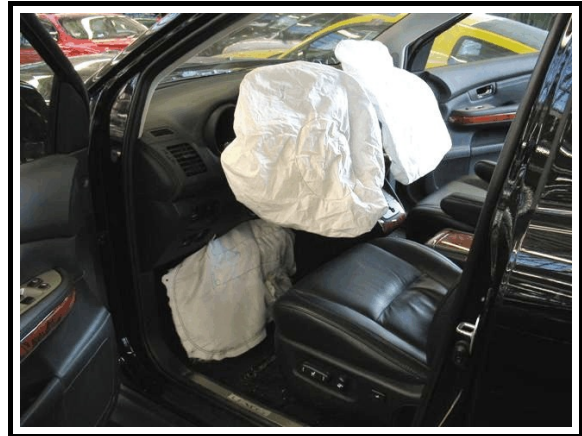
The two frontal air bags and the driver's knee air bag deployed during the crash (**Figure 7**). The left and right seat-mounted side air bags and side impact IC air bags did not deploy.

**Figure 7.** Deployed frontal and knee air bags

The driver's frontal air bag deployed from the steering wheel hub through one upper and two lower cover flaps. The cover flaps opened at the tear seams and there was no damage to them or the air bag. The bag was circular in shape and measured 60 cm (23.6 in) in diameter. A circular stitching pattern in the bag's front center measured 22 cm (8.7 in) in diameter and connected the air bag's front panel to two internal tethers. Two vent ports were located on the back of the air bag in the upper aspect. The vent ports comprised a series of three slots which were cut in the shape of small arrows. They measured approximately 5 cm (2.0 in) in length and 1 cm (.4 in) in width.

Three dark-colored transfer marks were located on the front panel of the driver's frontal air bag. The first transfer measured 3 cm (1.2 in) in length and was located in the upper left quadrant, 30 cm (11.8 in) from the center. This transfer was determined to be a makeup transfer deposited when the driver's face loaded the air bag. The second transfer measured 8 cm (3.2 in) in length was located in the upper right quadrant, 22 cm (8.7 in) from the center. This transfer was determined to be a fabric transfer deposited when the air bag contacted the driver's right forearm during deployment. The third transfer measured 3 cm (1.2 in) in length and was located in the lower right quadrant, 26 cm (10.2 in) from the center. This contact was determined to be a fabric transfer deposited when the air bag contacted the driver's right thigh during deployment.

The driver's knee air bag deployed from the lower left instrument panel through one upper and one lower cover flap. The bag was rectangular in shape and measured 60 cm (23.6 in) in width and 35 cm (13.8 in) in length. A rectangular sail that measured 20 cm (7.9 in) in width and 30 cm (11.8 in) in length was stitched to the air bag's lower right quadrant. The knee air bag was designed without vent ports or tethers. Two occupant contacts were located on the front panel of the air bag. One contact was a smudge mark that measured 5 x 15 cm (2.0 x 5.9 in) and was located in the upper left quadrant, and the second contact was a black transfer mark that measured 5 x 2 cm (2.0 x 0.8 in) and was located in the lower right quadrant. The contacts were determined to be fabric transfers deposited when the driver's lower legs loaded the knee air bag.

The right passenger's frontal air bag deployed from the top right instrument panel through a single rectangular cover flap. The flap opened at the tear seams and was not damaged. The air bag was configured with two round vent ports that measured 5 cm (2.0 in) in diameter and were located on the upper rear panel. The bag was octagonal in shape and measured 64 cm (25.2 in) in diameter. No damage or evidence of occupant contact was observed on the air bag.
