CALSPAN ON-SITE AMBULANCE CRASH INVESTIGATION

SCI CASE NO: CA08034

**VEHICLE: 2005 FORD E450 CHASSIS
HORTON CUSTOM AMBULANCE MODULE**

CRASH DATE: JUNE, 2008

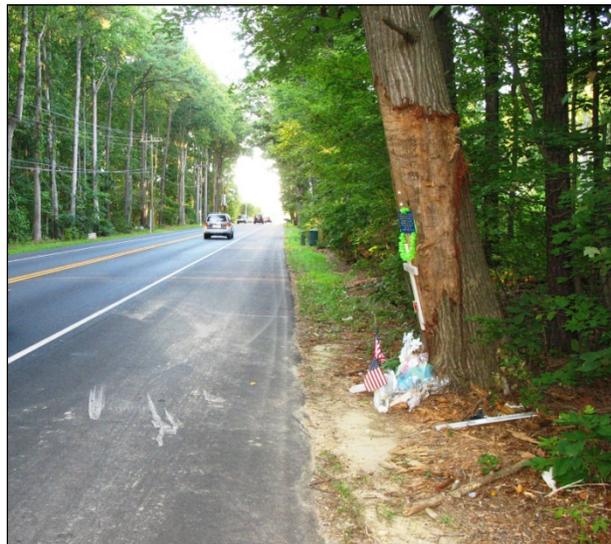
The first impact occurred when the front right corner area of the cab of the ambulance impacted the large diameter oak tree. The front right corner of the ambulance was crushed and displaced rearward by the 12 o'clock direction of force. The upper right corner of the protruded frontal plane of the ambulance module impacted the angled tree. As the ambulance engaged the tree, the module sustained severe integrity loss as the right side of the module separated full-height from its front right corner rearward to the forward edge of the right rear exterior storage compartment.

Figure 8: Tree struck by right front of ambulance.

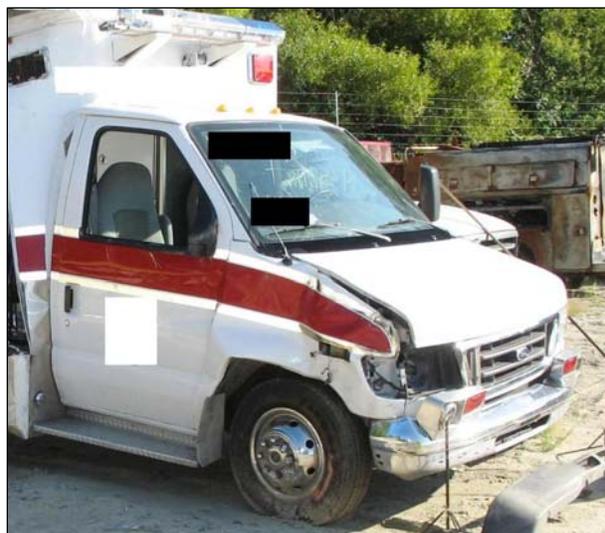
The front of the ambulance sustained moderate damage from the crash. There was rearward crush to the bumper, grille, hood, and right fender. The fiberglass hood had a fracture to its right aspect. The right headlight assembly had disintegrated, and the right mirror was sheared mid-support stalk. Bark and other debris were embedded within the cast aluminum emergency siren speaker box mounted on the right bumper corner, as well as the forward aspect of the right front fender and the remnants of the right mirror support stalk.

Figure 9: Damage to Ford chassis.

Scratching and abrasions from contact with the bark of the trees covered the protruding edges of the front right body panels. Five lug nut caps on the right front wheel were bent or separated. The windshield glazing was shattered in a spider web pattern, right laterally offset from centerline. Integrity loss to the cab was limited to the disintegration of the right front glazing.

Direct contact damage extended 15 cm (6 in) inboard from the front right bumper corner. The direct and induced damage Field L extended across the entire bumper width from corner to corner. The residual crush measured along the bumper was as follows: C1 = 7 cm (3 in), C2 = 2 cm (1 in), C3 = 1 cm (0.5 in), C4 = 1 cm (0.5 in), C5 = 3 cm (1 in), and C6 = 11 cm (4.5 in). Maximum crush was located on the right bumper corner at C6. Severe damage was sustained by the ambulance module from this event, and is summarized in a latter section designated as such. The Collision Deformation Classification associated with this event was 12FRAE9.

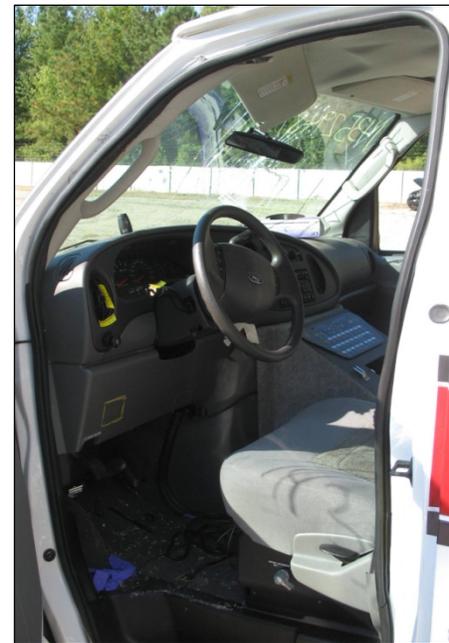
Occupant contact in the cab was limited to the front left occupant position. An area of scuffing was found on the knee bolster 76-83 cm (30-32.5 in) left of center, located 38-43 cm (15-17 in) below the top of the instrument panel.

A second area of knee bolster scuffing was found 46-52 cm (18-20.5 in) left of center, 47-51 cm (18.5-20 in) below the top of the instrument panel. The Heating, Ventilating, and Air Conditioning (HVAC) vent outboard of the steering column was fractured at its lower aspect. The end of turn signal stalk on the left side of the steering column was fractured and missing. These contacts are highlighted by yellow markings in **Figure 10**.

Figure 10: Left front occupant position.

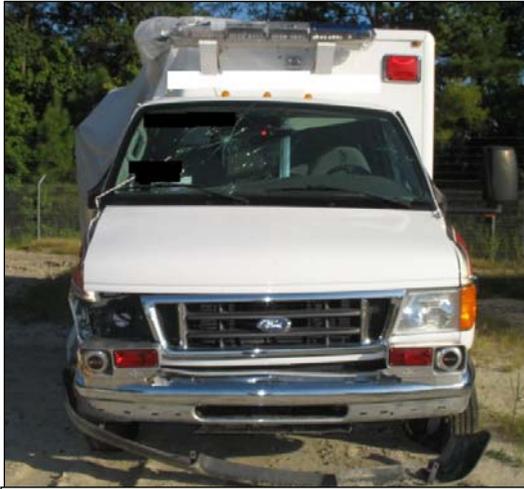
Figure 12: Frontal view of ambulance.

Figure 11 depicts a frontal view of the ambulance (note damage to the module on the right side in relation to the left), while **Figure 12** shows the severe integrity loss to the right side.

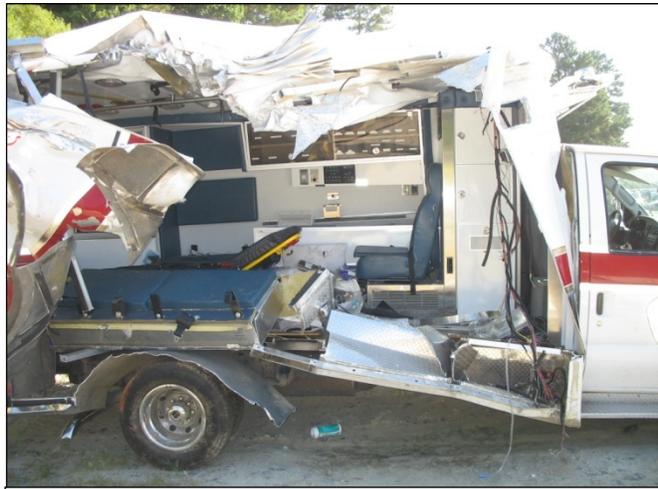
The ambulance module sustained severe exterior and interior damage from the crash. Direct contact damage from the first impact extended along the forward roof rail from the front right corner extending 48 cm (19 in) inboard and extending downward 104 cm (41 in). There was also direct damage on the right aspect of the protruding light bar. The upper right corner was folded

inward 51 cm (20 in). The majority of the right side of the ambulance module was separated. There was a gaping hole extending full-height from the front right chassis cab seam to rear of the right rear axle.

Figure 11: Integrity loss to right side of ambulance module.

Along its upper aspect, the right roof side rail was torn completely away from the roof framework from the front right corner rearward to 31 cm (12 in) forward of the rear axle, a length of 279 cm (110 in). The second of the six major roof frame rails, with respect to the front of the module, was crushed rearward approximately 76 cm (30 in) at its right aspect.

The forward four of the six major roof frame rails were fully exposed on the right side of the roof, having separated from the roof side rail at their gussets. The paneling of the roof was crushed rearward on its right side and exhibited a distinct U-shaped fold pattern from direct engagement with the large diameter oak tree.

The right passenger access and right forward storage compartment doors were separated completely from the ambulance module. The right side exterior body paneling spanning from the access door to the rear storage compartment, including the right rear glazing above the rear axle, was crushed rearward to the forward edge of the rear storage compartment and separated at its upper and lower seams. Exterior fascia, trim, and molding were sheared and had separated full-height from the ambulance module, from the right front corner to the forward edge of the rear storage compartment. The lower frame rail was bent upward from the forward corner to the rear axle. Portions of the frame rails of the floor were exposed, exhibiting rearward shift at their right aspects.

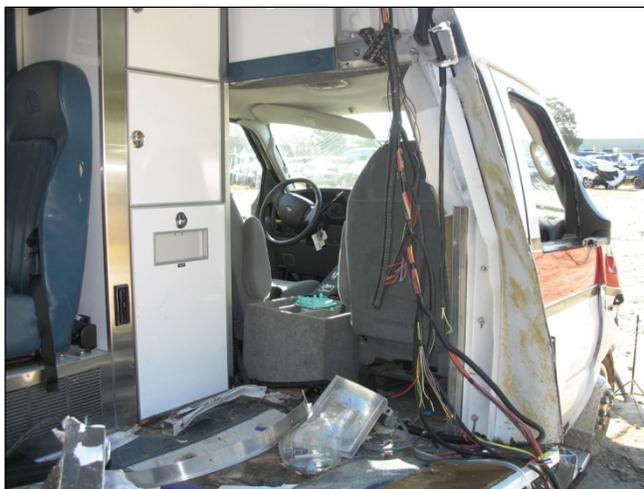
Interior damage was extensive due to the integrity loss on the right side. The entire stack of compartments in the forward right corner of the patient compartment was sheared away on all sides, as depicted in **Figure 13**. The corresponding forward wall that separated the patient compartment from the cab and contained the center pass-through was separated on the right side.

The wall-mounted seatback of the left-facing three-passenger bench seat was also separated as a direct result of the integrity loss. The seat cushion of the bench seat was angled downward on its outboard edge.

Figure 13: Forward right corner of patient compartment.

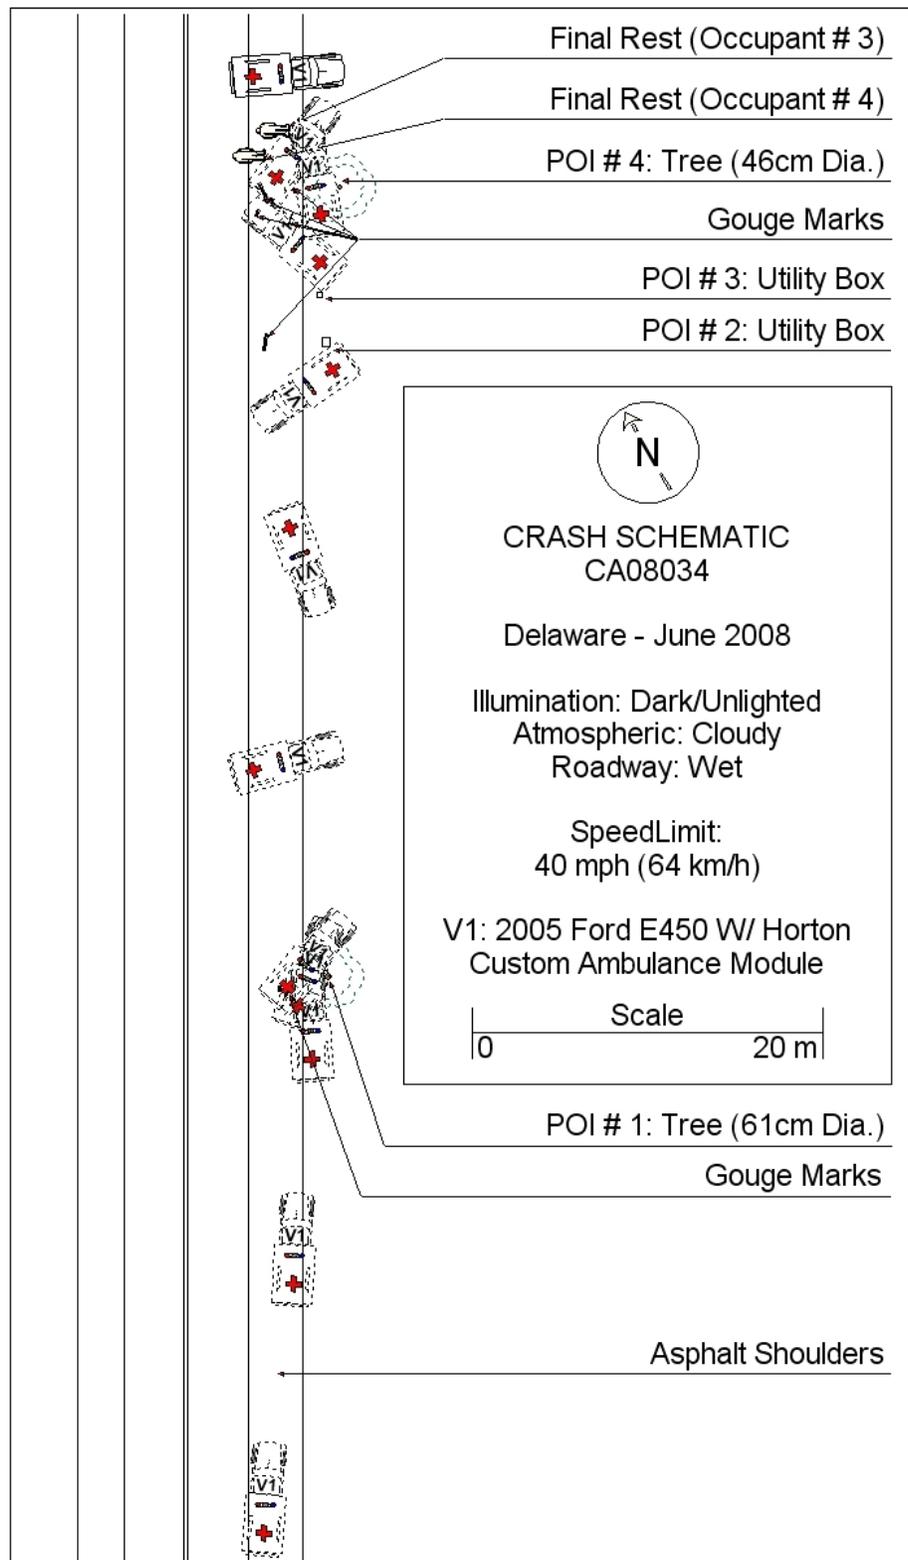
The offset right impact initiated a clockwise (CW) rotation. The ambulance continued on its northbound trajectory for 36.3 m (119 ft) as it rotated approximately 250 degrees CW. The second impact occurred as the ambulance impacted

the first utility box. Gouge marks in the shoulder surface from the right front wheel identified the angle of the vehicle at impact. The ambulance maintained its CW rotation for approximately another 40 degrees and impacted the second utility box. After continuing to maintain its northbound trajectory and CW rotation for another 6.1 m (20 ft), the right side of the ambulance module struck the large diameter pine tree.

The occupants of the CPR seat and stretcher were ejected from the patient compartment through the gaping right-sided integrity loss of the module as the ambulance completed its final 160 degrees of CW rotation. The vehicle came to rest 8.6 m (28 ft) from the final impact location, facing eastward, and perpendicular to the roadway.

The final rest position was evidenced by rear axle tire location markings painted on the road surface by local police, located 53.7 m (176 ft) from the point of the initial impact. Total CW rotation of the ambulance during the crash sequence was 450 degrees. The ejected occupants came to rest on the roadway within the ambulance's travel path, between its final impact and final rest positions.

Figure 14: Crash schematic.
