## ON-SITE ROLLOVER INVESTIGATION

CASE NUMBER - IN08039

VEHICLE - 2008 CHEVROLET K1500 SILVERADO Z71 4X4 CREW CAB

CRASH DATE - September 2009

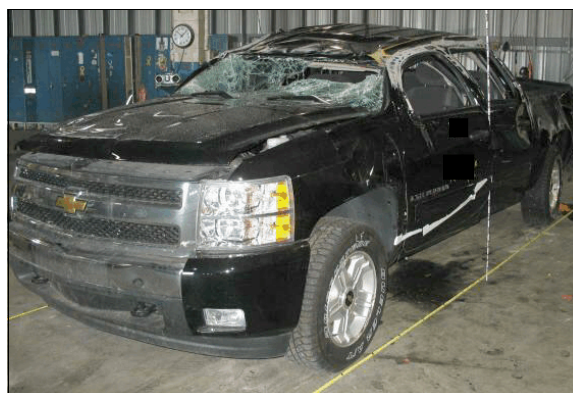
**Figure 1:** The damaged 2008 Chevrolet K1500 Silverado Z71 4x4 Crew Cab pickup truck

**Exterior Damage:** The damage from the rollover (**Figures 1 and 5**) involved the Chevrolet's top plane and both side planes. The direct damage involved the hood, roof, windshield, fenders, doors and the truck bed on both sides of the vehicle. The direct damage on the left side began 97 cm (38.2 in) rear of the left rear axle and extended 496 cm (195.3 in) forward. The direct damage on the top began 77 cm (30.3 in) forward of the right front axle and extended 340 cm (133.9 in) rearward and involved the full width of the roof, 116 cm (45.6 in). There was also a small

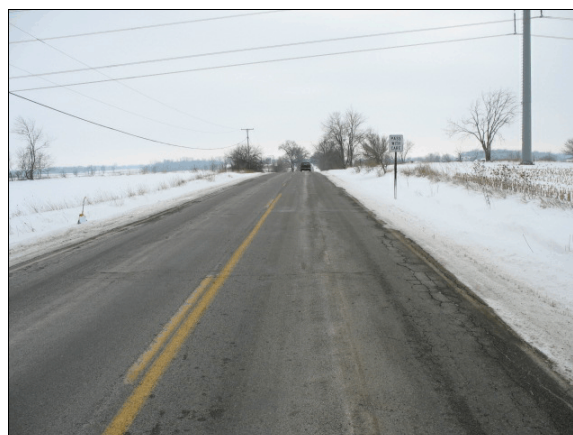
**Pre-Crash:** The Chevrolet was traveling south (**Figure 2**) and was occupied by a restrained 23-year-old male driver. The police crash report indicated that the driver had been consuming alcoholic beverages and his blood alcohol test result was 0.06. It is not known if the driver took any actions to avoid the crash.

**Figure 2:** Approach of the Chevrolet southbound to area of the rollover

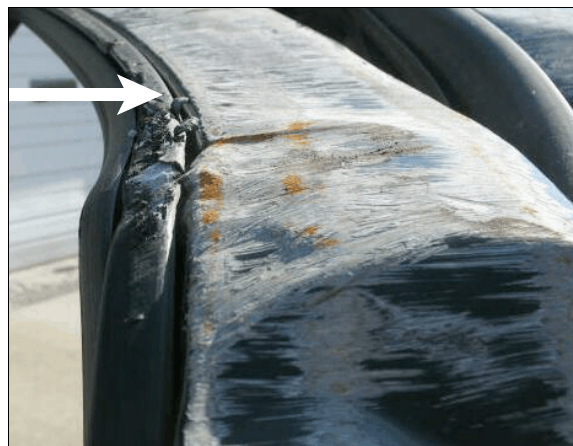
equipped with Electronic Stability Control (ESC), the driver was unable to regain control of the vehicle and it rolled over on the roadway. The direction that abrasions were formed on the damaged vehicle components (**Figures 3 and 4**) indicated that it rolled over with the left side leading. There was insufficient evidence at the crash scene to determine the area of rollover initiation, and an estimation of the number of quarter turns that occurred during the rollover could not be determined. Based on the police crash schematic, the vehicle came to final rest on its top in the center of the roadway heading southwest.

**Figure 3:** Front to rear view of top of right front door; arrow shows direction abrasions were formed

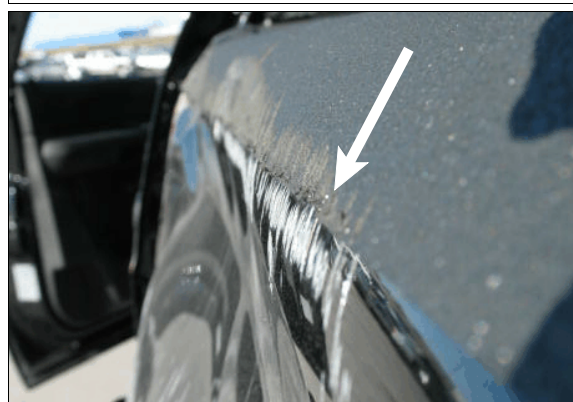
**Figure 4:** Arrow shows direction that abrasions were formed on the left side of the truck bed based on displacement of the bed liner material; view from back

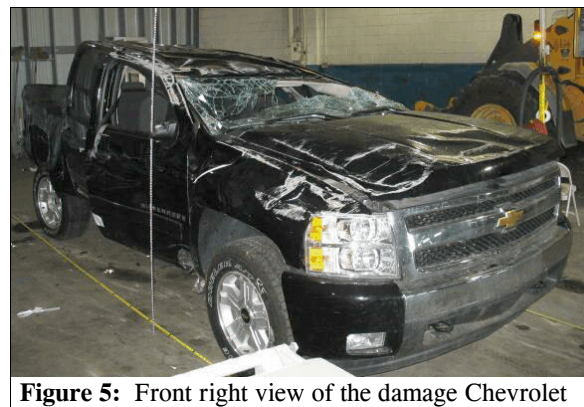
**Figure 5:** Front right view of the damage Chevrolet

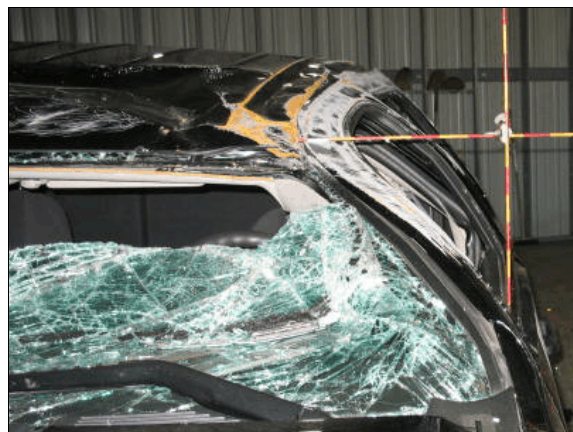
area of direct damage on the top left corner at the back of the truck bed. The maximum vertical and lateral crush occurred on the left A-pillar (**Figure 6**) and were 21 cm (8.3 in) and 19 cm (7.7 inches), respectively. The induced damage involved the roof, truck bed, back bumper, and the

**Figure 6:** The maximum vertical and lateral crush occurred on the left A-pillar

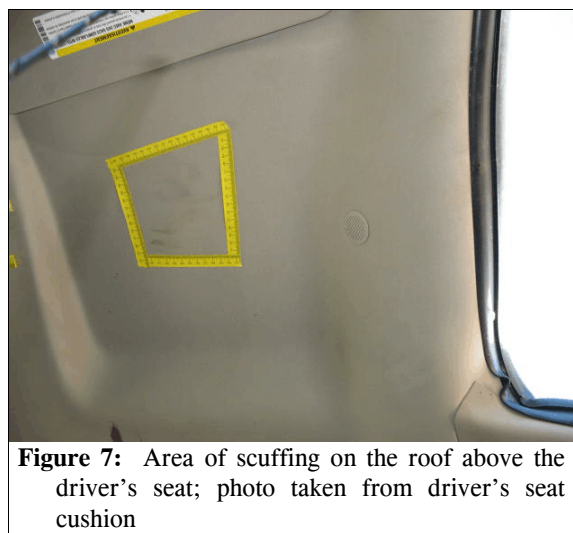
**Vehicle Interior:** Inspection of the Chevrolet's interior revealed a 15 x 12 cm (5.9 x 4.7 in) area of scuffing on the roof above and to the right of the driver's seat (**Figure 7**), which was probably the result of loading by the driver's head. There was also a scuff mark that extended 72 cm (28.3 in) across the roof from the roof console to the front right seating area (**Figure 8**). There were fluid stains within and adjacent to this area of scuffing that appeared to be from a spilled drink. The vehicle's right rear door was jammed shut and the other doors remained closed and operational. All the vehicle's window glazing were either closed or fixed. The left front, left rear, right front, and backlight glazing were disintegrated due to impact forces. The windshield glazing was in place and cracked by impact forces. The glazing

**Figure 7:** Area of scuffing on the roof above the driver's seat; photo taken from driver's seat cushion

Occupant kinematic principles indicate that as the vehicle rolled over, the driver was displaced toward the roof within his seat belt. The occupant contact scuff mark on the roof above the driver's seat indicated that the driver probably loaded his head on the intruding roof structure during the rollover.

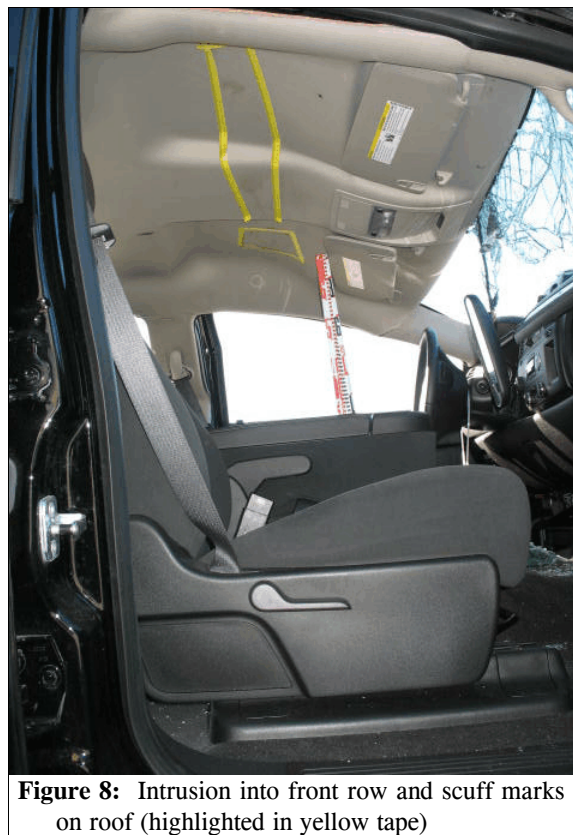
The Chevrolet sustained 15 intrusions into the passenger compartment. The most severe intrusions into the driver's occupant space (**Figure 8**) all occurred along the vertical axis and involved the left A-pillar, roof, windshield header, and the left roof side rail. The A-pillar and roof intruded 22 cm (8.7 in) while the windshield header and roof side rail intruded 21 cm (8.3 in) and 19 cm (7.5 in), respectively.

**Figure 8:** Intrusion into front row and scuff marks on roof (highlighted in yellow tape)
