**CALSPAN ON-SITE CERTIFIED ADVANCED 208-COMPLIANT VEHICLE
CRASH INVESTIGATION**

SCI CASE NO.: CA08040

VEHICLE: 2008 SATURN AURA

CRASH DATE: JULY 2008

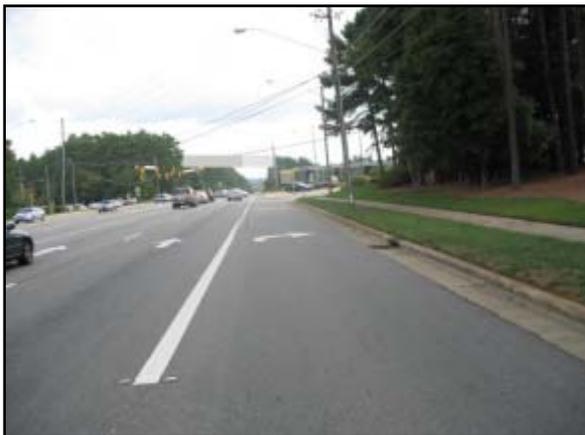
The unrestrained 26-year-old male driver was operating the Saturn in a southerly direction in the right turn only lane approaching the intersection (**Figure 2**) while under the influence of alcohol. Post-crash testing revealed a BAC of .09. Witnesses, including an off-duty police officer, observed the Saturn as it approached the intersection. One of the witnesses estimated the travel speed to be between 129-161 km/h (80-100 mph). The EDR data indicated that the vehicle speed was 153 km/h (95 mph) five seconds prior to Algorithm Enable (AE).

The driver's intention was to turn right at the intersection as he was en route to his residence. As the driver attempted a right turn at high speed, the Saturn continued its southerly travel direction and initiated a slight CW yaw. The investigating officer documented 37.5 (123 feet) of tire marks on the right turn only lane leading to the raised concrete gore. The Saturn departed the left side of the lane and mounted the gore as it rotated CW evidenced by off-tracking tire marks (**Figure 3**). The tire marks were documented on the gore area. The left side mark measured 6.9 meters (22.6 feet) and the right side mark measured 4.6 meters (15 feet) in length. The Saturn entered and crossed the westbound travel lanes as it began to return to a tracking mode. The Saturn continued 7.5 meters (24.6 feet) in a southerly travel direction as it traversed the westbound travel lanes.

Figure 2. Pre-crash approach in the right turn only lane.

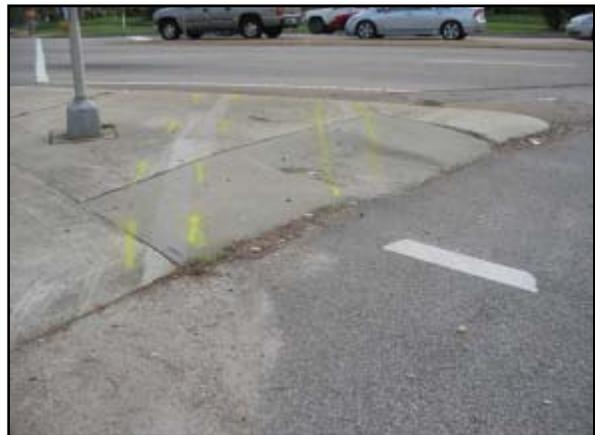
Figure 3. Saturn's travel across the concrete gore.

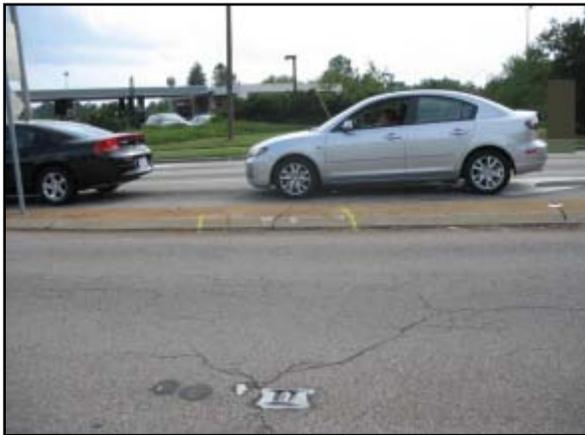
The undercarriage impacted the curb (Event 1) that bordered the center median (**Figure 4**). This impact resulted in two tire marks on the curb and median with multiple gouges to the referenced area. The Saturn traveled an additional 15 meters (49 feet) traversing the median and the eastbound travel lanes where it impacted the south curb with the undercarriage (Event 2). The vehicle mounted the curb and entered the roadside where it traveled 5.6 meters (18.4 feet) and struck a utility pole (Event 3) with the front left corner (**Figure 5**). As the vehicle crushed, the left front tire engaged the pole. This contact sheared the left tire and wheel from the axle. The utility pole was damaged from this

Figure 4. Undercarriage impact to the median.

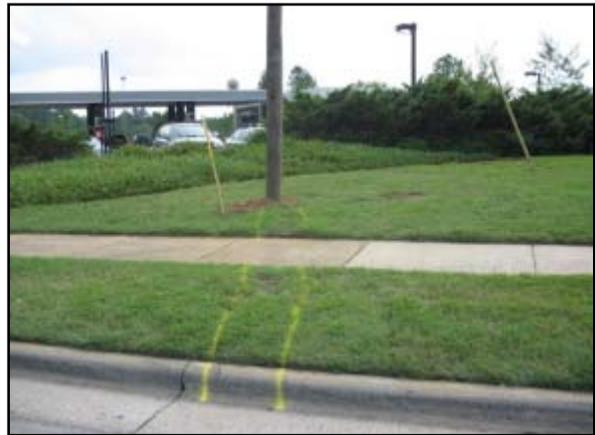
impact and was replaced prior to the SCI scene inspection. The Saturn rotated CCW approximately 130 degrees and came to rest near the pole facing a northeasterly direction.

Figure 5. Curb and utility pole impact.

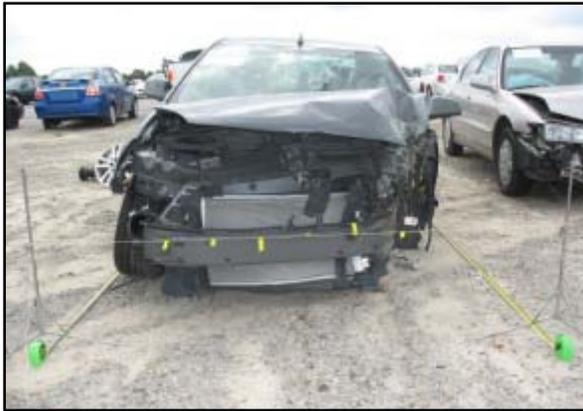
The Saturn sustained damage to the front and left side planes as a result of the utility pole impact. The damaged components included, but were not limited to, the bumper fascia, bumper beam, hood, left fender, and the left front wheel and suspension components. The direct contact damage began 36 cm (14.1") left of the centerline and extended 57 cm (22.4") to the left corner of the vehicle. The maximum crush measured 28 cm (11") and

was located on the corner of the left bumper beam. Six equidistant crush measurements were documented along the bumper beam of the vehicle and were as follows: C1 = 28 cm (11"), C2 = 20 cm (7.9"), C3 = 13 cm (5.1"), C4 = 6 cm (2.4"), C5 = 0 cm, C6 = 0 cm.

Figure 6. Residual frontal damage.

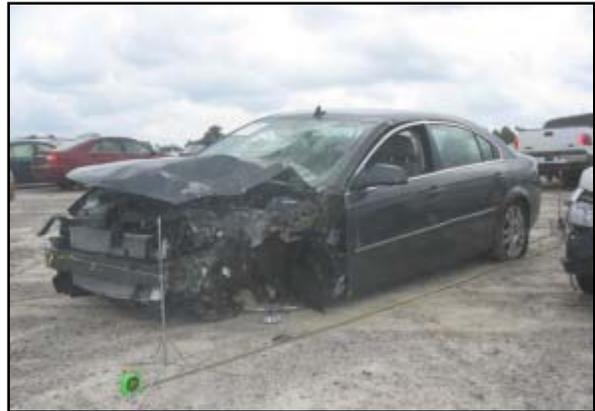
The damage from the utility pole extended down the left side of the vehicle. As the vehicle reached maximum engagement, the left front wheel engaged the pole. This engagement sheared the left front wheel from the axle. The Collision Deformation Classification (CDC) for the pole impact was 12-FLEE-4. **Figures 6 and 7** depict the residual damage to the front and left side planes.

Figure 7. Damage to the left front aspect of the vehicle.

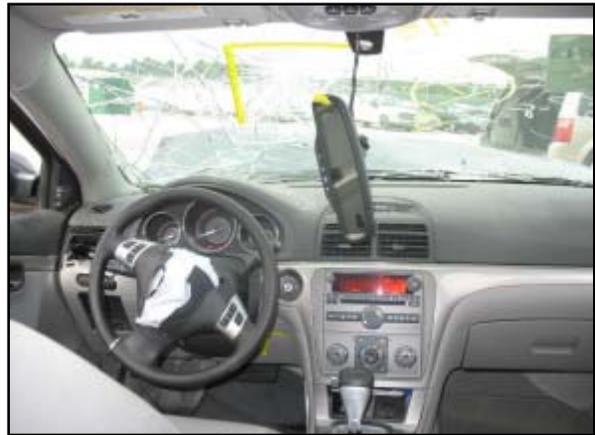
The interior of the Saturn sustained moderate damage that was associated with passenger compartment intrusion and occupant contact. The driver's toe pan was displaced rearward approximately 5 cm (2") and the floor buckled upward 5 cm (2") as a result of the pole impact and subsequent separation of the axle and suspension components. The unrestrained driver initiated a forward trajectory in response to the frontal pole impact. The driver's right hand contacted and displaced the rearview mirror forward into the windshield. This contact was evidenced by the displaced rearview mirror and the fractured windshield. The driver's torso loaded the deployed air bag resulting in the forces to be transmitted into the steering column. The loading compressed the steering column approximately 4 cm (1.5"). Two knee contacts were noted on the knee bolster. **Figure 8** is an overall view of the driver's area.

Figure 8. Overall view of the driver's side area.

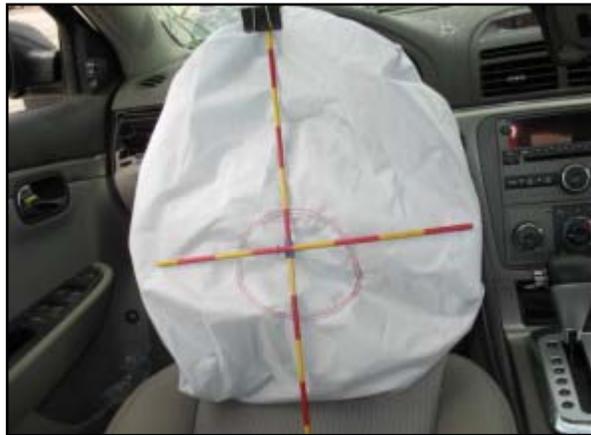
The driver's frontal air bag was contained within the three-spoke steering wheel rim and concealed by a tri-flap module cover. A narrow rectangular flap that measured 4 x 13 cm (1.6 x 5.1") was positioned across the top of the module with two I-configuration flaps immediately below. Both I-flaps were 14 cm (5.5") in height. The left and right flaps measured 9 cm (3.5") and 6 cm (2.4") in width, respectively. All flaps opened at the designated tear seams and there was no damage or occupant contact evidence to the flaps.

Figure 9. Deployed driver's frontal air bag.

The air bag membrane was 62 cm (24.4") in diameter in its deflated state. The air bag was internally tethered by two bands at the 12 and 6 o'clock positions. Two vent ports were located on the back side of the bag at the 11 and 1 o'clock positions. The face of the air bag contained black vinyl transfers that resulted from expansion of the bag within the module assembly. There was no damage to the air bag or evidence of driver loading.

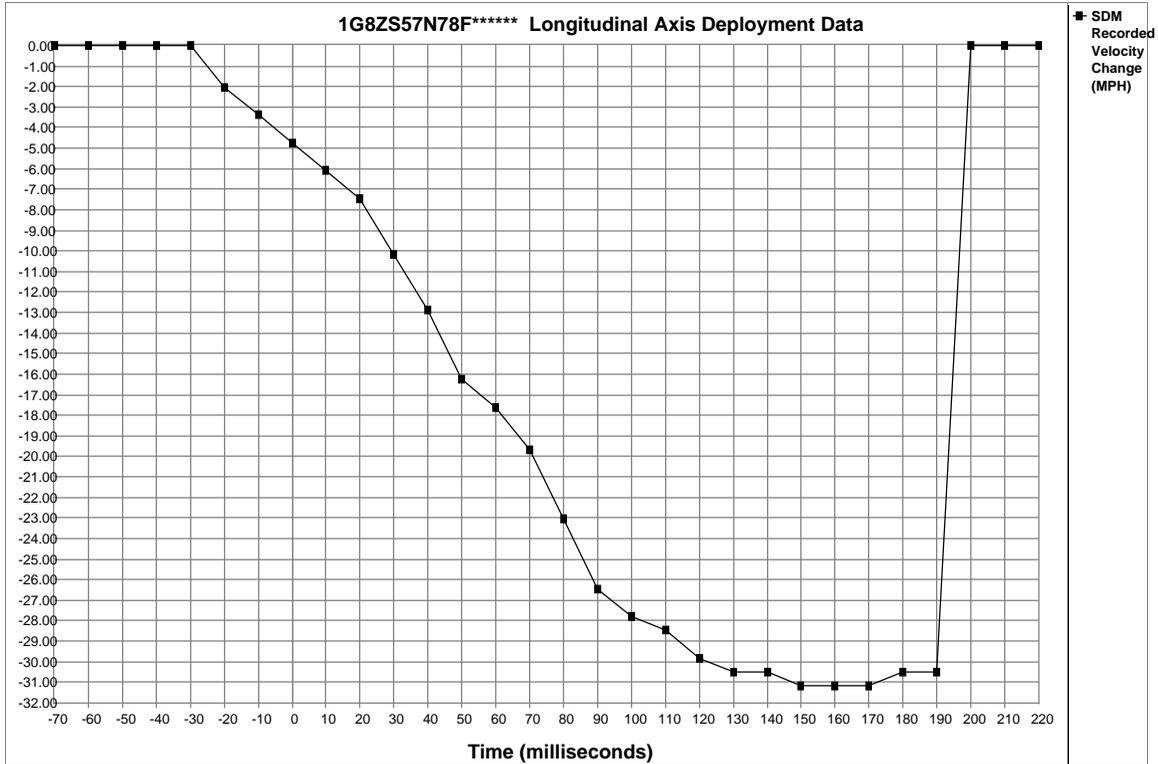
Time (milliseconds)	-70	-60	-50	-40	-30	-20	-10	0	10	20	30	40	50	60	70
SDM Longitudinal Axis Recorded Velocity Change (MPH)	0.00	0.00	0.00	0.00	0.00	-2.03	-3.39	-4.74	-6.10	-7.46	-10.17	-12.88	-16.27	-17.62	-19.66
Time (milliseconds)	80	90	100	110	120	130	140	150	160	170	180	190	200	210	220
SDM Longitudinal Axis Recorded Velocity Change (MPH)	-23.05	-26.44	-27.79	-28.47	-29.82	-30.50	-30.50	-31.18	-31.18	-31.18	-30.50	-30.50	0.00	0.00	0.00

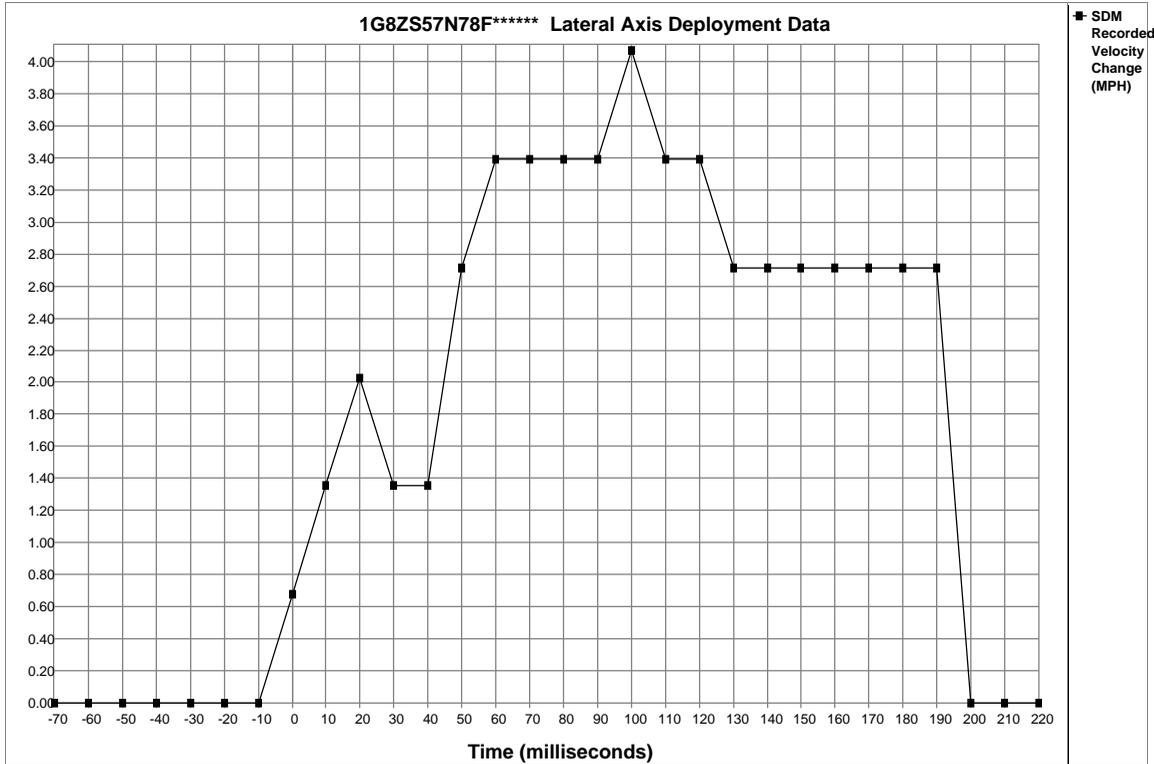
Time (milliseconds)	-70	-60	-50	-40	-30	-20	-10	0	10	20	30	40	50	60	70
SDM Lateral Axis Recorded Velocity Change (MPH)	0.00	0.00	0.00	0.00	0.00	0.00	0.00	0.68	1.36	2.03	1.36	1.36	2.71	3.39	3.39
Time (milliseconds)	80	90	100	110	120	130	140	150	160	170	180	190	200	210	220
SDM Lateral Axis Recorded Velocity Change (MPH)	3.39	3.39	4.07	3.39	3.39	2.71	2.71	2.71	2.71	2.71	2.71	2.71	0.00	0.00	0.00
