**CALSPAN ON-SITE CERTIFIED ADVANCED 208-COMPLIANT
VEHICLE CRASH INVESTIGATION
CALSPAN CASE NO: CA08041**

**VEHICLE: 2008 HONDA ACCORD
LOCATION: TENNESSEE
CRASH DATE: MAY, 2008**

Contract No. DTNH22-07-C-00043

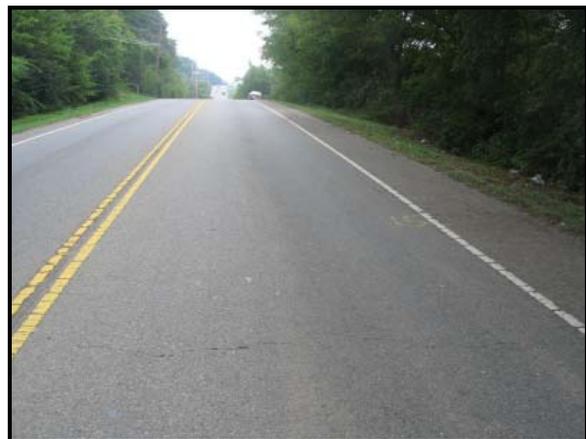
The crash occurred during the daylight hours of May 2008. At the time of the crash, the weather was not a factor. The crash occurred on the south roadside of an east/west road in a suburban setting. **Figure 2** is an eastbound trajectory view at the estimated roadside departure. There was a positive two-percent grade eastbound. The road consisted of two lanes separated by a double-yellow centerline. The width of the travel lanes measured 3.6 m (11.8 ft). Asphalt shoulders bordered the travel lanes. The south shoulder measured 1.4 m (4.6 ft) in width. The south road side sloped away from the pavement to a tree line that was located

Figure 2: Eastbound trajectory view at the crash site.

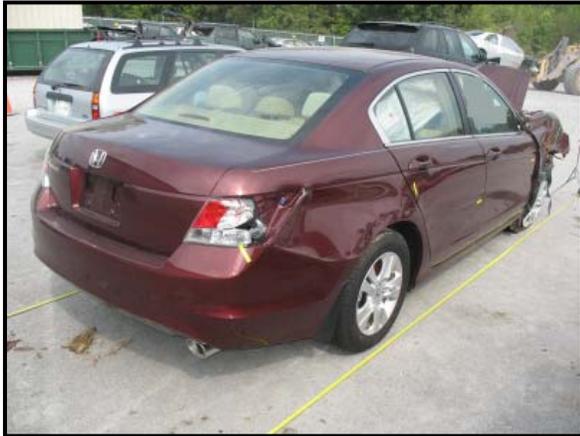
The Honda Accord sustained impact damage to the right and front planes as a result of the multiple event crash sequence. **Figures 3 and 4** are a right rear oblique view and a front view of the damaged vehicle. The Honda sustained minor damage to the right quarter panel from the sideswiping contact to the tree line (Event 1). The direct damage for this event measured 119 cm (46.9 in) in length and began 24 cm (9.4 in) forward of the right rear axle. The maximum lateral deformation from this impact was 5 cm (2 in) located at the mid point of the quarter panel. Longitudinal abrasions were noted throughout the deformation. The Collision Deformation Classification (CDC) was 12RZES1.

Figure 3: Right rear oblique view of the Honda.

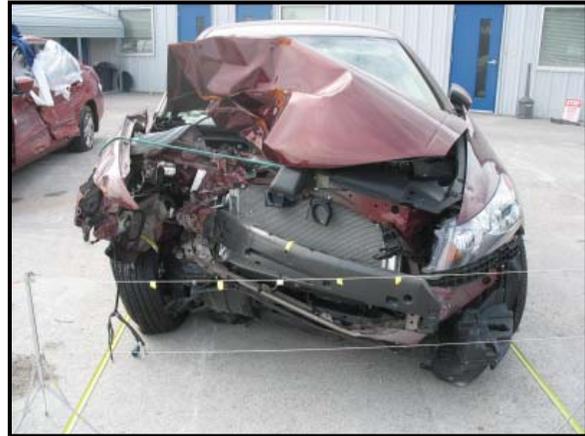
Moderate severity damage was noted the frontal plane as a result of the impact with the tree (Event 2). The damaged components included but were not limited to the bumper fascia, bumper beam, hood, right fender, and the right front wheel and suspension components. The direct contact damage began 43 cm (17 in) right of the vehicle's centerline extending 34 cm (13.5 in) to the right corner of the bumper fascia. The maximum crush measured 58 cm (22.8 in) and was

located at the right corner. The crush profile documented along the bumper reinforcement beam was as follows: C1 = 0 cm, C2 = 4 cm (1.5 in), C3 = 18 cm (7 in), C4 = 35 cm (13.7 in), C5 = 55 cm (21.7 in), C6 = 58 cm (22.8 in). The impact location on the right corner resulted in an 11 cm (4.3 in) reduction of the right wheelbase. The left wheelbase lengthened 14 cm (5.5 in) due to body deformation. All four doors remained closed during the crash and were operational post-crash. The windshield was fractured by the exterior crash force. The side and rear glazing were intact. The Collision Deformation Classification (CDC) for the tree impact was 12FZEN3.

Figure 4: View of the Honda's frontal damage.

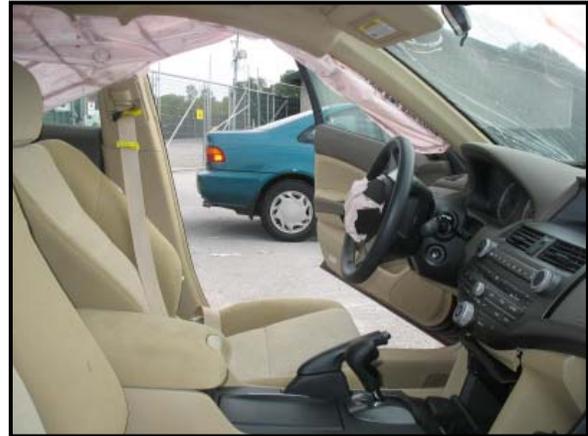
The interior of the Honda Accord (**Figure 5**) sustained minor severity damage as a result of passenger compartment intrusion, deployment of the safety systems and driver contact. The six-way power driver seat was located in a mid-to-rear track position that measured 5 cm (2 in) forward of full-rear. The total seat track travel measured 24 cm (9.5 in). The seat back angle measured 28 degrees aft of vertical. The horizontal distance from the seat back to the driver air bag module measured 73 cm (28.7 in). The four-spoke steering wheel was rotated 90 degrees counterclockwise. The adjustable steering wheel was in the full-down position. There was no steering wheel rim deformation. Examination of the steering column shear capsules revealed minor evidence of movement. The right shear capsule was displaced 6 mm (0.25 in). The left shear capsule was unchanged.

Figure 5: Interior view of the driver's position.

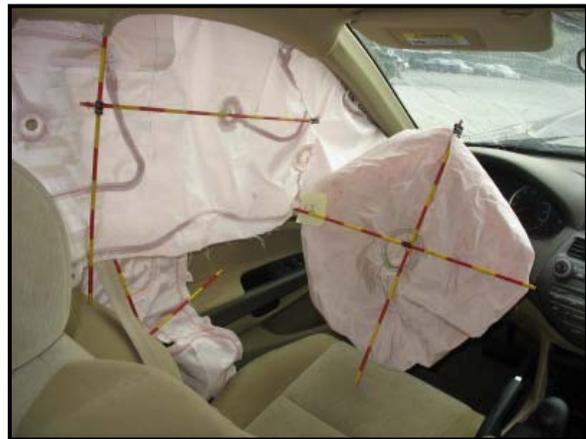
The driver's air bag (**Figure 6**) was concealed within a module located in the center hub of the four-spoke steering wheel. The air bag module cover flaps had a tri-flap design. The top flap was 13 cm (5 in) in width at the horizontal tear seam and 8 cm (3 in) in height. The lower flaps each measured 6 cm (2.5 in) in width and 5 cm (2 in) in height. The air bag was 58 cm (23 in) in diameter in its deflated state and was tethered internally by two straps. The air bag was vented by two ports located at the 11 and 1 o'clock positions. The driver's air bag contained body fluid spatter at the top aspect. There were no occupant contact points or damage to the frontal air bag.

Figure 6: Deployed air bags in the driver's position.

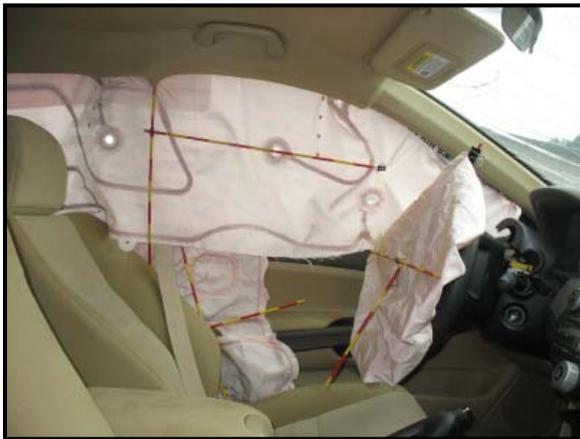
The left seat back mounted air bag (**Figure 7**) was concealed within the outboard aspect of the seat back. The air bag deployed through a tear seam at the forward aspect of the seat back. The air bag measured 46 cm (18 in) in height and 28 cm (11 in) in width at the top and 20 cm (8 in) in width at the bottom. The air bag consisted of two panels sewn together at the forward edge with a single 3 cm (1 in) diameter vent port at the top forward aspect. The membrane contained a square-shaped cut out that measured 10 cm (4 in) in and width. This cut-out was located 18 cm (7 in) above the bottom and 9 cm (3.5 in) aft of the forward edge. The air bag membrane was designed to inflate around the cut-out forming two chambers. The air bag membrane was not damaged and did not contain evidence of occupant contact.

Figure 7: View of the left IC and left side impact air bag.

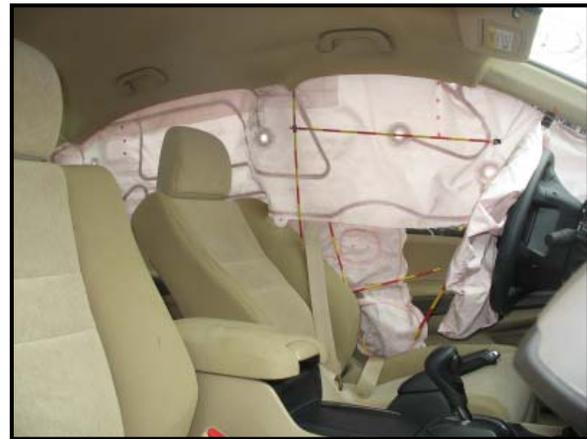
The left and right IC air bags deployed from the roof side rails. **Figure 8** is an overall view of the left IC. The deployed IC air bag measured 203 cm (80 in) in length. At the front seating positions, the air bag measured 38 cm (15 in) in height extending 3 cm (1 in) below the beltline. The height of the air bag at the second row position was 33 cm (13 in) and extended 3 cm (1 in) below the top of the door panel. The curtains provided full longitudinal and vertical coverage across the side glazing. There was no identified damage or occupant contact points to the curtains.

Figure 8: Overall view the left IC air bag.

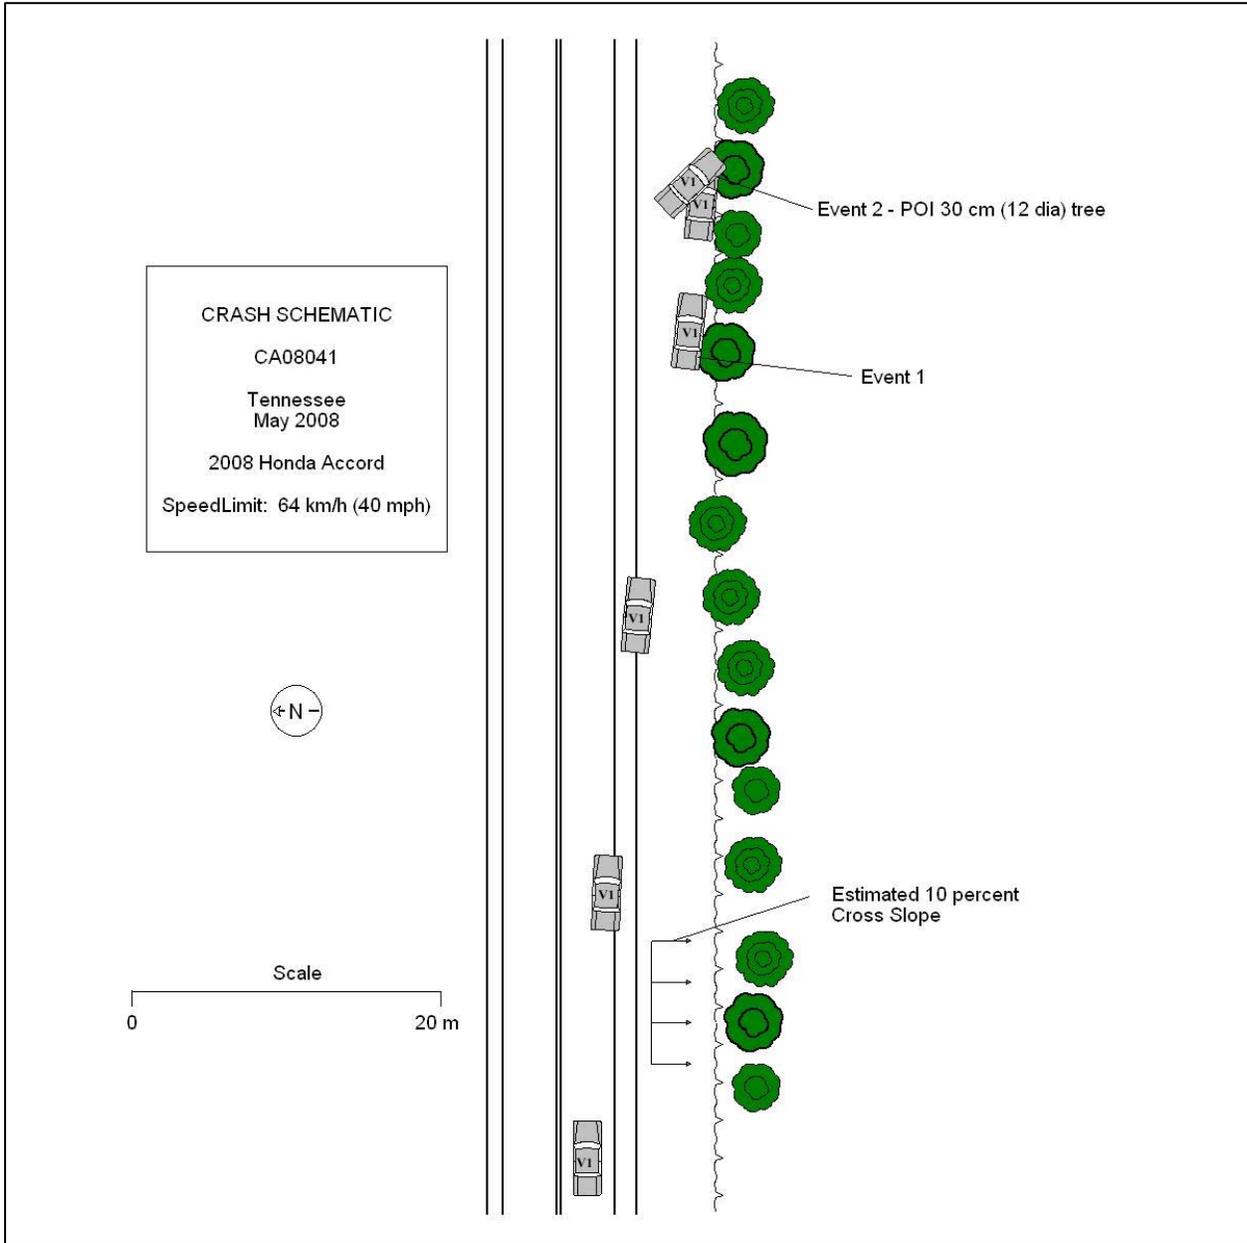
Figure 9: Crash schematic.

The 59-year-old restrained female was operating the Honda in an eastbound direction. She was the sole occupant of the vehicle. The driver fell asleep and allowed the vehicle to drift off the right side of the road. The Honda departed the right shoulder and travelled down the cross slope to the tree line. Due to the passage of time between the date of the crash and SCI notification there was no physical evidence of the vehicle's trajectory through the road side. A schematic of the crash is attached to the end of this report as **Figure 9**.
