ON-SITE ROLLOVER INVESTIGATION

CASE NUMBER - IN08041
LOCATION - MISSOURI
VEHICLE - 2007 CHEVROLET UPLANDER LS
CRASH DATE - October 2008

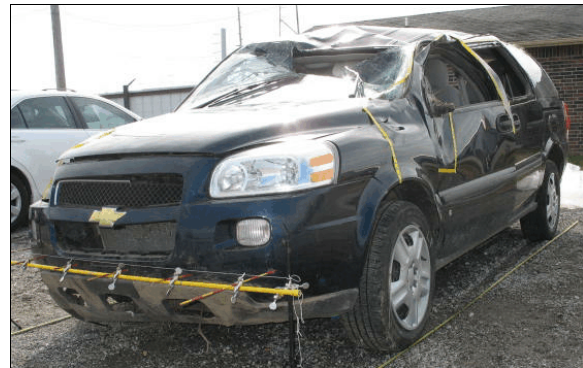
Figure 1: The damaged 2007 Chevrolet Uplander LS

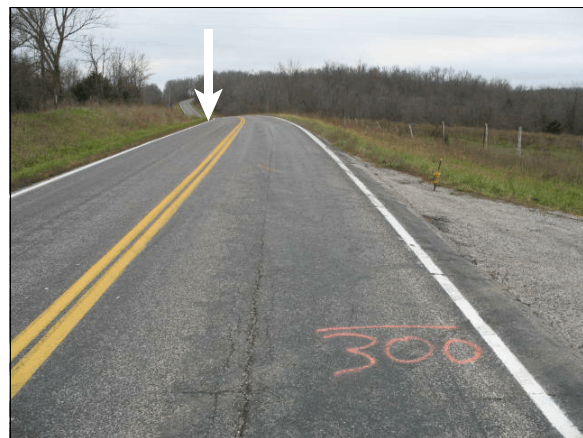
Pre-Crash: The Chevrolet's unrestrained 26-year-old female driver was traveling south negotiating a left curve (**Figure 2**) at the driver's estimated speed of 64-80 km/h (45-50 mph). The driver stated during the SCI interview that the right side tires departed the right (west) side of the roadway and she initiated a left steer maneuver. She had no recollection of applying the brakes. The driver

Figure 2: Southbound approach of the Chevrolet; number on pavement shows feet to area roadway departure to the rollover (arrow)

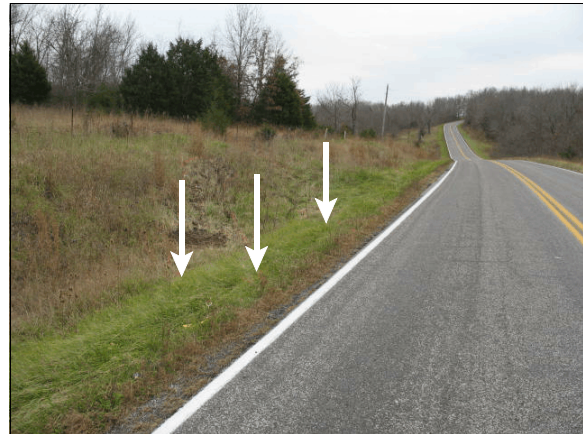
stated that as the vehicle reentered the roadway, the right front axle broke causing her to lose control of the vehicle. She had no memory of what occurred next. There was no evidence to support the right front axle breaking on the roadway. The inspection of the Chevrolet revealed a broken right front steering arm; however, this damage occurred during the rollover. The dirt embedded in the right front wheel and a wheel-shaped divot on the ground in the path of the rollover indicated that the steering arm broke when the right front wheel impacted the ground during the rollover. The tire mark evidence in the grass (**Figure 3**) just prior to the area of rollover initiation indicated that the vehicle was in a counterclockwise (CCW) yaw when it departed the left (east) side of the roadway just prior to the rollover.

Figure 3: Chevrolet's approach to departure of east side of roadway with arrows (left to right) showing left front tire mark, right front tire mark, and right rear tire mark

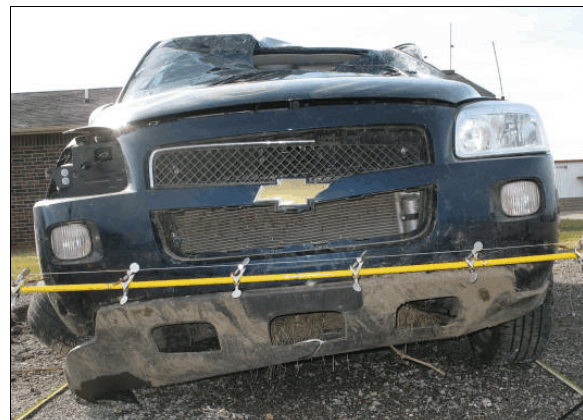
Crash: After the Chevrolet departed the left side of the roadway, it continued to rotate CCW and traveled 6 m (19.7 ft) down a 20% grade into a ditch. The vehicle had rotated CCW approximately 40 degrees from its initial southerly heading on the roadway when the front plane (**Figure 4**) impacted an embankment (**Figure 5**, event 1). The vehicle continued to rotate CCW as it traveled up the embankment and it tripped and rolled over, right side leading (event 2). The left front window glazing was disintegrated during the rollover and the driver was fully ejected out of the left front window opening. She was thrown clear of the vehicle in a southerly direction. The vehicle rolled over a total of 6 quarter turns across a distance of approximately 16 m (52.5 ft) and came to final rest on its top heading northeast (**Figure 6**). The driver came to final rest on top of the embankment (**Figure 6**) 9.5 m (31 ft) south of the final rest position of the vehicle. She was oriented parallel to the roadway with her head toward the south.

Figure 4: Damage to lower portion of Chevrolet's front bumper from impact with the embankment

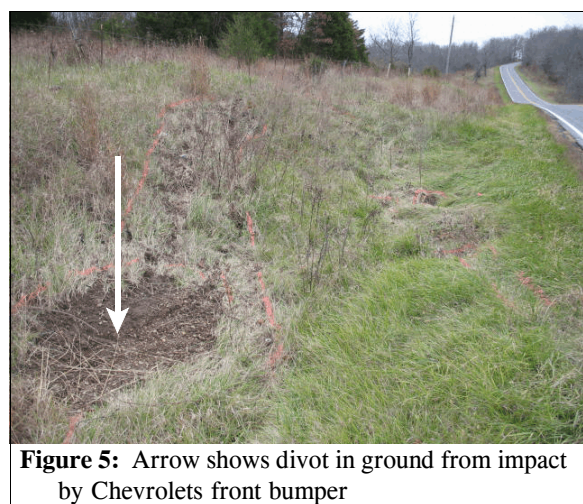
Figure 5: Arrow shows divot in ground from impact by Chevrolet's front bumper

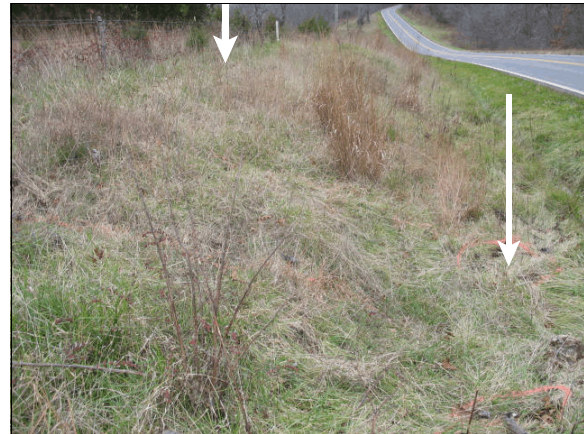
Figure 6: Final rest position of Chevrolet; arrow on right shows deposit of tinted, tempered glass fragments from the backlight; arrow on left shows area where driver came to rest

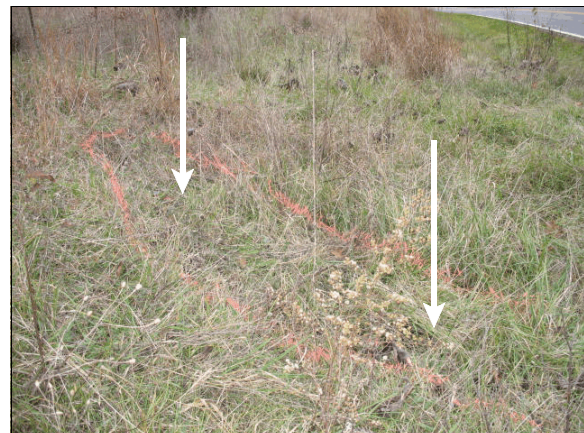
Figure 7: Impression on the ground where left portion of roof and left roof side rail touched down during second quarter turn; left arrow shows area of tempered glass fragments from left front window; right arrow shows area of tinted, tempered glass fragments from left rear window

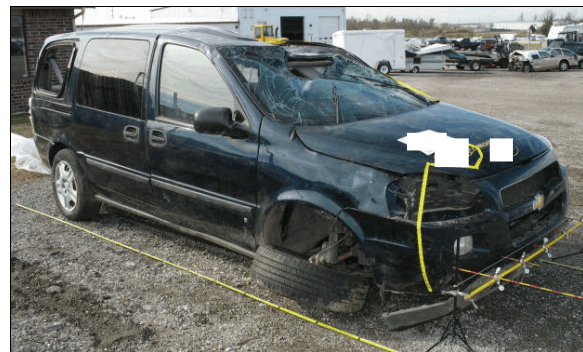
Exterior Damage: The damage from the impact with the embankment involved the full width of the front bumper (Figures 8 and 9). The lower portion of the front bumper was directly damaged and grass and mud were embedded in the lower frame and coils of the radiator. The direct damage began at the front left bumper corner and extended 146 cm (57.4 in) across the bumper. The residual maximum crush was 2 cm (0.8 in) and occurred at C₆. The table below shows the vehicle’s front crush profile.

The damage from the rollover involved the top plane, both side planes (Figures 1 and 8), and the undercarriage of the vehicle. The direct damage on the top plane began 74 cm (29.1 in) forward of the left front axle and extended 381 cm (150 in) rearward, and involved the full width of the top, 116 cm (45.7 in). The direct damage on the right side plane began 94 cm (37 in) rear of the right rear axle and extended 478 cm (188.2 in) forward along the right side. The direct damage on the left side plane began at the left front axle and extended 400 cm (157.5 in) rearward along the left side. The maximum residual vertical and lateral crush occurred on the left roof side rail (Figures 9 and 10) and was located 200 cm (78.7 in) rear of the left front axle. The maximum vertical crush was 20 cm (7.9 in) while the maximum lateral crush was 26 cm (10.2 in).

Figure 8: Front right view of damage to the Chevrolet from the rollover and embankment impact

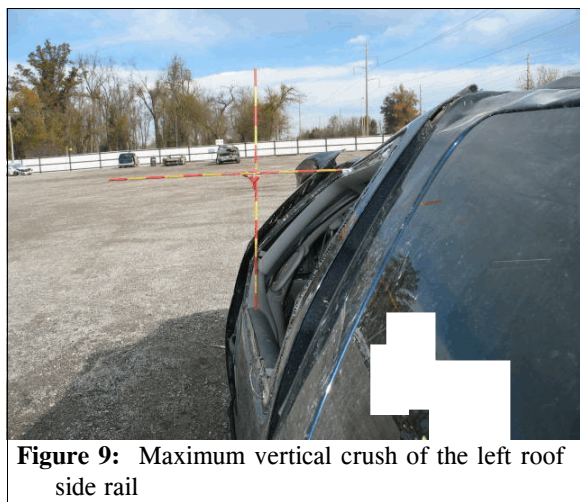
Figure 9: Maximum vertical crush of the left roof side rail

The vehicle’s passenger compartment sustained 19 intrusions. The most severe intrusion occurred in the second row left and involved the left roof side rail, which intruded laterally 26 cm

(10.2 in) and vertically 20 cm (7.9 in). The most severe intrusion in the driver's occupant space also involved the left roof side rail, which intruded laterally 17 cm (6.7 in) and vertically 11 cm (4.3 in).

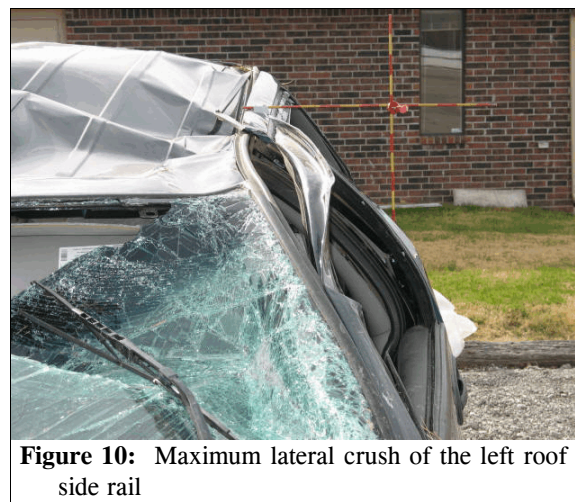
Figure 10: Maximum lateral crush of the left roof side rail

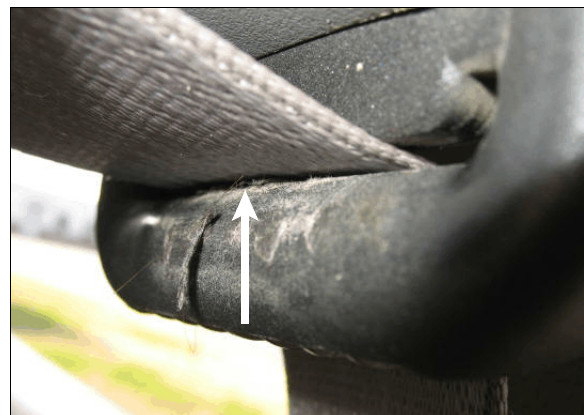
Inspection of the driver's seat belt assembly revealed some historic usage scratches on the latch plate but no evidence of loading was found on the seat belt webbing, D-ring or latch plate belt guide. Deposits of lint, dust, and hair were present on the D-ring under the belt webbing (**Figure 11**). This

Figure 11: Lint, dust, and hair on driver's D-ring

evidence indicated that the belt had not been pulled across the D-ring for some time and also indicated that the seat belt was not in use at the time of the crash. The remaining seat positions were unoccupied.

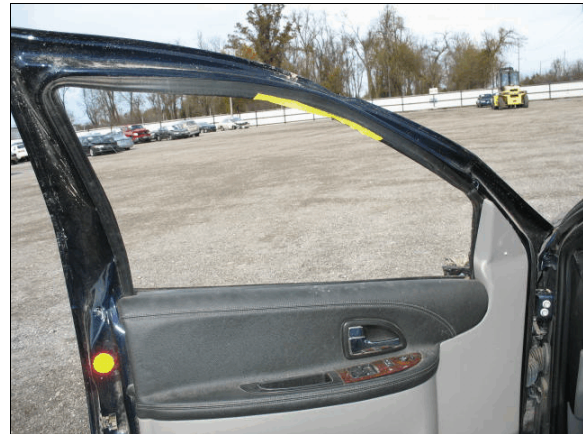
Vehicle Interior: The inspection of the Chevrolet’s interior revealed a deposit of hair embedded in the top of the left front window frame. The evidence indicated that the driver contacted her head on the window frame during the rollover, and supported the disintegrated left front window as the driver’s path of ejection. No other discernable evidence of occupant contact was located within the vehicle.

Figure 12: Driver was ejected out of left front window; yellow tape shows location of hair deposited in the window track

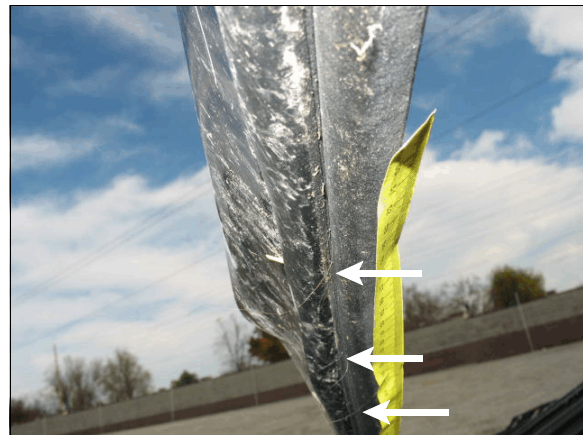
Figure 13: Arrows show hair embedded in top of left front window track
