**CALSPAN ON-SITE INFLATABLE SIDE IMPACT
OCCUPANT PROTECTION INVESTIGATION
CALSPAN CASE NO: CA08042**

**VEHICLE: 2007 HONDA ACCORD
LOCATION: TENNESSEE
CRASH DATE: MAY, 2008**

Contract No. DTNH22-07-C-00043

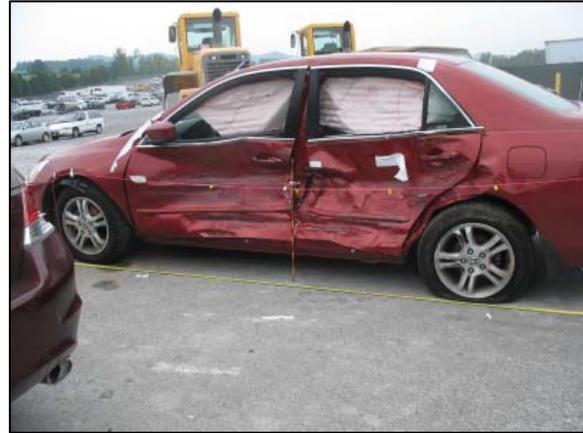
Figure 1: Left side view of the 2007 Honda Accord.

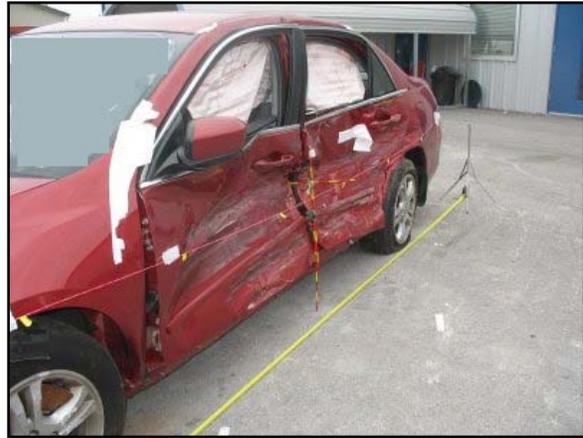
The 2007 Honda Accord sustained moderate severity damage to the left plane as a result of the impact. The damage consisted of lateral deformation to the left doors, left sill, and left B-pillar structure. The front left wheel was contacted during the impact. Its involvement in the impact was evidenced by abrasions to the face of the alloy rim and a fracture of the wheel rotor. The contact damage began at the left front axle, 100 cm (39.4 in) rear of the front bumper, and extended across the left plane to the quarterpanel. The length of the left side damage measured, 283 cm (111.4 in). The crush profile documented at the mid-door level was as follows: C1 = 0 cm, C2 = 22 cm (8.6 in), C3 = 25 cm (9.8 in), C4 = 17 cm (6.7 in), C5 = 3 cm (1.2 in), C6 = 0 cm. The maximum crush was located at C3, the forward aspect of the left rear door and measured 25 cm (9.8 in). The elevation of the maximum crush measured 67 cm (26.3 in) above the ground. The Door Sill Differential (DSD) was 15 cm (6 in). The left side doors were jammed closed. The right doors remained closed during the crash and were operational post-crash. The left door glazing disintegrated during the crash. The windshield and the remainder of the side glazing were intact. The Collision Deformation Classification (CDC) for the impact was 11-LDEW2.

Figure 4: Oblique view of the left side damage.

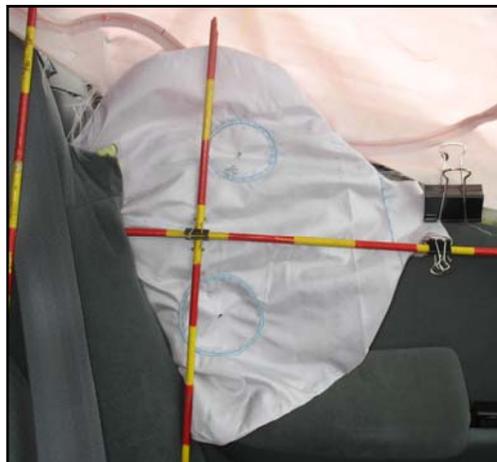
The left seat-mounted air bag, **Figure 5**, was concealed within the outboard aspect of the seat back and the bag deployed through a 28 cm (11 in) tear seam. The air bag was elliptical in shape, and measured 38 cm (15 in) in height and 23 cm (9 in) in width. The bag consisted of two panels sewn together at the forward edge. The base of the air bag was located at the horizontal surface of the arm rest, 23 cm (9 in) above the seat cushion. The expanded air bag filled the area above the arm rest. The air bag was vented at the forward edge by a port that measured 5 cm (2 in) in width and 8 cm (3 in) in height. The air bag contained two circular tethers that were sewn to the panels. The tethers were located at the 12 and 6 o'clock positions, 16 cm (6.2 in) apart. The air bag was not damaged and did not contain occupant contact evidence.

Figure 5: Left side impact air bag.

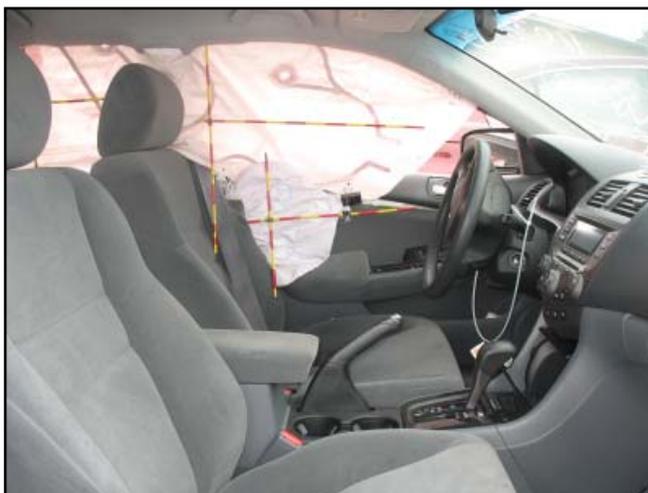
The left IC air bag deployed from the roof side rail. The curtain air bag measured 173 cm (68 in) in length and 39 cm (15.5 in) in height. The curtain provided vertical coverage that extended 3 cm (1 in) below the beltline. The IC air bag overlapped the seat-mounted air bag by 7 cm (2.8") in the deflated state. The air bag was not tethered to the A- and C-pillars. Longitudinally, the coverage area of this curtain air bag did not completely span across the front glazing. A triangular shaped void was present between the curtain air bag and the A-pillar. The maximum length of the void was 30 cm (12 in) with a maximum height of 18 cm (7 in). In its deflated state, the air bag overlapped the C-pillar approximately 10 cm (4 in) providing protection beyond the rear glazing area. There was no occupant contact evidence or damage to the curtain air bag. **Figure 6** depicts the deployed left seat-mounted and IC air bags.

Figure 6: Right interior view of the deployed air bags at the driver's position.

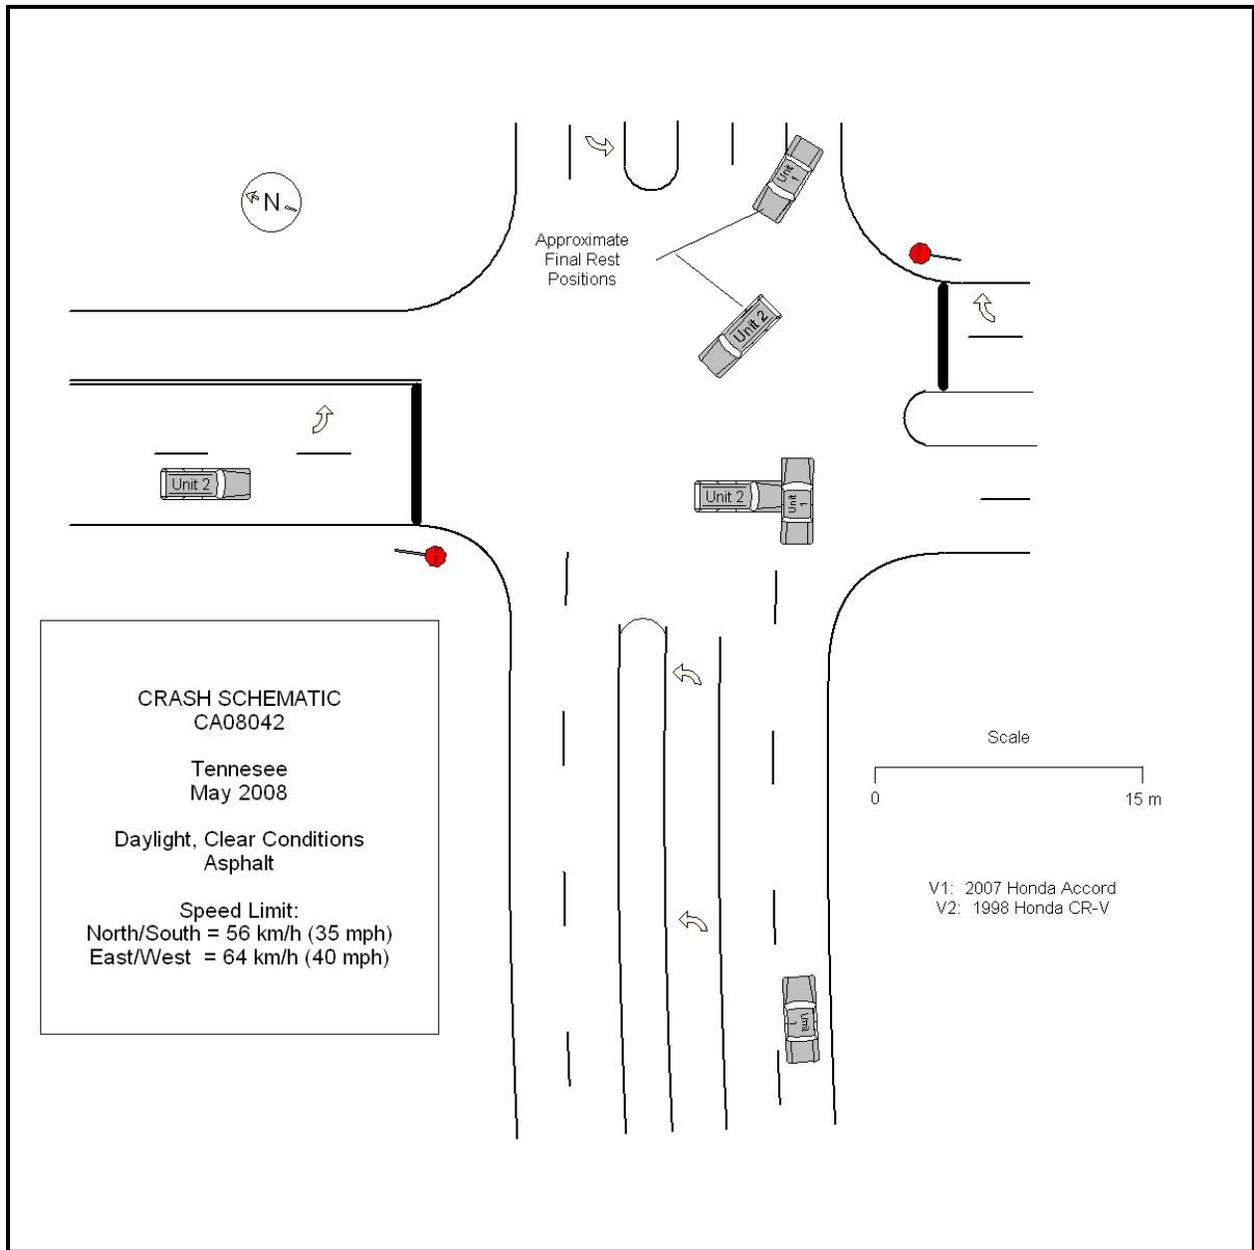
The 2007 Honda Accord was driven by a 38-year-old restrained male. He was operating the vehicle on the outboard eastbound through lane. The 1998 Honda CR-V was southbound driven by a 79-year-old restrained female. Both vehicles were passing straight through the intersection. **Figure 8** at the end of this report is an overhead schematic of the crash.

Figure 7: Crash schematic.
