**CALSPAN ON-SITE BACK OVER INCIDENT INVESTIGATION**

**SCI CASE NO.: CA08043**

**VEHICLE: 1999 TOYOTA SIENNA**

**DATE OF INCIDENT: JULY 2008**

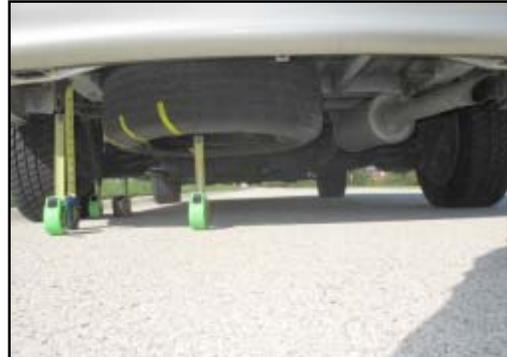
**Figure 4. Overall view of the undercarriage components.**

**Figure 4** is an overall view of the rear undercarriage components. The vertical clearance heights of the rear components of the Toyota were measured from the paved surface of the roadway in front of the residence and are listed in the following table:

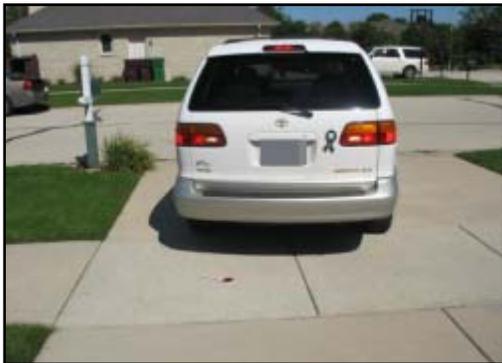
As she entered the driveway, the vehicle was facing in a northeast direction. The driver continued into the driveway approximately 6 meters (20 feet), unaware of the non-motorists presence and struck her with the rear bumper, left of the centerline. The driver did not feel the impact and continued backing.

**Figure 11. Area where the vehicle struck the child.**

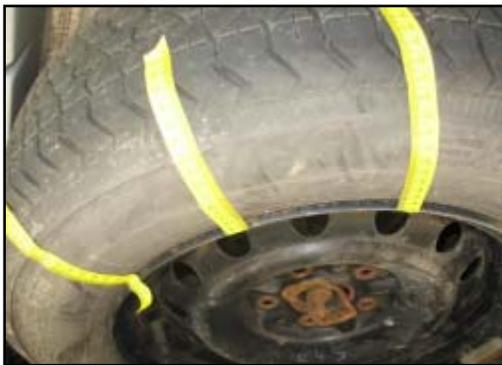
The Toyota was inspected by the SCI investigator at the residence where the incident occurred 53 days post-incident. The vehicle had been used on numerous occasions since the incident. The SCI investigator inspected the rear bumper and undercarriage of the vehicle for contact evidence. Upon inspecting the undercarriage of the vehicle, two areas of wipe marks were observed on the sidewall of the undercarriage mounted spare tire

**(Figures 13 and 14).** These wipe marks consisted of dirt/road film being cleaned away from the rubber surface of the spare tire. These suspected areas of contacts measured 9 cm (3.5”) and 34 cm (13.4”) respectively and were located on the rear and left aspects of the tire. Additionally, these contact areas extended 38-89 cm (15”- 35”) forward of the bumper fascia. Based on the injuries sustained by the non-motorist and the suspected area of contact, the SCI investigator concluded that the child was seated perpendicular to the rear of the Toyota. The Toyota’s rear bumper contacted the right shoulder area of the child knocking her to the ground where the left side of her face contacted the concrete surface. As the vehicle continued backing, the spare tire contacted the child’s right upper body area. She was compressed between the spare tire and the concrete surface resulting in a green stick fracture of the left clavicle and tension pneumothorax of the right lung. Additionally, as she was compressed, she was displaced rearward resulting in the abrasions to the left face and inner right leg.

**Figure 13. Contact to the rear aspect of the spare tire.**

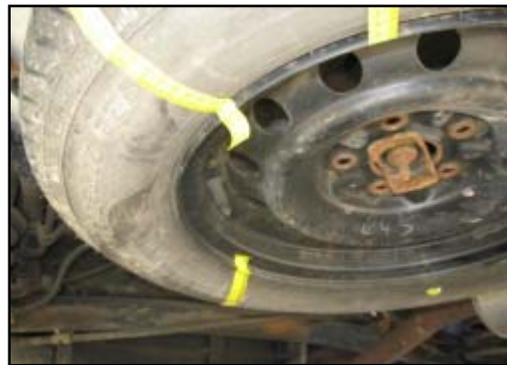
**Figure 14. Area of contact to the left side of the spare tire.**

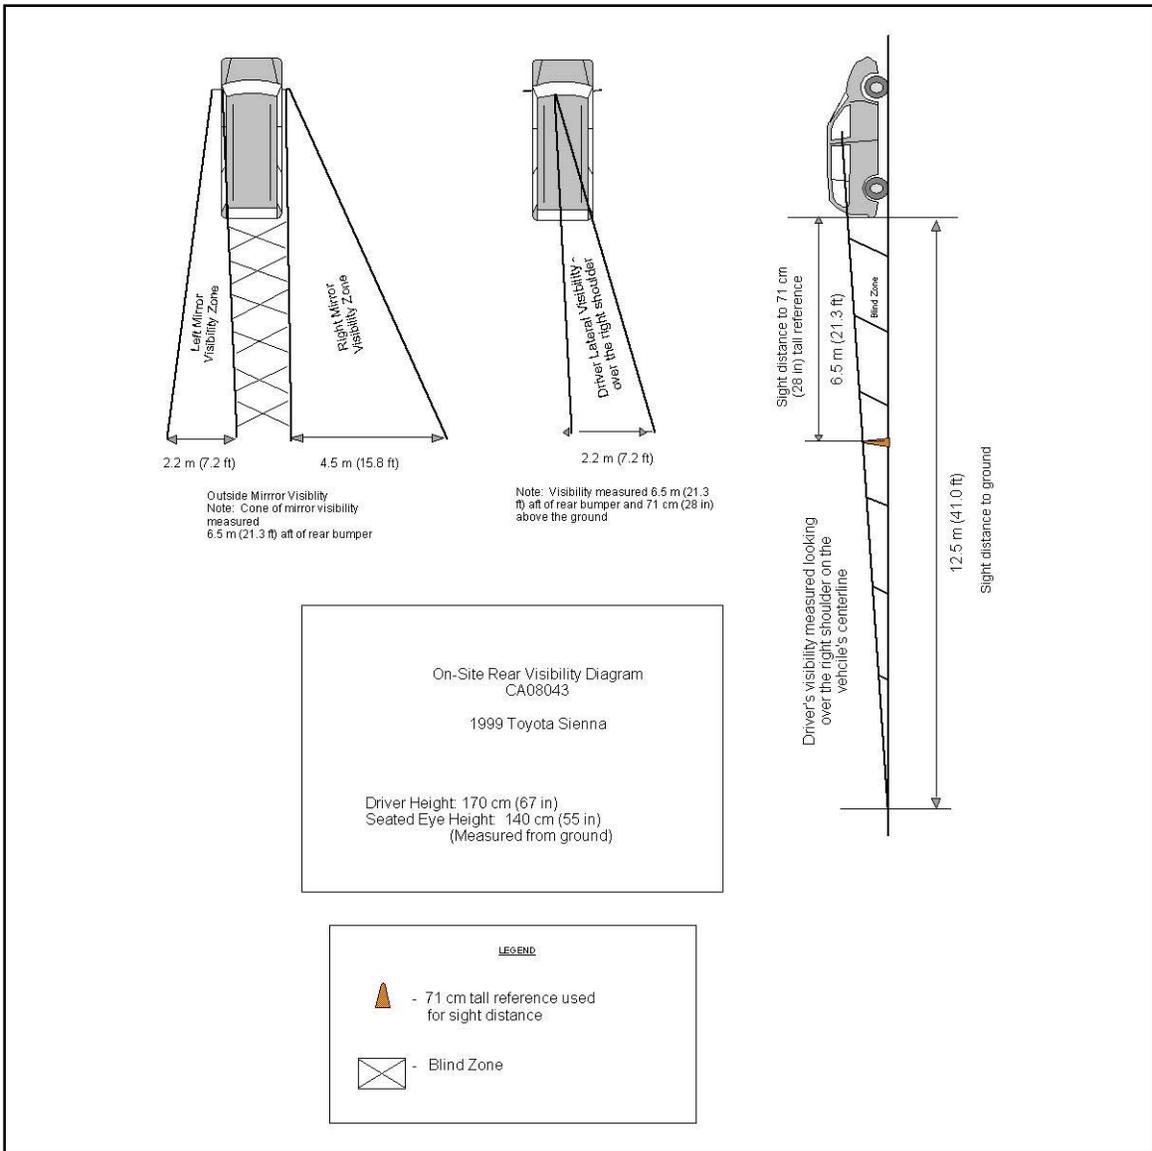
**Figure 15. Rear Visibility Diagram**

The driver detected the reflective marker in the rear view mirror 6.5 m (21.3 feet) aft of the back bumper. The driver continued a straight line of sight that intersected the ground at a point that was 12.5 m (41 feet) from the rear bumper. Lateral cones of visibility were established with driver looking over her right shoulder. Due to her positioning, a left lateral cone (left of the vehicle) could not be determined as she could not see left of the centerline. The right cone was began at the centerline and extended 2.2 meters (7.2 feet) to the right. Although the driver noted that there were no interior sight line obstructions, the third row head restraints and the D-pillars may have obstructed the driver's vision. At the onset of the final backing trajectory into the driveway, the non-motorist was positioned within the blind zone based on the visibility study.
