ON-SITE OTHER INFLATABLE OCCUPANT PROTECTION INVESTIGATION

CASE NUMBER - IN08044
LOCATION - TEXAS
VEHICLE - 2006 MAZDA 5
CRASH DATE - October 2008

1. <i>Report No.</i> IN08044		2. <i>Government Accession No.</i>		3. <i>Recipient's Catalog No.</i>	
4. <i>Title and Subtitle</i> On-Site Other Inflatable Occupant Protection Investigation Vehicle - 2006 Mazda 5 station wagon Location - Texas			5. <i>Report Date:</i> September 28, 2009

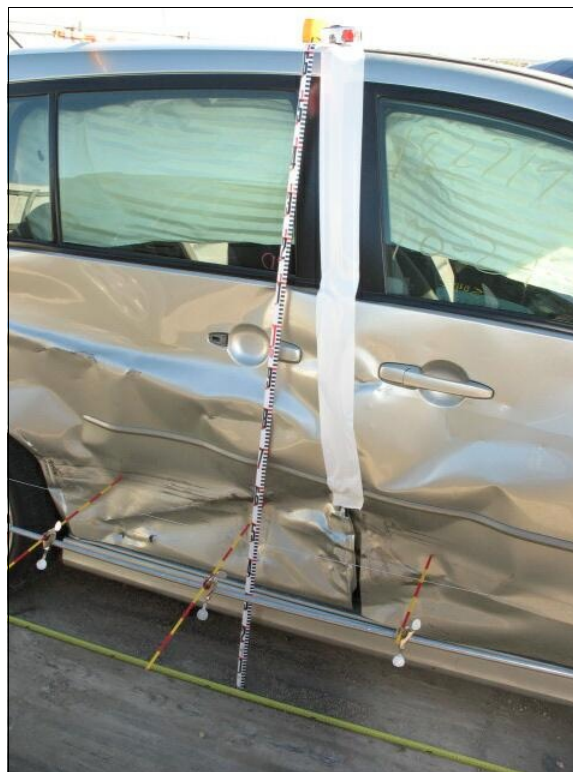
Crash: The right side of the Mazda was impacted by the front of the Chevrolet, causing the Mazda's right side curtain air bag to deploy (**Figure 4**). The left front seat back-mounted side impact air bag and the left side curtain air bag also deployed during the collision sequence. The unoccupied right front seat's seat back-mounted side air bag did not deploy during the right side impact. The Mazda was redirected in a west-southwesterly direction and rotated approximately 190 degrees clockwise. The vehicle came to rest straddling the raised curbed median that separated the east and west roadways on the west leg of the intersection, heading in an east-southeasterly direction (**Figure 3**).

Figure 4: Mazda's right side damage from impact by Chevrolet showing crush positions C₃ through C₅ and deployed right side curtain air bag

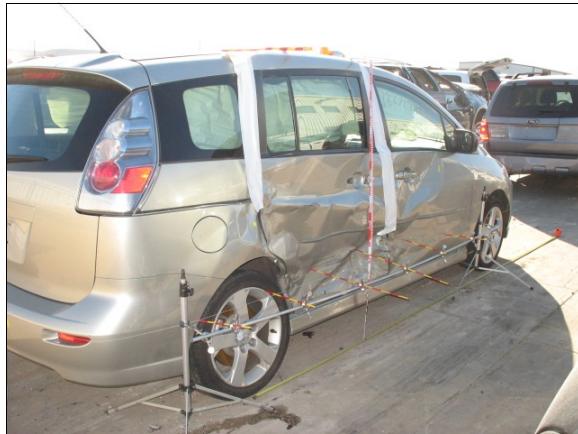
Exterior Damage: The Mazda's contact with the Chevrolet involved the right side with the damage distributed along the back half (**Figure 5**). Direct damage began 197 centimeters (77.6 inches) rearward of the right front axle and extended 175 centimeters (68.9 inches) along the right side. The location of the Field L began 82 centimeters (32.3 inches) rearward of the right front axle and extended 222 centimeters (87.4 inches) along the right side (**Figure 6**). Residual maximum crush was measured as 14 centimeters (5.5 inches) at C₄ (**Figure 7**). The table below shows the case vehicle's crush profile.

Figure 5: Mazda's right side damage viewed from back; C₁ begins behind right rear wheel

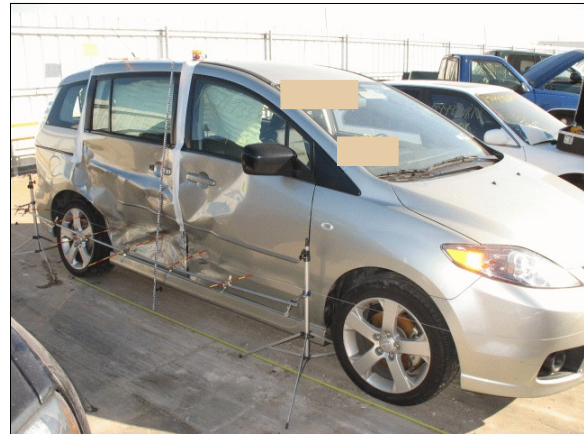
Figure 6: Mazda's right side damage viewed from front; C₆ located mid-right front door

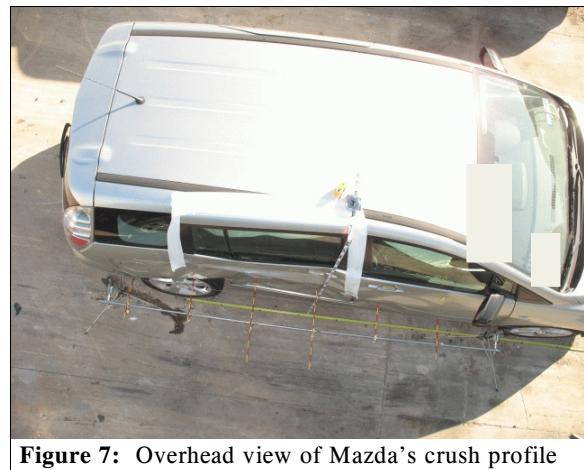
Figure 7: Overhead view of Mazda's crush profile

Damage Classification: The Collision Deformation Classification for the Mazda was: **02-RZEW-2 (60 degrees)**. The WinSMASH reconstruction program, Missing Vehicle algorithm, was used on the Mazda's highest severity impact. The Total, Longitudinal, and Lateral Delta Vs were, respectively: 19.0 km/h (11.8 mph), -9.5 km/h (-5.9 mph), and -16.5 km/h (-10.3 mph).

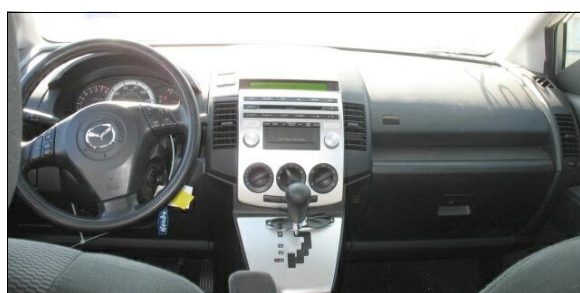
Figure 8: Mazda's instrument panel, steering wheel, and transmission selector lever with no apparent evidence of occupant contact, and non-deployed driver and front right passenger air bags

Interior Damage: Inspection of the Mazda's interior revealed that there was no evidence of occupant contact on the interior surfaces (**Figures 8 through 10**). There were 14 centimeters (5.5 inches) of intrusion to the right rear door panel and 3 centimeters (1.2 inches) of intrusion to the side panel for the third row right seating position. There was no evidence of compression to the energy absorbing shear capsules in the steering column, and no deformation to the steering wheel rim.

The Mazda was equipped frontal air bags that were manufacturer Certified Advanced 208-Compliant and featured multi stage inflators at the driver and front right passenger positions. Based on the manufacturer’s website, the multi stage frontal air bag system senses the severity of a crash, then determines if the air bags should be deployed at stage 1 or 2 level. The front right passenger sensing system automatically switches the front right passenger air bag on or off based on the passenger’s weight and the type of pressure on the seat. The driver’s air bag was located in the steering wheel hub (Figure 8) and the front right passenger’s air bag was located in the middle of the instrument panel (Figure 8). Neither of these air bags deployed in this side impact crash.

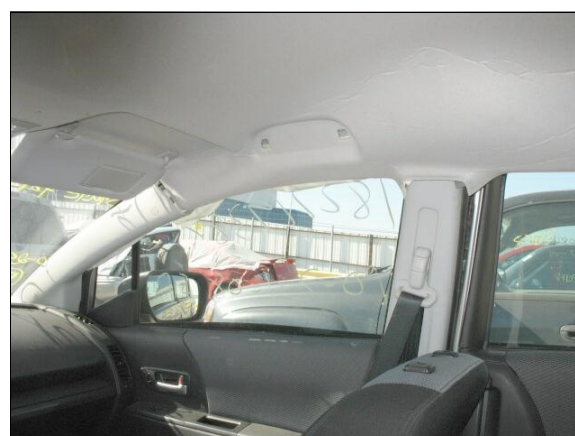
Figure 9: Mazda's right A- and B-pillars, instrument panel, front interior door surface, roof side rail and roof with no apparent evidence of occupant contact; roof headliner disrupted from induced damage (i.e., remote buckling)

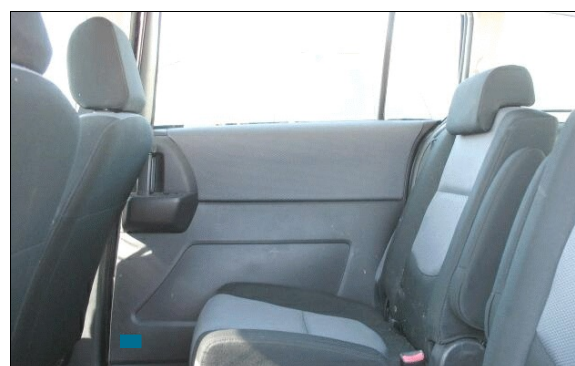
Figure 10: Interior surface of right rear door showing no apparent occupant contact evidence

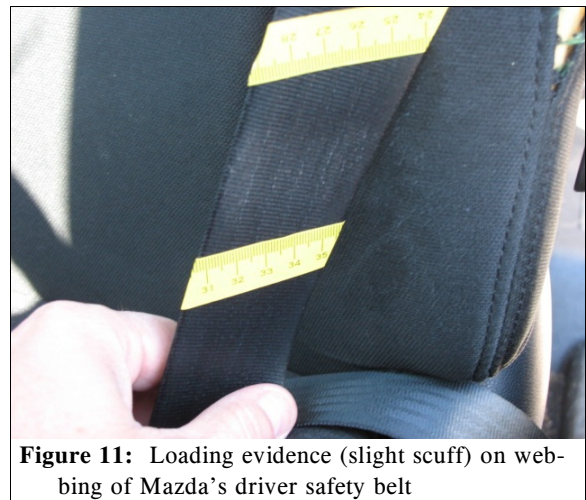
Both front and second row seat belts exhibited indications of historical usage. The inspection of the driver’s safety belt webbing, D-ring, and latch plate revealed that the retractor-mounted pretensioner had not actuated and showed a loading scuff mark on the webbing, 102 centimeters (40.2 inches) from the stop button (**Figure 11**). The inspection of the second row left passenger's safety belt webbing, D-ring, and latch plate showed a faint scuff mark on the safety belt’s webbing, 82 centimeters (32.3 inches) from the base of the safety belt (no stop button was present–**Figure 12**). This scuff was probably from the child safety seat used by the second row left passenger. The inspection of the second row right passenger’s safety belt webbing, D-ring, and latch plate did not show any indications of usage during this crash.

Figure 11: Loading evidence (slight scuff) on webbing of Mazda’s driver safety belt

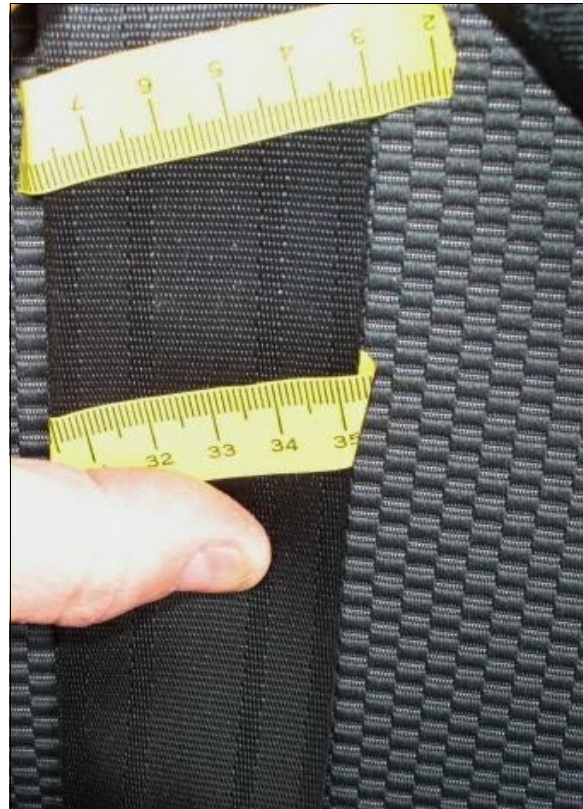
Figure 12: Loading evidence (faint scuff) on webbing of Mazda’s second row left safety belt

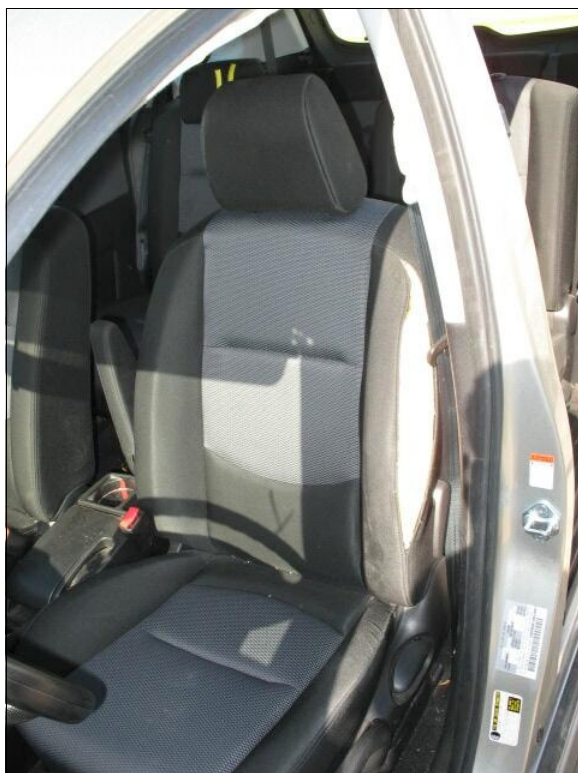
Figure 13: Mazda’s driver seat showing lateral location of seat back-mounted side impact air bag

bags were attached on the lateral surfaces (**Figure 13**). An inspection of the driver's seat and the air bag's fabric revealed that the air bag deployed through the designated tear points, and there was no evidence of unintended damage during the deployment to the air bag or to the side of the seat. The driver's side air bag was designed without any tethers or vent ports. The deployed air bag was designed in a reverse kidney shape with two circular areas connected by a common area (**Figure 14**). The top circular area had a diameter of 20 centimeters (7.9 inches) while the bottom circular area had a diameter of 16 centimeters (6.3 inches). The total height of the air bag was 58 centimeters (22.8 inches). An inspection of the driver's side air bag fabric revealed no contact evidence on either the outboard or inboard surfaces of the air bag's fabric.

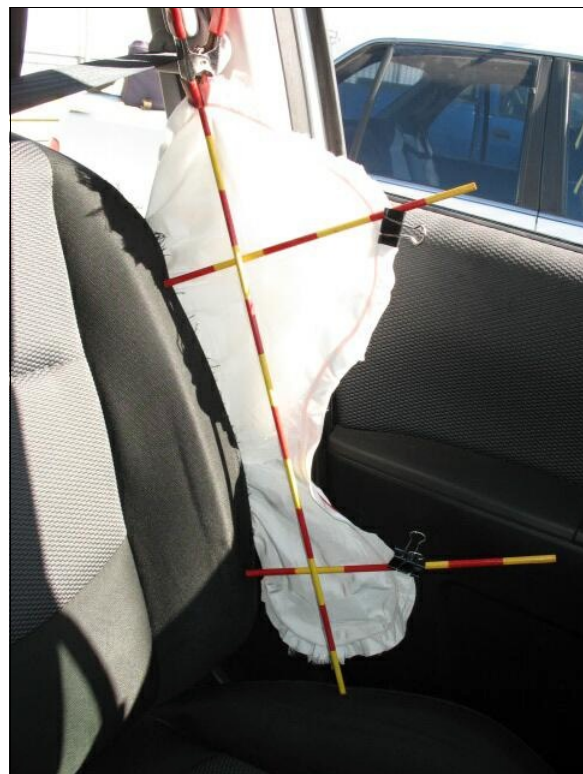
Figure 14: Inboard surface of Mazda’s driver seat back-mounted side impact air bag; no evidence of occupant contact was readily apparent

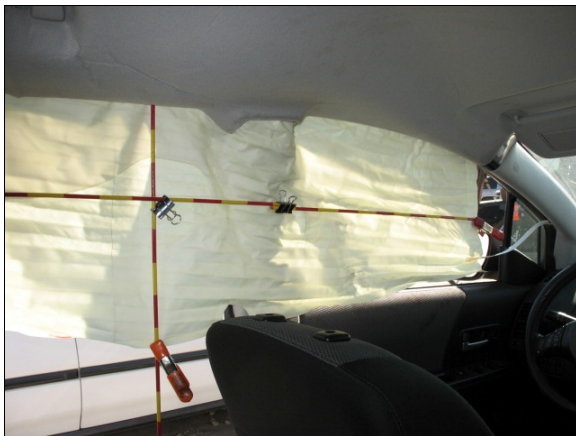
Figure 15: Front portion of Mazda's left side curtain air bag; tether attached to lower left A-pillar

The Mazda's right and left inflatable side curtain air bags were housed within the left and right roof side rails (**Figures 15 through 20**). Both air bags extended along the front, second row, and third row seats. They were designed to provide protection to an occupant's head during a side impact. Each side air bag was anchored to the lower portion of their respective A-pillars by a tethered cord 33 centimeters (13.0 inches) in length (**Figures 15 and 18**). Each curtain air bag was essentially rectangular with a length of 210 centimeters (86.7 inches) and a height of 37 centimeters (14.6 inches).

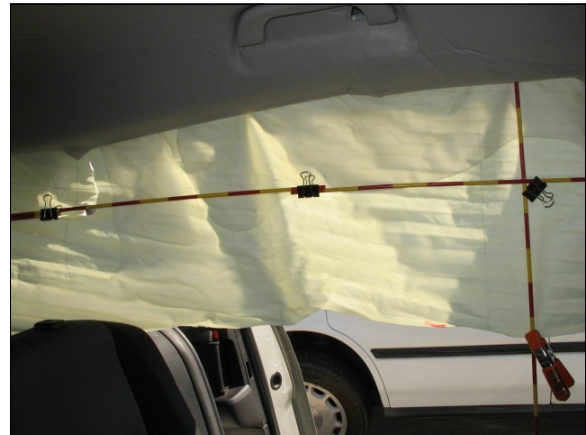
Figure 16: Middle portion of Mazda's left side curtain air bag

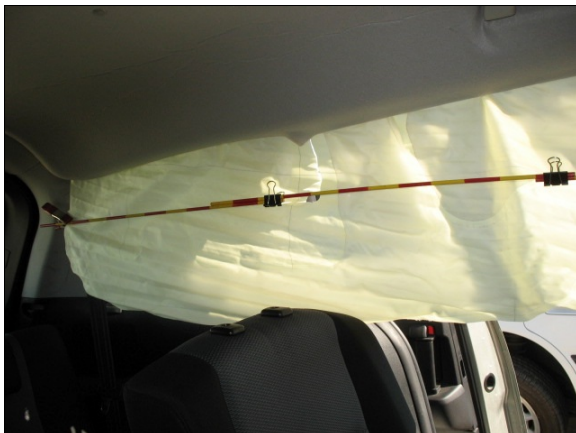
Figure 17: Back portion of Mazda's left side curtain air bag

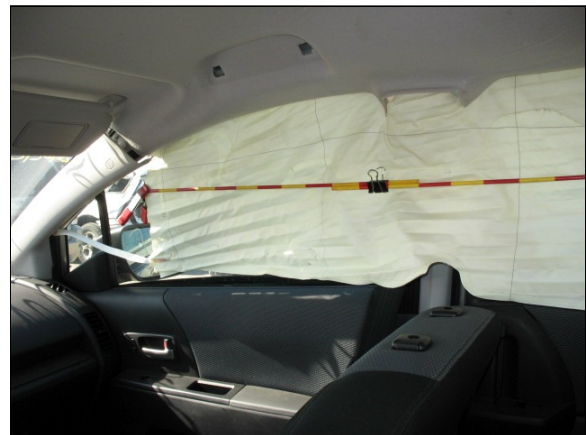
Figure 18: Front portion of Mazda's right side curtain air bag; tether attached to lower portion of right A-pillar

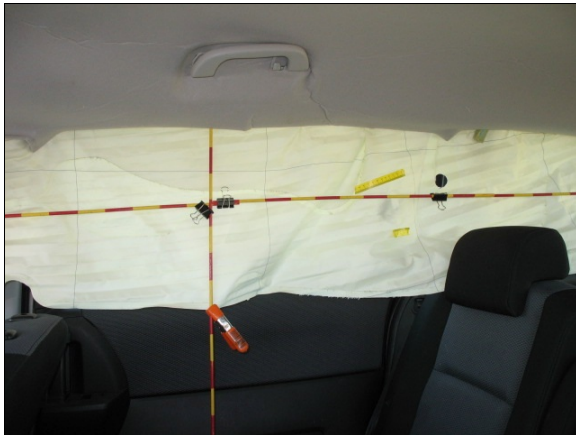
Each air bag was designed with one elongated inflation chamber located in the lower half of the air bags. The upper half of each bag contained inflatable and noninflatable areas designed to provide protection for the occupants. The most significant noninflatable areas were found at or behind the second row and third row seat backs where occupant loading was improbable. Inspection of the air bags revealed a probable deployment scuff on the interior surface of the right side curtain air bag's fabric (Figures 19 and 20) located 67 centimeters (26.4 inches) from the back edge of the air bag (Figure 21). There was no evidence of damage due to deployment on the outboard surfaces of either air bag or the inboard surface of left side curtain air bag. An inspection of both the left and right side curtain air bag's fabric revealed no contact evidence on the interior surfaces of the air bags.

Figure 19: Middle portion of Mazda's right side curtain air bag; probable deployment scuff (upper and lower portions bracketed by tape) near second row right seat back

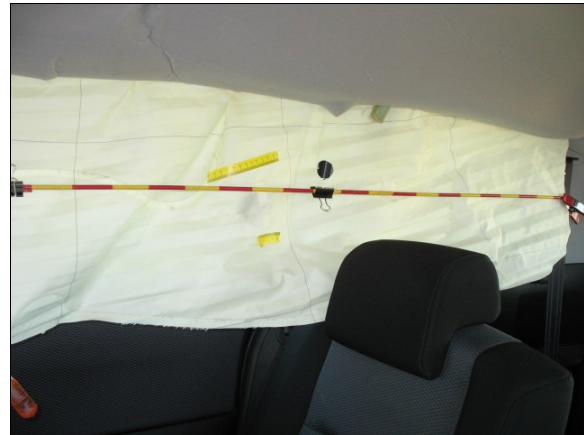
Figure 20: Back portion of Mazda's right side curtain air bag with probable deployment scuff bracketed by tape

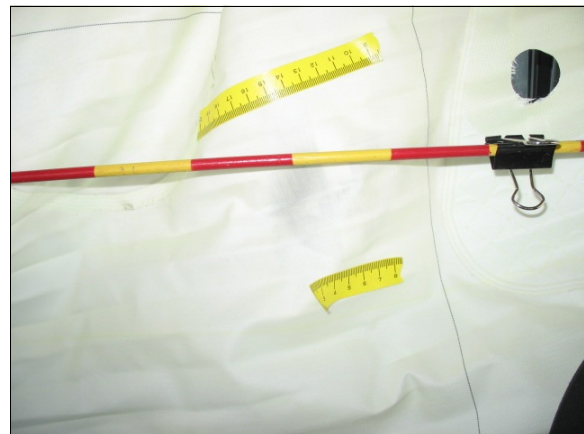
Figure 21: Close-up of probable deployment scuff on Mazda's right side curtain air bag
