**CALSPAN ON-SITE SIDE IMPACT  
INFLATABLE OCCUPANT PROTECTION SYSTEM CRASH INVESTIGATION**

**SCI CASE NUMBER: CA08049**

**VEHICLE: 2007 TOYOTA 4RUNNER**

**CRASH DATE: AUGUST 2008**

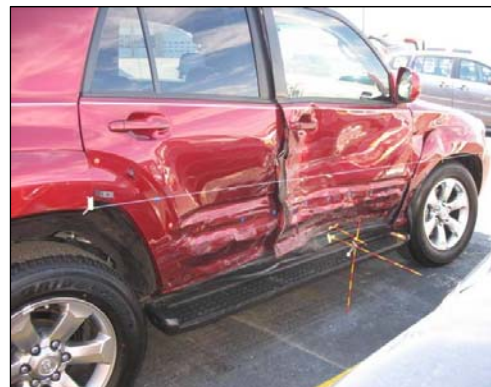
The exterior of the Toyota sustained damage to its right plane as a result of the side impact crash. This included the lateral crush and inward buckling of both passenger doors and the rear aspect of the front fender above and aft of the right front axle. The Toyota's right front door was jammed closed at the time of SCI inspection. However, the right rear door remained operational. This damage pattern is depicted in **Figure 5**.

**Figure 5:** Right side damage pattern on the Toyota.

The direct contact damage began 25 cm (10 in) forward of the right front axle and extended 262 cm (103 in)

rearward to the lower right C-pillar area. The combined direct and induced damage (Field L) began 33 cm (13 in) forward of the right front axle and extended 293 cm (115.5 in) rearward.

The residual crush measured along the right side at mid-door level was as follows: C1 = 0 cm, C2 = 4 cm (1.5 in), C3 = 8 cm (3 in), C4 = 3 cm (1.25 in), C5 = 4 cm (1.5 in), and C6 = 0 cm. Maximum crush was located at C3, 51 cm (20 in) forward of the right B-pillar. The door-sill differential measurement was zero. The Collision Deformation Classification (CDC) associated with the right side damage pattern was 02RYEW2.

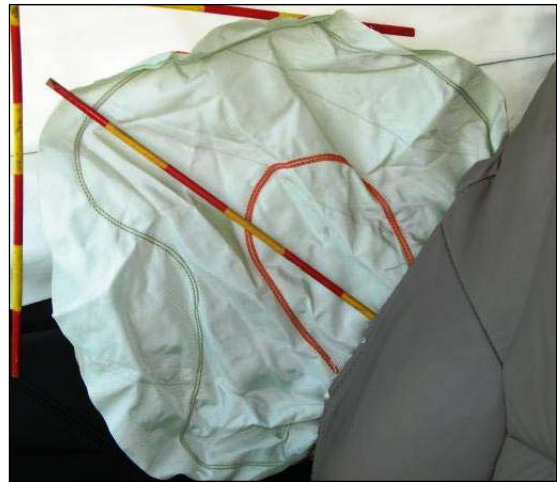
The right seatback-mounted air bag was constructed of Automotive Safety Components International (ASCI) recognized PA 6.6 nylon material and had deployed through the 51 cm (20 in) outboard seam stitching and underlying foam padding of the seatback. In its deflated state, the air bag measured 36 cm (14 in) vertically by 28 cm (11 in) horizontally. The air bag, depicted in **Figure 6**, was not tethered. There was no evidence of occupant contact on the air bag at the time of SCI inspection.

**Figure 6:** Deployed right seatback-mounted air bag.

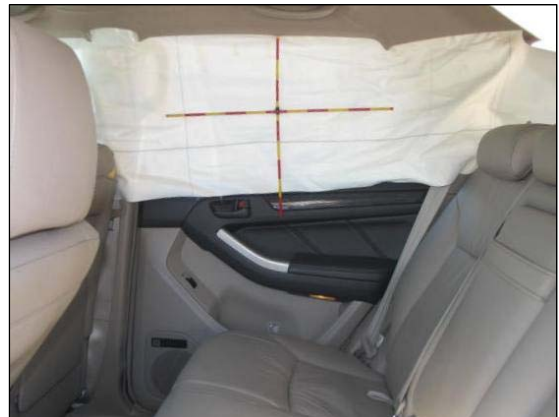
The side impact/rollover IC air bags were mounted to the roof side rails between the A- and D-pillars. A single curtain provided coverage for both the front and rear occupant positions, over the full-height of the side glazing. This coverage began immediately aft of the A-pillar and extended rearward to the C-pillar, wrapping around the C-pillar at occupant head level and ending above the rear axle position, as seen in **Figure 7**. Accordingly, the two IC air bags were trapezoidal in shape and measured 213 cm (84 in) and 198 cm (78 in) in length at their upper and lower aspects, respectively. Vertical coverage of the IC air bags measured 46 cm (18 in) for the front occupant position and 42 cm (16.5 in) for the rear. Both air bags were tethered to the A-pillar and roof side rail at their respective forward and aft aspects.

**Figure 7:** Rear right coverage of the IC air bag.

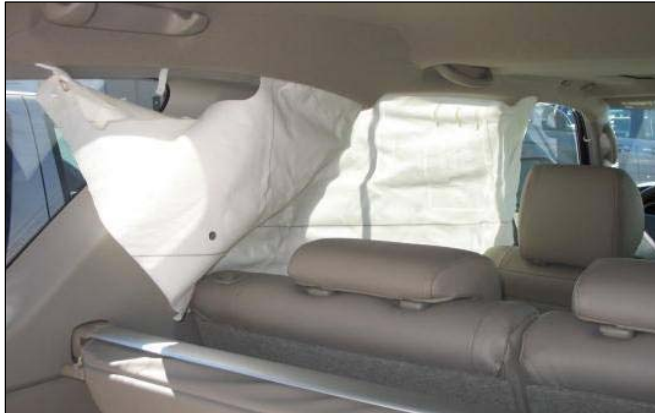
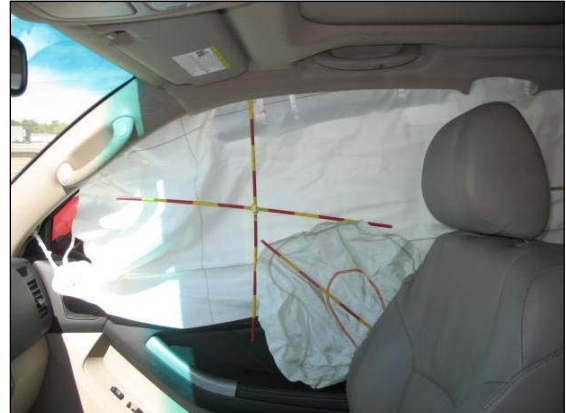
**Figure 8: Remaining left IC air bag.**

**Figure 9: Forward aspect of right IC bag.**

Prior to SCI inspection, and as reported to the SCI team by the buyer of the vehicle, the forward aspect of the left IC bag was cut from the vehicle for photographic purposes to aid in the resale of the vehicle. The left IC bag was cut vertically at the B-pillar, full-height, and at the A-pillar tether. **Figures 8** and **9** depict the IC air bags at the time of SCI inspection.

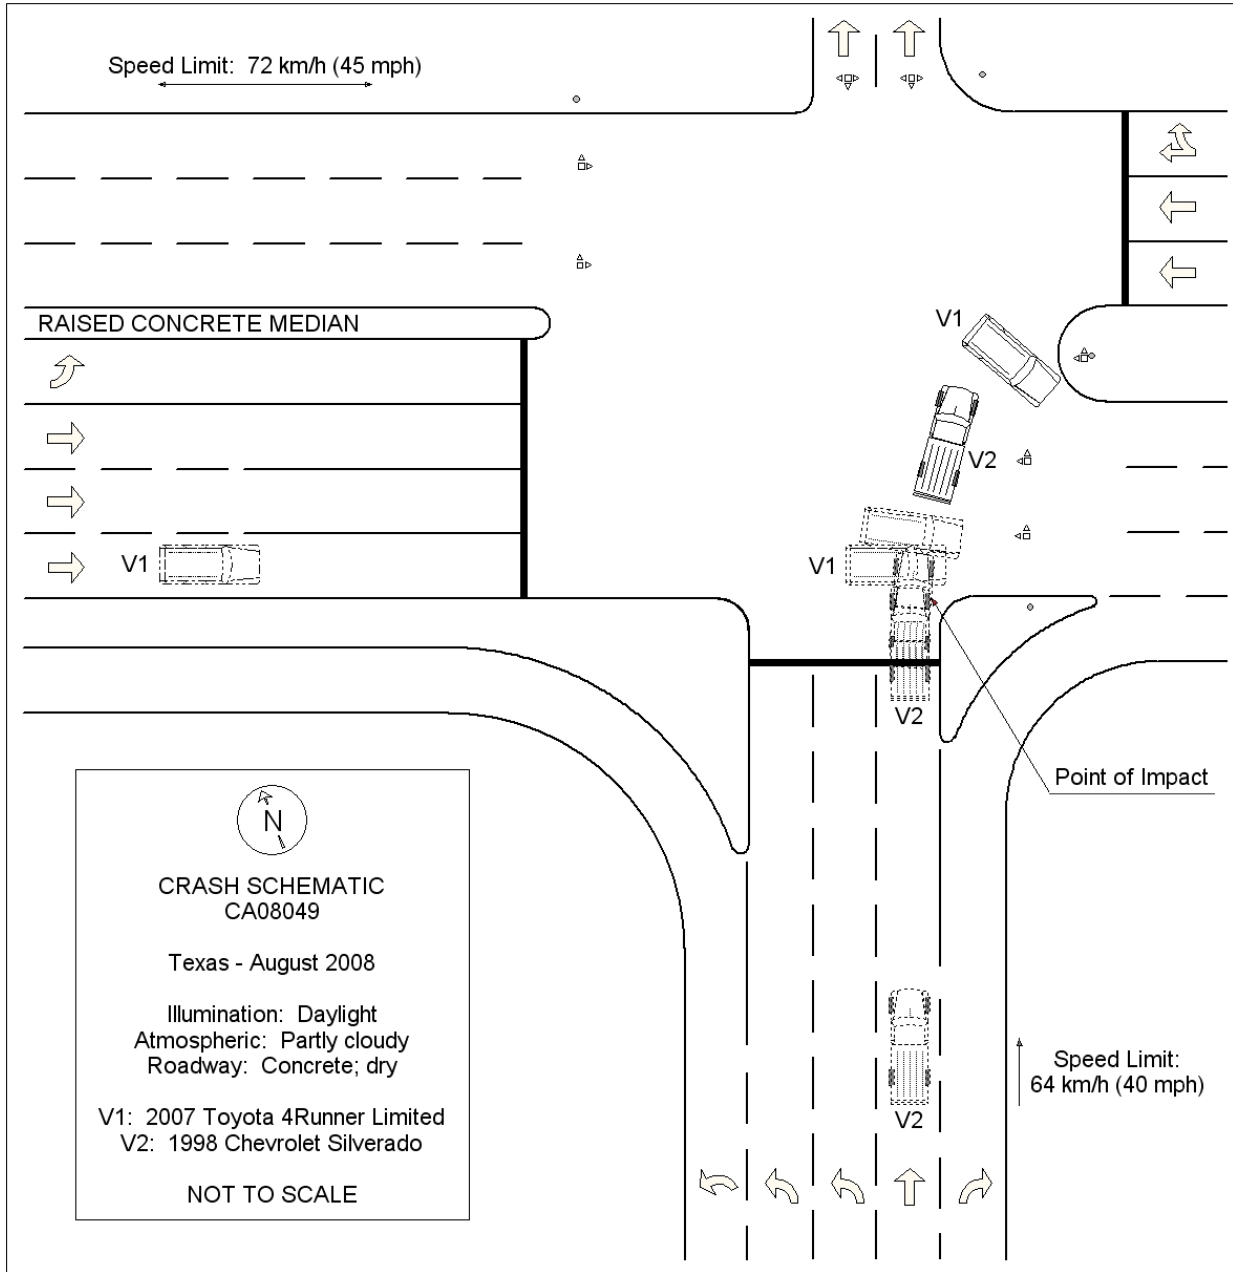
Figure 10: Crash Schematic.

The frontal plane of the Chevrolet impacted the right side of the Toyota. The resultant directions of force were 2 o'clock for the Toyota and within the 11 o'clock sector for the Chevrolet. The missing vehicle algorithm of the WinSMASH model was used to calculate the severity of the crash (delta-V) due to the unavailability of the Chevrolet for this investigation. The total delta-V of the Toyota was 11 km/h (6.8 mph). The longitudinal and lateral components were -5.5 km/h (-3.4 mph) and -9.5 km/h (-5.9 mph), respectively. The total calculated delta-V of the Chevrolet was 13 km/h (8 mph), with a longitudinal component of -11.3 km/h (-7 mph) and lateral component of 6.5 km/h (4 mph). This algorithm serves as a borderline reconstruction for the impact event between the two vehicles. The side impact resulted in the deployment of the front right seatback-mounted air bag and the IC air bags in the Toyota. The PAR listed the frontal air bag system as deployed in the Chevrolet. The Toyota initiated a left lateral translation due to the force of the impact on its right side. Subsequently, both vehicles rotated clockwise (CW) and slid to final rest within the intersection.
