CALSPAN ON-SITE ROLLOVER CRASH INVESTIGATION

SCI CASE NO.: CA08050

VEHICLE: 2006 FORD ESCAPE

CRASH DATE: AUGUST 2008

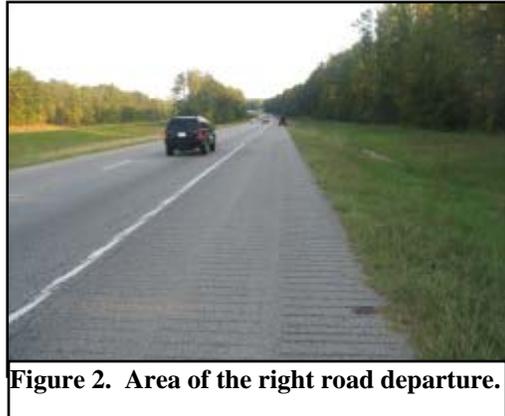
The 19-year-old male driver was operating the 2006 Ford Escape southbound on the inboard lane with the cruise control set to 121 km/h (75 mph). The driver stated to the SCI investigator that while traveling southbound, he observed a large section of tire debris on the inboard lane. He applied a left steering input to avoid the debris and entered the grass median. The driver subsequently applied a right steering input in an attempt to regain the travel lane. The Ford reentered the roadway and initiated a clockwise yaw as it traversed the travel lanes and departed the west roadside (**Figure 2**). The driver

Figure 2. Area of the right road departure.

applied the brakes in an attempt to regain control of the Ford. It should be noted that two locked tire marks were present on the shoulder in the area of the crash site. The tread pattern of these marks was indicative of a vehicle in a near tracking attitude and was not consistent with the CW yaw of the Ford. Therefore, these marks were deemed to be unrelated to this crash.

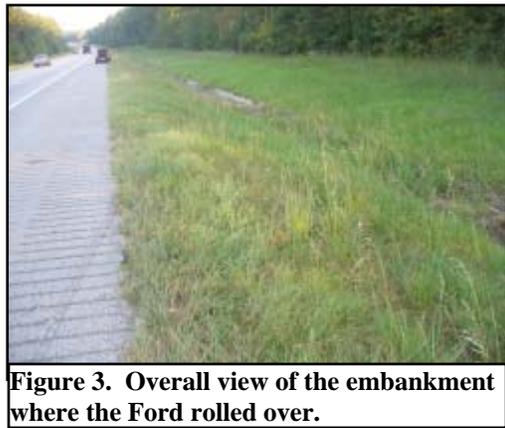
The Ford entered the grass embankment area where the left tires rolled under the alloy wheels exposing the rim beads to the soft terrain. The rim beads gouged the ground which tripped the vehicle into a left side leading rollover event. The Ford rolled down the embankment and partially climbed the back slope of the embankment. The vehicle rolled over a total of four-quarter turns coming to rest on its wheels facing a westerly direction. The rollover sensor actuated the dual pretensioners and deployed both IC air bags. **Figure 3** is an overall view of the crash site.

Figure 3. Overall view of the embankment where the Ford rolled over.

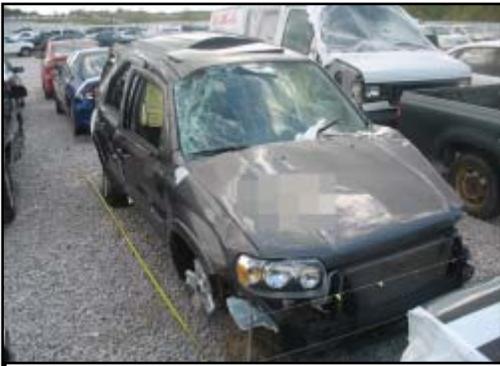
The Ford sustained moderate severity damage from this rollover crash (**Figure 4**). The damage consisted of scattered abrasions throughout the sides and roof of the vehicle. In addition to the abrasions, the vehicle sustained multiple areas of isolated deformation. The top plane sustained the majority of the deformation with 8 cm (3.1 in) of maximum vertical crush and 5 cm (2 in) of maximum lateral crush occurring at the right A-pillar (**Figure 5**). In addition to the crush, the windshield was fractured and the right front, rear door, and backlight glazing were disintegrated. The front left, front right, and the rear right alloy wheels were fractured near the base of the spokes. The rear left wheel was not damaged. The CDC assigned to this impact was 00-TDDO-3. The four doors remained closed during the crash. Post-crash, the left side, tailgate, and the rear right doors were operational. The front right door was jammed in the closed position.

Figure 4. Front right oblique view of the residual damage.

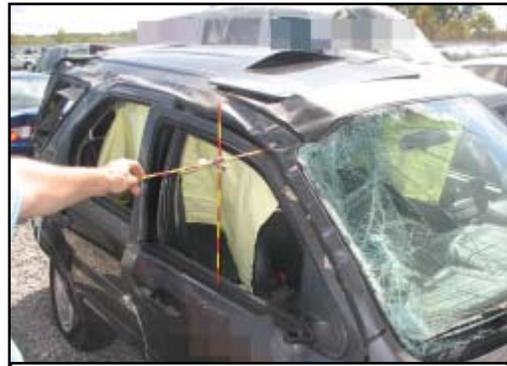
Figure 5. Location of maximum vertical and maximum lateral crush.

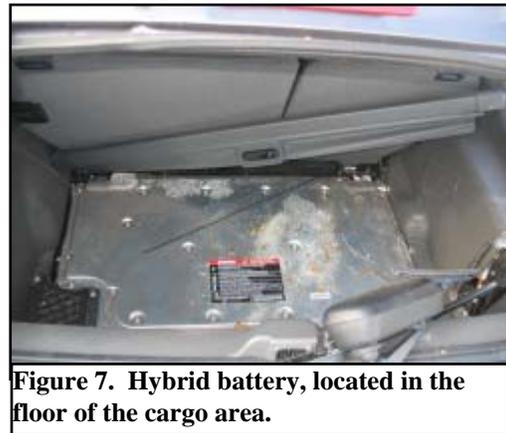
The 2006 Ford Escape Hybrid was equipped with a hybrid battery system used to drive an electric motor that assists the gasoline engine. This system improves fuel efficiency while the gasoline engine is in use, or to provide power for vehicle movement at lower speeds without the use of the gasoline engine. The hybrid battery was manufactured by Sanyo and consisted of 250 cells in 50 modules. It has a nominal voltage of 300-V with a capacity of 5.5-Ah using nickel-metal hydride cells and a potassium hydroxide electrolyte. The hybrid battery was located centered under the cargo area of the vehicle. The hybrid battery system was not damage during the crash.

Figure 7. Hybrid battery, located in the floor of the cargo area.

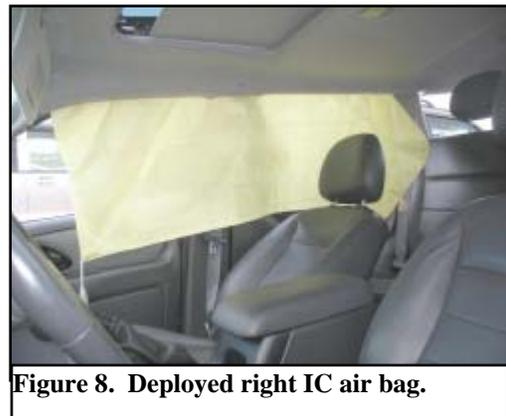
The Ford was equipped with seat back-mounted side impact air bags and roof rail-mounted IC air bags with rollover sensing. The seat back-mounted side impact air bags did not deploy during the crash. Both IC air bags deployed during the rollover crash sequence (**Figure 8**). The curtain air bags were 150 cm (59 in) in length and 43 cm (17 in) in height. The IC did not provide full coverage across the side glazing of the Ford. A triangular shaped void that measured 33 cm (13 in) in height and 36 cm (14

Figure 8. Deployed right IC air bag.

in) in width was present at the forward aspect of the IC's. Vertically, a 3 cm (1 in) gap was present between the IC's and the beltline. Rope-type tethers were used to tether the IC's to the A- and C-pillars. These tethers were cut post-crash by rescue personnel. There was no damage or occupant contact points to the IC's.

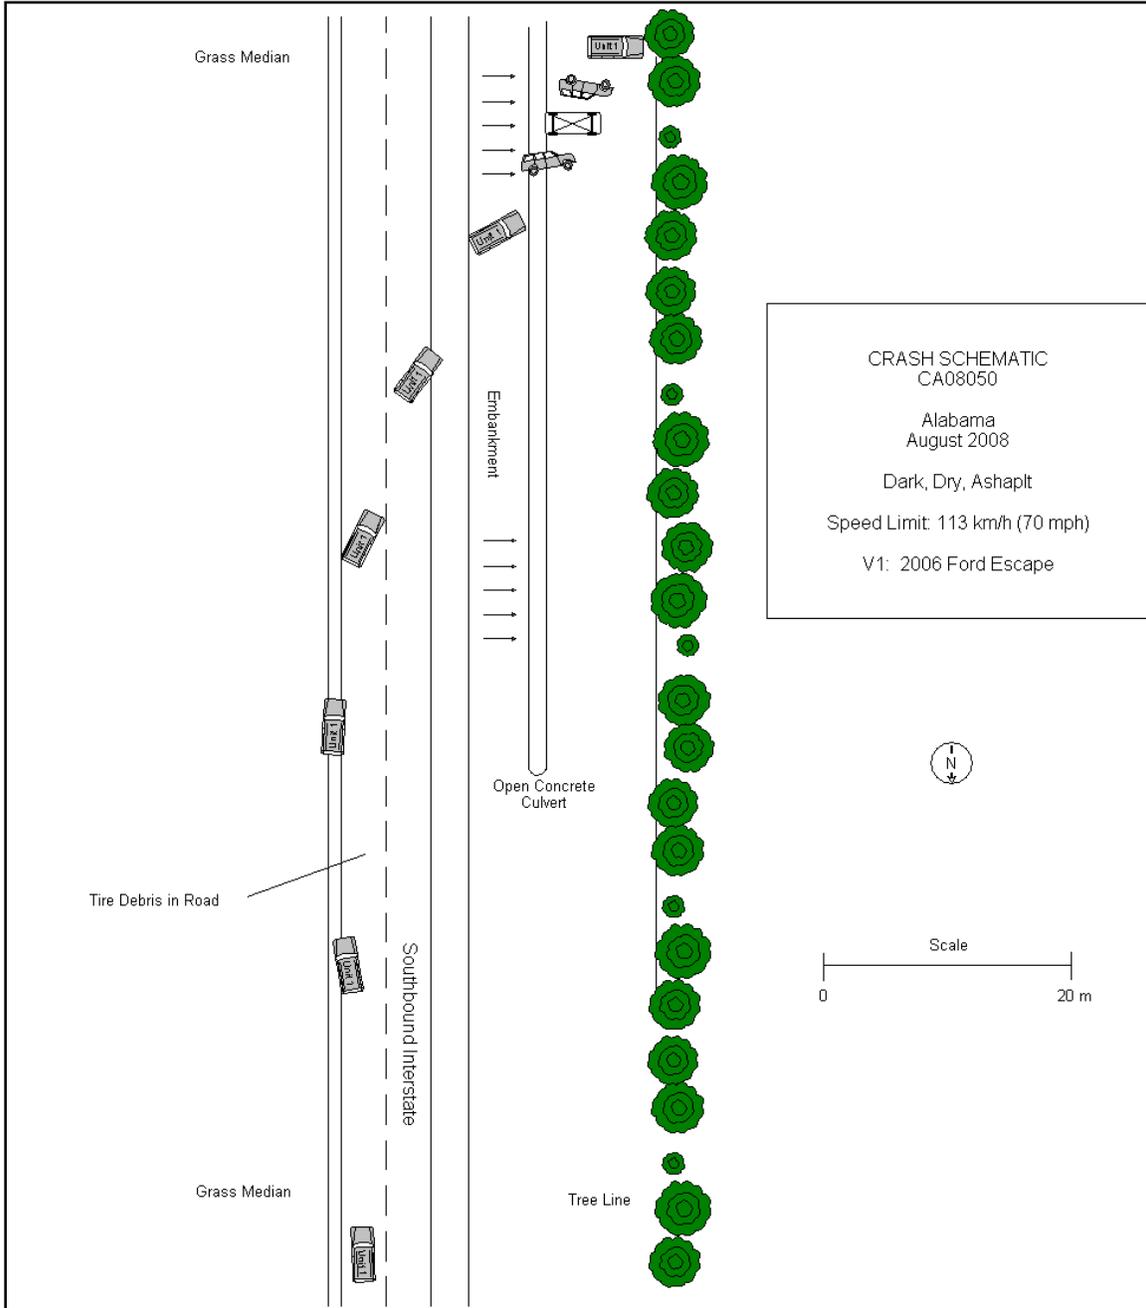
Figure 8. Crash Schematic

This crash occurred during the nighttime hours of August 2008 on the roadside of a four-lane north/south interstate. The travel lanes were surfaced with asphalt and at the time of the crash the weather conditions were reported as clear and the road surface was dry. The interstate was configured with the two travel lanes in each direction that were separated by a depressed grass median. The southbound lanes were bordered by asphalt shoulders. The shoulder on the east roadside was surfaced with asphalt and was approximately 0.9 meters (3 feet) in width. The west shoulder was surfaced with asphalt and was 3.1 meters (10.2 feet) in width. Three rows of rumble strips were cut into the west shoulder. The posted speed limit was 113 km/h (70 mph). The west roadside consisted of a 17.2 meter (56.4 feet) wide grass embankment. The down slope began at the end of the shoulder and extended 4.9 meters (16 feet) to an open concrete culvert. The open concrete culvert measured 1.3 meters (4.3 feet) in width. The Crash Schematic is included as **Figure 9** of this report.
