CALSPAN ON-SITE CHILD RESTRAINT SYSTEM CRASH INVESTIGATION

SCI CASE NO: CA08051

VEHICLE: 2000 CHEVROLET MALIBU

CRASH DATE: OCTOBER 2008

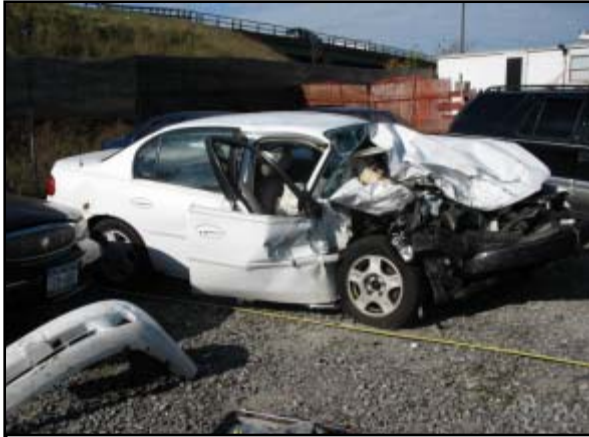
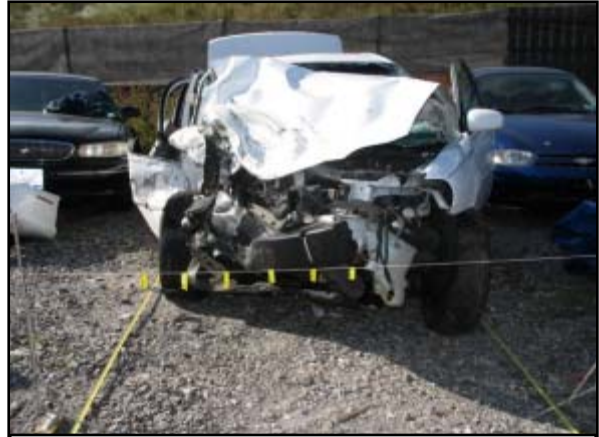
The 2000 Chevrolet Malibu sustained severe frontal damage as a result of the head-on impact with the Oldsmobile (**Figure 6 and 7**). The damage from this impact consisted of longitudinal deformation of the frontal structure that involved the following components: bumper fascia, bumper beam, upper and lower radiator supports, frame members, hood, and the right fender. The damage was slightly off-set to the right resulting in 66 cm (26 in) of compression to the right wheelbase. The direct contact damage began 30 cm (12 in) left of the centerline and extended 76 cm (30 in) to the right bumper corner. The maximum crush was located 13 cm (5 in) inboard of the right bumper corner and measured 111 cm (43.7 in) in depth. Six equidistant crush measurements were documented along the bumper beam and were as follows: C1 = 4 cm (1.6 in), C2 = 25 cm (9.8 in), C3 = 45 cm (17.7 in), C4 = 97 cm (38.2 in), C5 = 111 cm (43.7 in), C6 = 110 cm (43.3 in). The Collision Deformation Classification (CDC) for the impact with the Oldsmobile was 12-FDEW-5.

Figure 6. Front right view of the frontal damage to the Chevrolet .

Figure 7. Overall view of the Chevrolet's frontal crush profile.

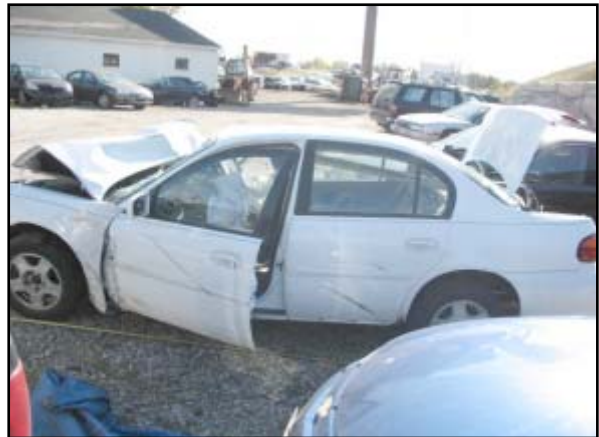
The Chevrolet sustained minor damage to the left plane from the secondary impact with the Ford (**Figure 8**). This impact consisted of abrasions to the left fender and doors and minor lateral deformation to the fender and left front door. The direct contact damage which contained rubber transfers from the left rear tire of the Ford measured 252 cm (9.2 in) beginning on the center of the left rear rim and extended forward. The direct contact had a maximum height of 83 cm (32.7 in). The maximum crush measured 6 cm (2.3 in) and was located at the rear aspect of the left fender. The CDC assigned to this impact was 12-LDES-1.

Figure 8. Left side damage to the Chevrolet from the impact with the Ford.

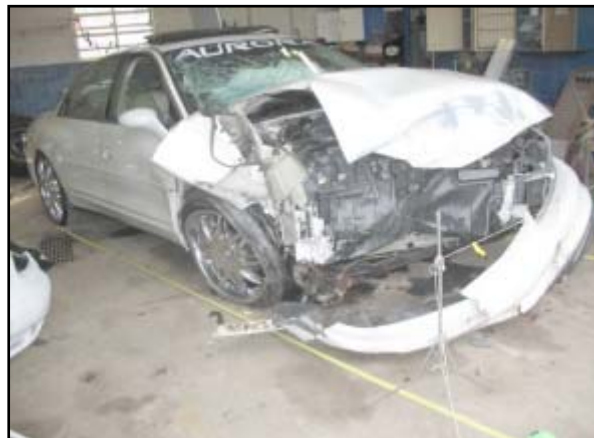
The 1997 Oldsmobile Aurora sustained severe damage as a result of the collision with the Chevrolet (Figure 10). The direct contact damage extended across the 142 cm (56 in) wide bumper fascia. The bumper beam was separated from its mounting points; therefore the crush documentation was obtained at the upper radiator support. The maximum crush was located 19 cm (7.5 in) inboard of the right end of the upper radiator support and was 83 cm (32.7 in) in depth. The crush profile along this component was as follows: C1 = 18 cm (7.1 in), C2 = 31 cm (12.2

Figure 10. Resultant damage to the front of the Oldsmobile.

in), C3 = 64 cm (25.2 in), C4 = 79 cm (31.1 in), C5 = 83 cm (32.7 in), C6 = 79 cm (31.1 in). The CDC for the impact with the Chevrolet was 12-FDEW-3.
