**CALSPAN ON-SITE OFFICE OF DEFECTS INVESTIGATION
ROLLOVER CRASH INVESTIGATION**

SCI CASE NO. – CA08052

VEHICLE – 2007 FORD ESCAPE XLT

CRASH DATE – OCTOBER 2008

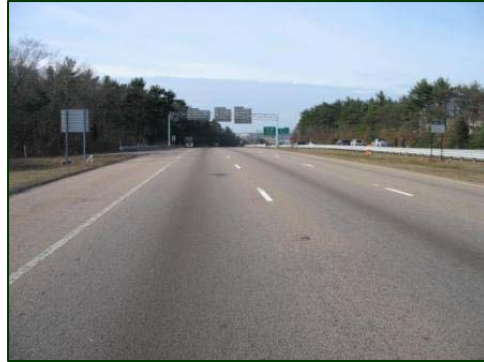
Figure 2. Look-back view of the Ford's pre-crash trajectory.

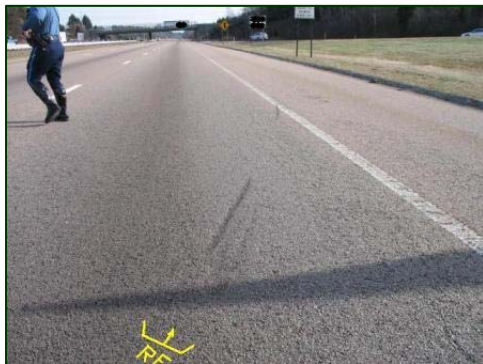
As the Escape entered the outboard travel lane, the driver applied a rapid counterclockwise (CCW) steering input in an attempt to maintain directional control of the vehicle. This CCW input loaded the right side tires. The right front tire rolled under the alloy wheel and probably experienced a loss of air pressure. The alloy wheel subsequently gouged the asphalt road surface, originating in the center of the outboard travel lane and arced in a CCW direction at the outboard edge line (**Figure 4**). As this point the vehicle was in a slight CCW yaw.

Figure 4. Right front wheel gouge mark.

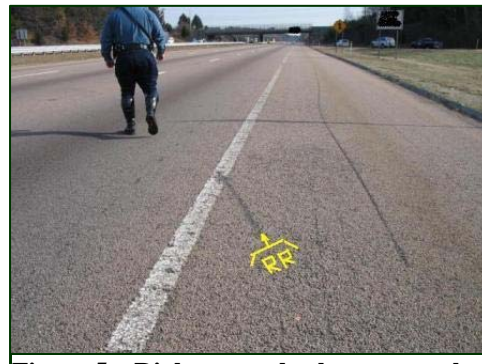
The right rear tire rolled under the alloy wheel, causing the wheel to gouge the asphalt shoulder, terminating at the edge line (**Figure 5**). These wheel gouges tripped the Escape into a lateral right side leading rollover event.

Figure 5. Right rear wheel gouge mark.

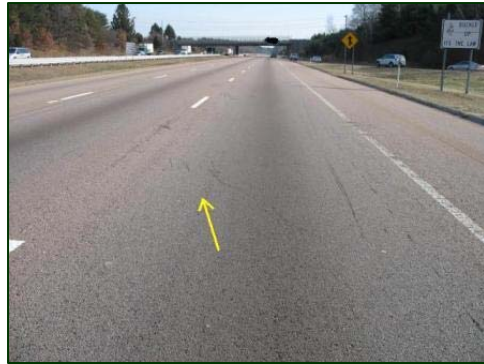
The vehicle overturned to its right as it traversed the eastbound travel lanes (**Figure 6**). The left roof side rail area impacted the pavement between the second and third quarter turns resulting in lateral and downward deflection of the roof. The left side glazing disintegrated. The restrained driver responded laterally to her left. Her head was partially ejected through the window opening and was crushed between the asphalt road surface and the left side rail of the vehicle. Body fluid and strands of hair evidenced the contact area on the vehicle.

Figure 6. Rollover trajectory of the Ford Escape.

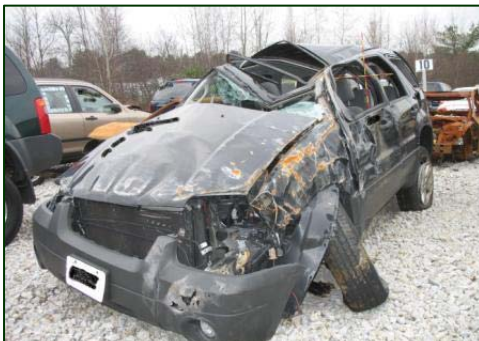
The exterior of the Ford escape sustained severe damage to the roof that was associated to the rollover event. The direct contact damage consisted of road surface abrasions that extended the full length and width of the vehicle (**Figure 7**). The abrasions were primarily laterally oriented across the leading edge of the hood, the roof side rails, the windshield header and the backlight header area at both D-pillars. The left aspect of the front bumper fascia was abraded with several small areas abraded full-thickness. The left corner of the bumper beam was crushed 5 cm (2").

Figure 7. Front left oblique view of the Ford Escape.

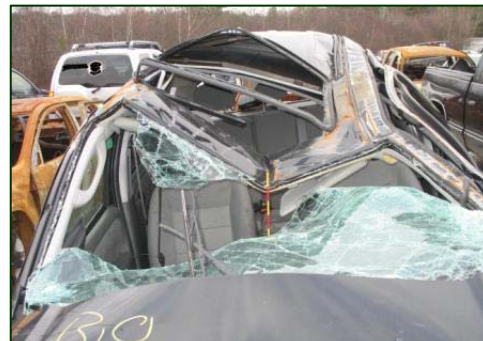
Maximum roof crush was 33 cm (12.9”) located at the mid aspect of the windshield header. This area of the roof buckled from lateral displacement of the left roof side rail. The left side rail was crushed downward approximately 20 cm (8”) and displaced laterally right 25 cm (10”) at the left A-pillar area (**Figure 8**). The Collision Deformation Classification (CDC) for this rollover is 00-TDDO-4.

Figure 8. Roof crush, vertical and lateral.

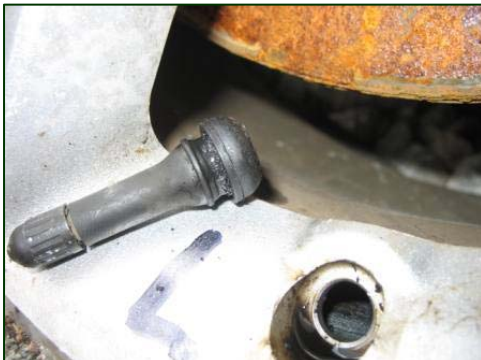
The OEM tire valves in the left front and rear wheels were presumed to have been manufactured by Topseal. These valve stems were closely inspected for signs of cracking during the SCI investigation. None of the valves appeared to have cracks. The SCI investigator proceeded to remove the valves from the alloy wheels. All four tires were flat and de-beaded from the wheels, thus the inner bulb of the valve was visible on the inside surface of the wheel. A silicone lubricant was applied to both surfaces of the stems at the wheel bore. A valve stem installation tool was threaded onto the stem and slight pressure was applied to stretch the stem away from the wheel to check for further cracking. None was visible. A small pry tool was used to push the bulb of the stem outward through the wheel bore as a slight pulling force was applied to the valve stem tool. All three valve stems were removed from the vehicle without difficulty and without further damage to the valves (**Figure 9**). This removal process facilitated a close and thorough inspection of the valve stems.

Figure 9. Removed LF valve stem.

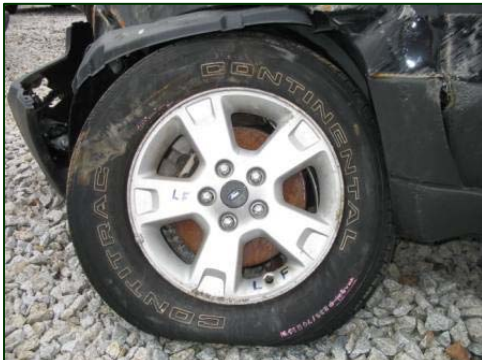
The left front tire was de-beaded. A 5 cm (2") vertically oriented cut was noted to the mid point of the outer sidewall of the tire, located nearly 180 degrees opposite of the tire valve. The sidewall of the tire was scuffed in this area from probable contact with the asphalt road surface during the rollover.

The left front alloy wheel was abraded 360 degrees circumferentially about the outer bead flange. A band of asphalt was embedded into the outer bead flange of the wheel and was 11 cm (4.5") in length. This asphalt was embedded immediately clockwise (CW) of the tire valve (**Figure 11**).

Figure 11. Left front tire and wheel.

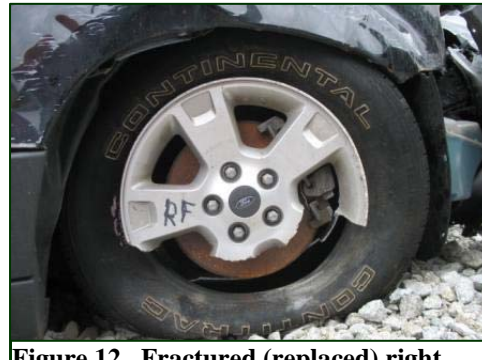
Figure 12. Fractured (replaced) right front alloy wheel and tire.

The right front tire was de-beaded with a 3 cm (1") vertical cut located near the bead of the tire. The sidewall was scuffed and abraded from contact with the asphalt road surface.

The right front alloy wheel was the replacement wheel. The wheel fractured from impact with the road surface during the rollover (**Figure 12**). The wheel fractured below the horizontal centerline with fracture lines extending through inner wheel, both bead flanges, and two spokes immediately outboard of the hub. The fractured section separated from the vehicle and was not recovered during the SCI investigation. A small area of circumferential bead abrasion was located on the wheel above the fracture line. The remaining face of the wheel was not damaged.

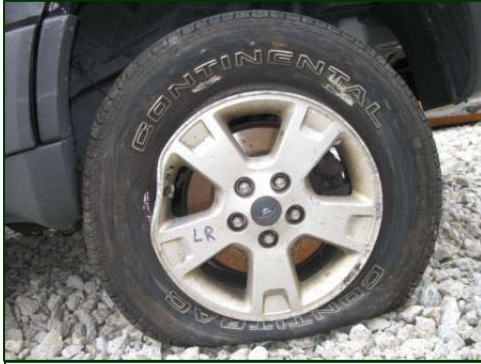
The left rear tire was de-beaded. A superficial gouge that measured 6x3 cm (2.5x1") was located on the mid aspect of the outer sidewall approximately 120 degrees CW of the tire valve. This gouge was not full thickness.

The outer bead flange of the left rear alloy wheel was deformed at the area of the tire valve (**Figure 13**). The dent was 15 cm (6") in length and approximately 3 cm (1") in depth. Subtle cracking of the wheel at the inner bead flange resulted from this deformation. The outer bead flange was abraded 360 degrees circumferentially with asphalt embedded into the flange nearly opposite of the valve.

Figure 13. Left rear tire and wheel.

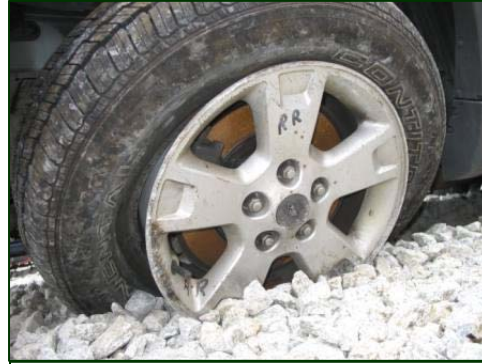
Figure 14. Right rear tire and wheel.

The right rear axle was deformed by the tire/wheel impact with the road surface during the rollover event. This resulted in severe camber to the axle position with the bottom aspect of the wheel cambered inward. The outer bead flange was abraded 360 degrees circumferentially with a 13 cm (5") area of asphalt embedded into the bead flange in the area of the tire valve (**Figure 14**). This probably occurred during the pre-crash counterclockwise yaw of the Escape as asphalt fragments were spattered onto the stem.

The right rear tire was de-beaded and no visible damage was noted to the tire. Scuffing on the sidewall of the tire appeared to have occurred from moving the vehicle on the coarse stone at the salvage facility.

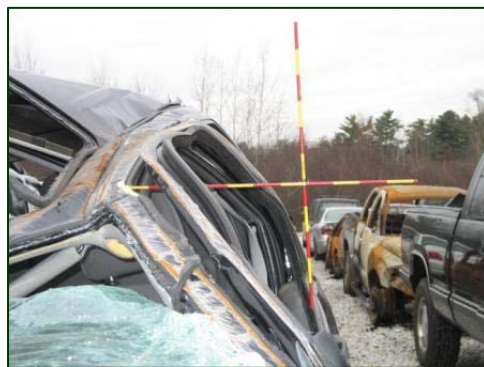
The driver responded to the non-horizontal rollover crash forces by moving laterally about the interior of the vehicle. During the third-quarter turn, the driver’s head moved left with respect to the vehicle as the left roof side rail was deflected laterally right, disintegrating the left front door glazing. The driver’s head was partially ejected through the left front door window opening and was crushed between the roof side rail and the asphalt road surface (**Figure 15**). The safety belt system restrained the driver’s body and prevented full ejection from the vehicle.

Figure 15. Lateral crush to the greenhouse area that created an ejection portal for the driver’s head.
