**OFFICE OF DEFECTS INVESTIGATION
CALSPAN ON-SITE CRASH RELATED VEHICLE FIRE INVESTIGATION
SCI CASE NO: CA08053**

**VEHICLE: 2007 DODGE CHARGER POLICE VEHICLE
LOCATION: TEXAS
CRASH DATE: NOVEMBER 2008**

<p>14. Sponsoring Agency Code</p>	
<p>15. Supplementary Note An investigation of a post-crash fire in a 2007 Dodge Charger Police Vehicle involved in a multiple impact crash event.</p>			
<p>16. Abstract</p> <p>This on-site investigation focused on the cause of a fuel leak that resulted in a fuel-fed fire of a 2007 Dodge Charger Police Vehicle that was involved in a three vehicle multiple event crash. The High Density Polyethylene (HDPE) fuel tank in the Charger was a saddle-bag design located forward of the rear axle spanning the drive shaft. The vehicle manufacturer certified that the 2007 Dodge Charger was compliant with the 80 km/h (50 mph)/70 percent overlap moving deformable barrier test requirements of Federal Motor Vehicle Safety Standard (FMVSS) No. 301.</p> <p>The Dodge Charger was involved in a police pursuit with lights and siren activated at the time of the crash. The Dodge entered an intersection where it was struck on the right side by a 1999 Honda Accord. The impac

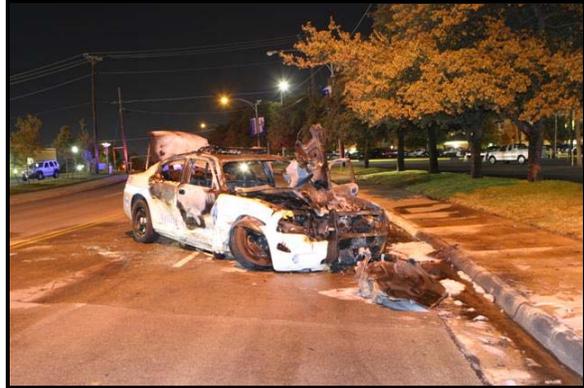
The vehicle slid to rest in the outboard westbound lane without further rotation. The Dodge came to rest 14 m (46 ft) west of the tire imprint facing southwest. The sparks generated during the ground impact and slide to final rest ignited the fuel vapor resulting in a post-impact fire. The fire completely consumed the vehicle. **Figure 9** is a view of the Dodge at final rest.

Figure 9: Final rest of the Dodge.

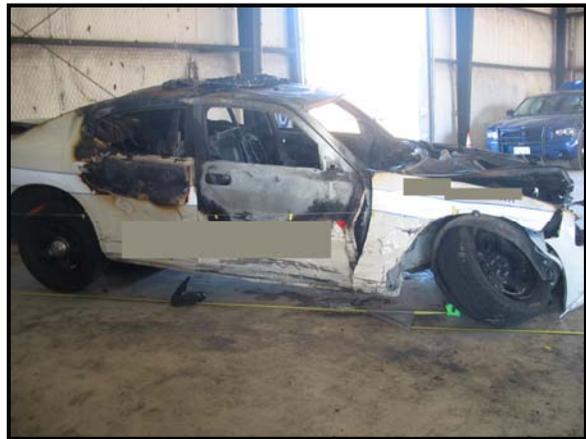
The Dodge Charger sustained multiple regions or zones of damage resultant to the multiple event crash sequence. The damage to the right plane consisted of a 252 cm (99.2 in) long region of deformation to the right fender and right doors as a result of the lateral impact with the Honda. The direct contact began on the right fender 15 cm (5.9 in) aft of the right front axle and extended to the right rear wheel opening. Refer to **Figure 10**. The maximum crush occurred on the right front door 16 cm (6.3 in) aft of the base of the A-pillar. The maximum crush measured 14 cm (5.5 in). The residual crush measured at the mid-door elevation was as follows: C1 = 1 cm (0.4 in), C2 = 10 cm (3.9 in), C3 = 11 cm (4.3 in), C4 = 13 cm (5.1 in), C5 = 12 cm (4.7 in), C6 = 3 cm (1.2 in). The Collision Deformation Classification (CDC) was 01-RYEW2.

Figure 10: Right view of the Dodge.

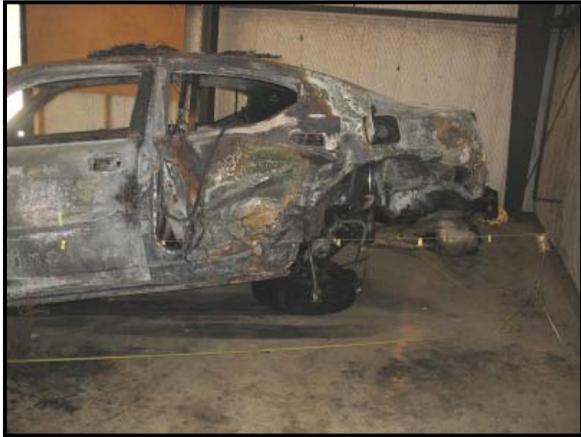
Figure 11 is a left side view of the Charger depicting the contact damage from the BMW. The direct contact damage to the left plane began on the mid-aspect of the left front door 135 cm (53.1 in) aft of the front left axle. The direct contact damage extended 238 cm (93.7 in) to the left corner. The forward edge of the rear left door snagged in the impact and buckled the door panel rearward. The residual mid-door crush measured was as follows: C1 = 9 cm (3.5 in), C2 = 6 cm (2.4 in), C3 = 9 cm (3.5 in), C4 = 14 cm (5.5 in), C5 = 13 cm (5.1 in), C6 = 0. The CDC of this impact was 11-LZEW2. The body panel damage under-represented the severity of the impact due to the presence of significant wheel-to-wheel interaction between the vehicles. The

Figure 11: View of the left side damage.

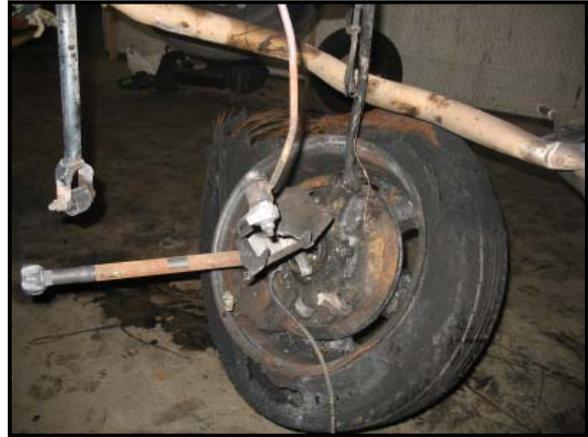
impact resulted in a near complete fracture of the left rear suspension components. The forward stabilizer link, lower control arm, and shock absorber fractured at the mounting points. The upper control arm fractured mid-shaft. The wheel remained attached by only the rear stabilizer link. During the post-impact rotation away from the BMW, the left axle shaft separated from the differential. **Figure 12** is a view of the left rear wheel and fractured suspension.

Figure 12: Damaged left rear wheel and suspension.

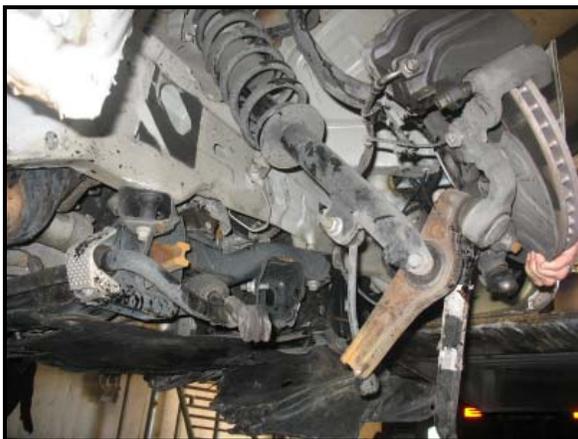
The Dodge impacted the curb in the storm drain with the front right tire. This force of this impact resulted in moderate damage to the wheel, completely fractured the suspension and altered the dynamics of the vehicle. The CDC of this impact was 12-FRWN3. **Figure 13-14** are views of the fractured suspension and separated wheel. The mounting points of forward control arm link fractured and the control arm separated from the box frame retainer. The center control arm link fractured mid-shaft. The vertical strut separated at the upper aspect. There was minor body deformation in the aft aspect of the wheel opening from tire contact. The outer sidewall of the tire was cut during the impact. The outboard wheel rim was deformed over a 30 cm (12 in) region with a 6 cm (2.5 in) deflection of the bead. Directly opposite this deformation on the inboard side, the rim was deformed over a 20 cm (8 in) region with a 3 cm (1 in) bead deflection.

Figure 14: Front right suspension damage.

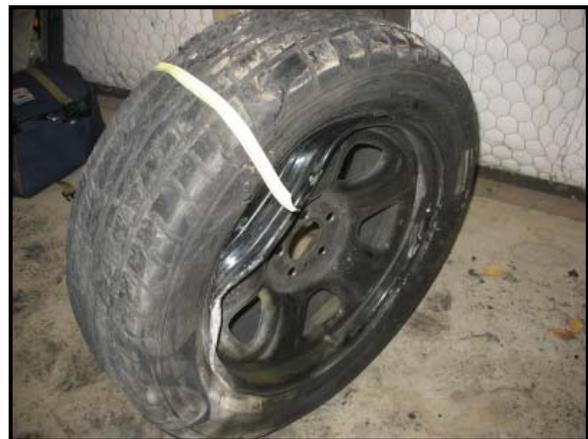
Figure 14: Front right wheel damage.

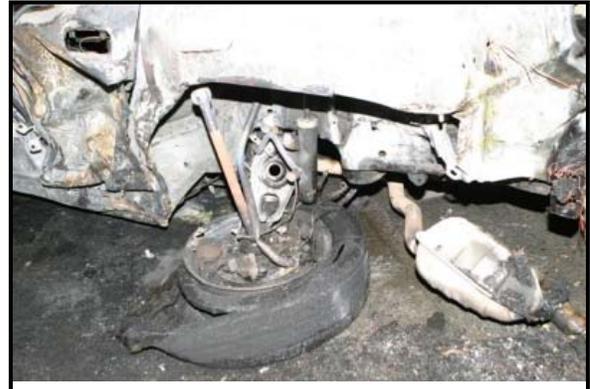
The fuel tank inlet was located in the lower left rear aspect of the fuel tank immediately forward of the rear left wheel opening. This area of the tank was the source of the leak and origin of the fire. **Figure 15** is a police image taken of the vehicle at final rest. As a direct consequence of the front right impact, the Dodge pitched down and rotated CW approximately 90 degrees. At ground contact, the separated rear left wheel and suspension was in the area of the fuel tank inlet. Due to the compression of the road impact, contact between the suspension/wheel and the fuel tank/inlet occurred at this time. That contact caused the separation of the fuel filler neck from the tank inlet as well as the separation of the inlet from the tank. It was possible, although undetermined, that the left outboard aspect of the fuel tank may have been punctured as well. The post-crash fire consumed that portion of the tank.

Figure 15: Rear left area of the Dodge at final rest.

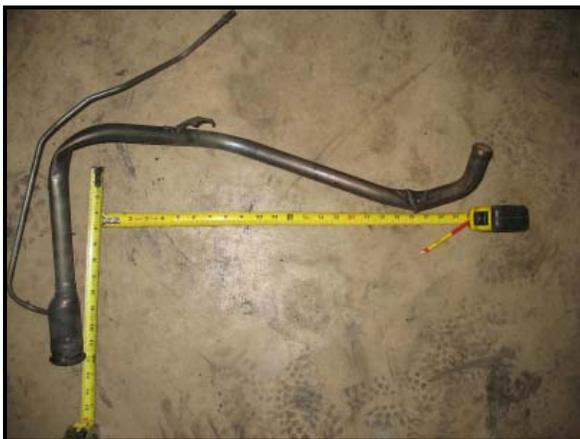
Figures 16 and 17 are views of the deformed filler neck and separated inlet. The filler neck was found dislodged within the rear left wheel opening. The tube was crushed full thickness 20 cm (8 in) from its downstream end. The mid-aspect of the tube was crushed and bent 90 degrees. The tube had separated from the filler door at its upper aspect and from the neoprene connector hose at its lower end. The band clamp fastening it to the connector hose fractured. The clamp was found along the curb line between the storm drain and final rest location. A cut 3 cm (1 in) in length was noted to the hose. The inlet valve completely separated from the tank. The check valve mounted within the inlet was not present and could not be found. There was no evidence of contact observed on the inlet or hose. The inlet was found in the grass beyond the sidewalk adjacent to the final rest area of the vehicle.

Figure 16: View of the deformed filler tube.

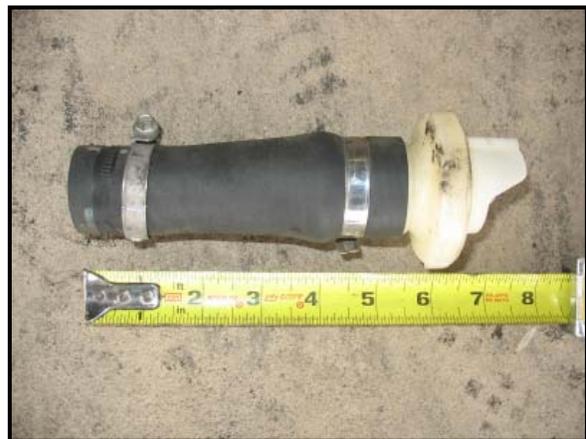
Figure 17: View of the separated inlet.

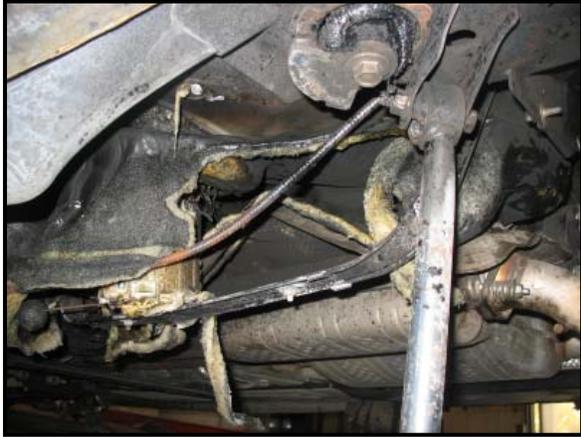
Figure 18 is a view of the burned fuel tank looking to the right. **Figure 19** is a right view of the burned tank. The left third of the tank was consumed in the fire. The SCI inspection revealed that there was no deformation of the vehicle's sill, frame or undercarriage that would have

Figure 18: View of the burned tank looking to the right side of the Dodge.

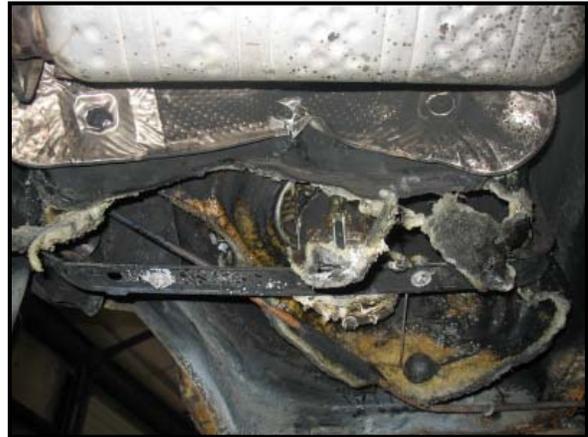
Figure 19: View of the burned tank looking to the left side of the Dodge.

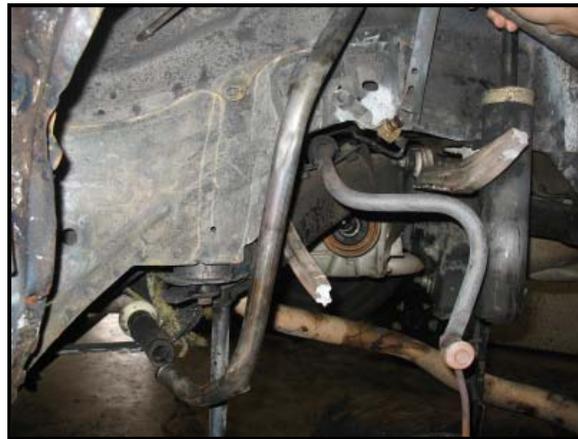
accounted for the inlet valve separation. The left band strap that held the tank in place was not deformed. **Figure 20** is a view depicting the orientation of the separated inlet and filler tube for reference.

Figure 20: View of the separated inlet and filler tube reconstructed for reference.

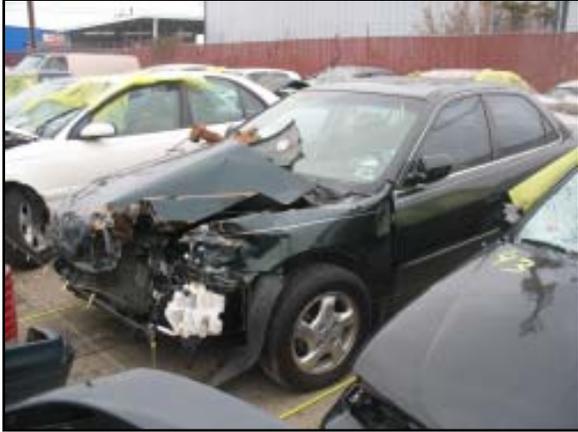
Figures 21 and 22 are the front left and overhead views of the Honda Accord. The Honda sustained moderate severity frontal damage as a result of the crash with the Dodge. The damage components consisted of the front bumper fascia, bumper beam, head light assemblies, hood, upper and lower radiator supports, and the fenders. The 10 o'clock direction force resulted in right shift of the frontal structure. The direct contact damage measured 148 cm (58.3 in) and extended across the full frontal plane. The maximum crush measured 20 cm (7.9 in) and was located 25 cm (9.8 in) inboard of the left end of the upper radiator support. During the impact, the front bumper fascia and bumper beam separated from the vehicle; therefore the crush was documented along the 125 cm (49 in) wide upper radiator support. The residual crush was as follows: C1 = 15 cm (6 in), C2 = 20 cm (7.9 in), C3 = 18 cm (7.1 in), C4 = 19 cm (7.5 in), C5 = 9 cm (3.5 in), C6 = 1 cm (0.4 in). There was no change in the wheelbase dimensions. The CDC for this impact was 70-FDEW-2 with an incremented end shift value of 60 added to the 10 o'clock direction of force.

Figure 22: Front left view of the Honda.

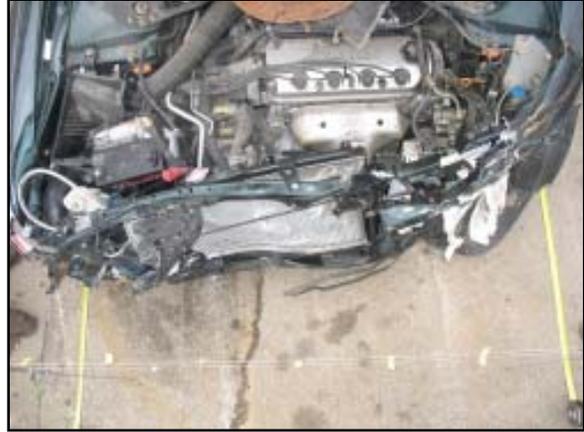
Figure 22: Overhead view of the frontal damage.

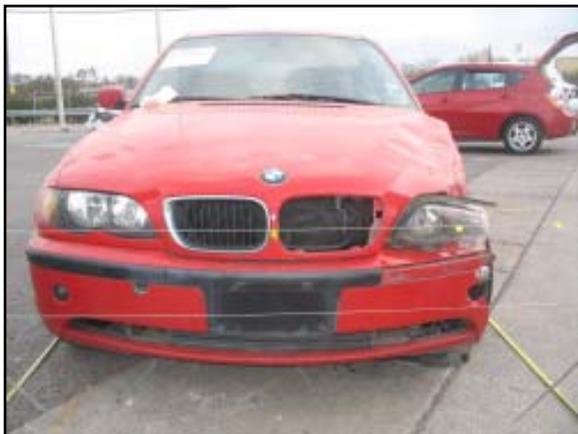
The 2004 BMW 325i sustained moderate severity damage to the front and left side planes, **Figures 23 and 24**. The direct contact damage began 50 cm (19.5 in) left of the centerline and extended 32 (12.5 in) to the left bumper corner. Crush was noted to the extreme outboard end of the bumper beam and measured 3 cm (1 in). The remainder of the bumper system was undamaged. As the vehicles continued to engage, the Dodge contacted the left side of the BMW resulting in deformation and abrasions to this plane. The direct contact damage extended 212 cm (83.5 in) onto the left front door. During this engagement, the left rear wheel of the Dodge impacted the BMW's front left wheel. The wheel deformed rearward and upward into the wheel opening. Refer to **Figure 24**. The left wheelbase was reduced 10 cm (4 in). The CDC for this impact was 12-FLEE-6.

Figure 23 Front view of the BMW.

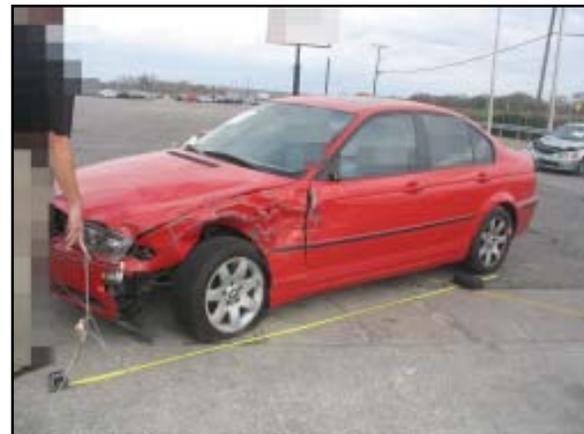
Figure 24: Front left view of the BMW.
