**CALSPAN ON-SITE CERTIFIED ADVANCED 208-COMPLIANT
VEHICLE CRASH INVESTIGATION**

CASE NO: CA09002

VEHICLE: 2008 HONDA PILOT

CRASH DATE: JANUARY 2009

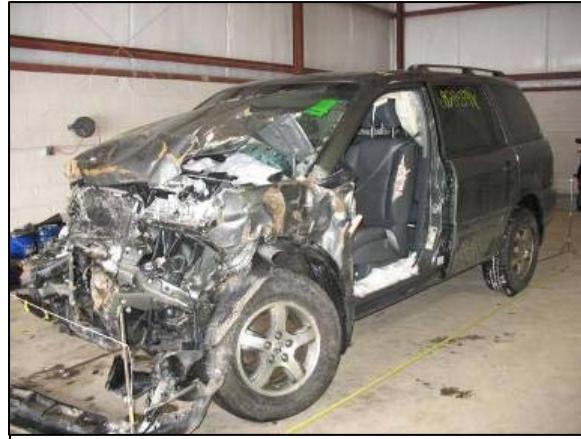
Figure 1: Left front oblique image of the 2008 Honda Pilot.

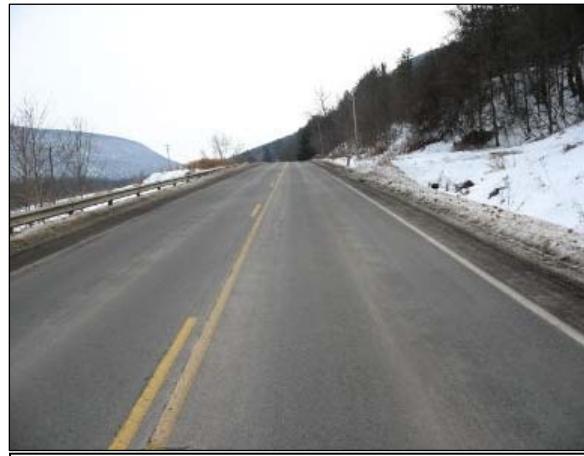
This crash occurred during the daylight morning hours of January 2009, on a 2-lane, 2-way north/south undivided roadway. At the time of the crash, the local area was experiencing snow showers and the bituminous road surface was snow covered. The roadway alignment was straight with a grade of 3.5 percent, positive to the south. The northbound travel lane measured 3.5 m (11.5 ft) in width while the southbound travel lane measured 3.9 m (12.8 ft) in width. Bituminous asphalt shoulders bordered both lanes. The west shoulder measured 0.7 m (2.3 ft) wide while the east side shoulder was 1 m (3.3 ft) wide. A W-beam guardrail bordered the east shoulder. The roadway was marked as a passing zone for the northbound travel direction with solid white edge lines. At the time of the SCI inspection, snow banks bordered the edges of the shoulders. The posted speed limit was 72 km/h (45 mph). The approximate point of impact was identified by a grouping of four gouge marks located in the southbound travel lane directly adjacent to a private driveway that was located on the west side of the roadway. **Figure 2** is a southbound view of the Honda Pilot's pre-crash path of travel. The Crash Schematic is included as **Figure 7** of this report.

Figure 2. Southbound trajectory view of the Honda's path of travel.

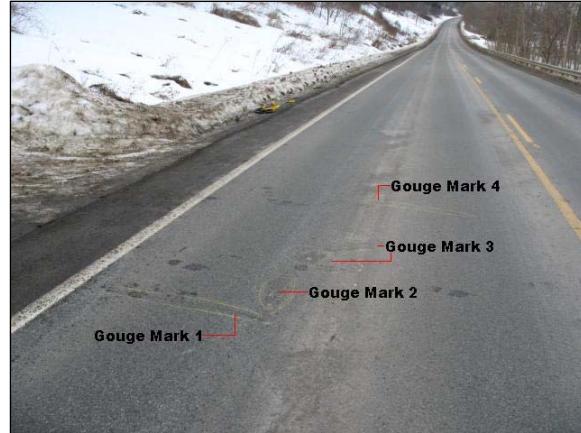
The full frontal area of the Honda impacted the left rear aspect of the Ford (Event 1). The damage to the Ford began of the left B-pillar and extended to the rear corner of the cargo bed. The directions of force were within the 12 o'clock sector for the Honda and the 9 o'clock sector for the Ford. The point of impact was located entirely within the southbound travel lane and was evidenced by a series of four gouge marks (**Figure 3**) that measured 0.2 m (0.7 ft) to 1 m (3.3 ft) in length. The Damage Algorithm of the WinSMASH program was used to calculate the severity (delta-V) of the crash. The total delta-V of the Honda was 43.0 km/h (26.7 mph). The longitudinal and lateral delta-V components were -43 km/h (-26.7 mph) and 0 km/h, respectively. The Ford's total delta-V was 37 km/h (23.0 mph) with longitudinal and lateral components of -6.4 km/h (-4.0 mph) and 36.4 km/h (22.6 mph). The impact resulted in the actuation of the Honda driver's safety belt pretensioner and the deployment of the Honda's driver's frontal air bag, the left seat back-mounted air bag and both IC air bags. The frontal air bags in the Ford did not deploy. The impact force was rearward of the Ford's center of gravity; therefore it induced a counterclockwise (CCW) rotation of approximately 70 degrees as the vehicle traveled to final rest. The Honda's left front fender area remained engaged with the Ford as the vehicles separated and headed on their respective post crash trajectories. The Honda's forward momentum was

Figure 3: Four gouge marks in southbound lane

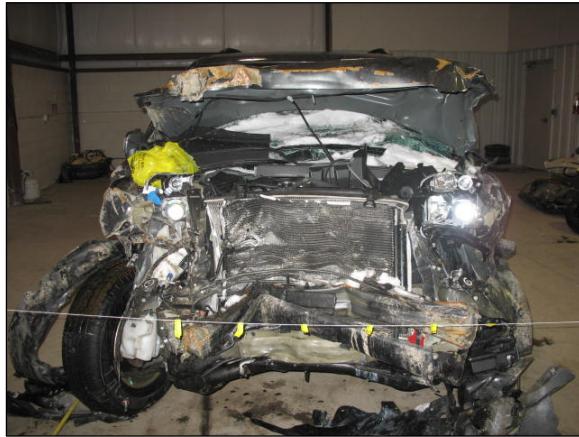
The exterior of the Honda sustained severe frontal damage as a result of the crash sequence. The direct contact damage was distributed across the entire width of the front plane and included the bumper fascia, bumper beam, radiator, both headlight assemblies, hood and both front fenders. The bumper fascia separated from the vehicle during the engagement; therefore the direct contact damage was measured along the bumper beam and was 194 cm (76.4 in) in width. The crash displaced the engine and transmission rearward into the cowl and toe pan of the Honda. The crush profile was documented at the level of the bumper beam along a deformed width (Field L) of 90 cm (35.4 in). The crush profile (**Figure 4**) was measured at the bumper level and its results are as follows: C1 = 17 cm (6.7 in), C2 = 26 cm (10.2 in), C3 = 47 cm (18.5 in), C4 = 47 cm (18.5 in), C5 = 46 cm (18.1 in), C6 = 19 cm (7.5 in). The maximum crush was located at C4. The left wheelbase was reduced in length by 1 cm (0.4 in) while the right wheelbase was elongated by the same measurement when compared to original specifications. The Collision Deformation Classification was 12FDEW3. The windshield was fractured, but all other glazing was intact. The left front door was jammed closed and was removed during on-scene extrication efforts of the driver. All remaining doors were intact and operational at the time of the SCI inspection.

Figure 4: Front plane crush profile of the Honda.

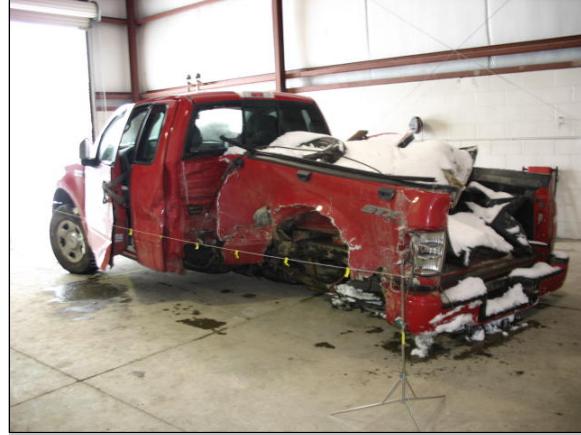
The exterior of the Ford sustained left side damage as a result of the crash sequence with the Honda. The direct contact damage began on the aft aspect of the left rear door and extended 207 cm (81.5 in) rearward to the left taillight assembly and included the entire length of the cargo bed and the left rear wheel/axle. It should be noted that the flareside-style cargo bed utilized fiberglass/composite quarter panels. The impact resulted in lateral deformation of the left side of the cargo bed which resulted in shifting of the bed to the right. The lateral offset of the bed to cab was 46 cm (18.1 in). The rear axle was displaced and separated from the vehicle. It was not with the Ford at the time of the SCI inspection. The combined induced and direct contact damage began at the midpoint of the left rear door and extended 218 cm (85.8 in) to the left rear corner. The crush profile (**Figure 5**) was measured at the lower door level of the cargo bed and was as follows: C1 = 57 cm (22.4 in), C2 = 65 cm (25.6 in), C3 = 61 cm (24.0 in), C4 = 65 cm (25.6 in), C5 = 79 cm (31.0 in), C6 = 0 cm. The maximum crush was located at C5. The Collision Deformation Classification was 09LZEW4.

Figure 5: Left side crush profile of the Ford F150

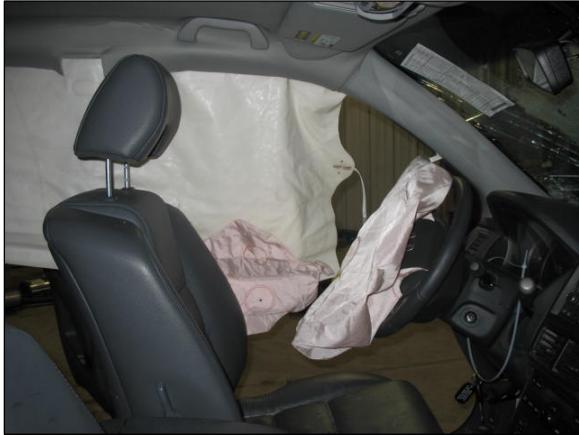
The Honda was also equipped with dual purpose rollover/side impact IC air bags (**Figure 6**) mounted within the roof side rails/headliner. Both IC air bags deployed as a result of the crash. The IC air bags measured 235 cm x 56 cm (92.5 in x 22 in) length x height in overall dimensions and provided coverage from the upper aspect of the A- to D-pillar

areas. A triangular shaped void in coverage was present at the forward third of the front door glazing. This area measured 51 cm x 36 cm (20.1 in x 14.2 in) length x height. A 24 cm (9.4 in) long tether extended from the A-pillars and was sewn to the forward aspect of the IC. The vertical coverage of the IC extended 11 cm (4.3 in) below the beltline in both the front and second row and 22cm (8.7 in) below the beltline in the third row. There was no contact evidence or damage to the deployed IC air bags.

Figure 6: Deployed driver IC airbag in Honda

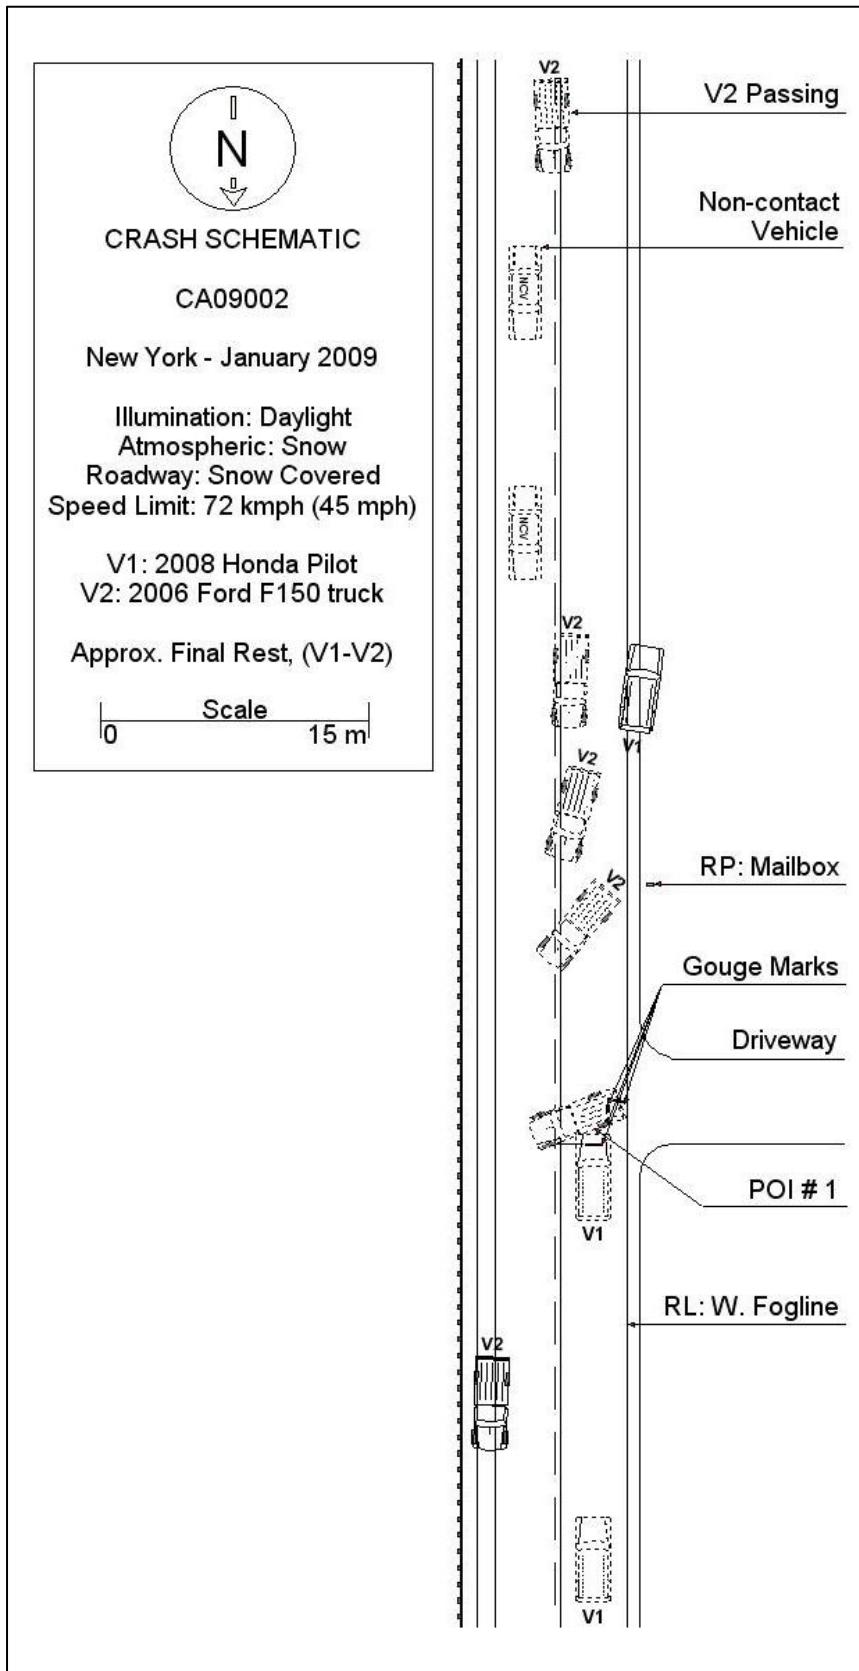
Figure 7. Crash Schematic

The Honda Pilot was traveling southbound, driven by the 49-year-old restrained female. The Ford F150 was traveling northbound, driven by the 42-year-old restrained male. The driver of the Ford lost directional control of the vehicle on the snow covered road surface as he attempted to pass a slower moving vehicle. The Ford initiated a counterclockwise yaw across the southbound travel lane, directly into the path of the southbound Honda.
